# Technical Service Bulletin

## 01 MIL on, DTC P243600 and/or P243700 stored in ECM

01 19 97 2049142/4 January 2, 2019. Supersedes Technical Service Bulletin Group 01 number 18-65 dated April 19, 2018 for reasons listed below.

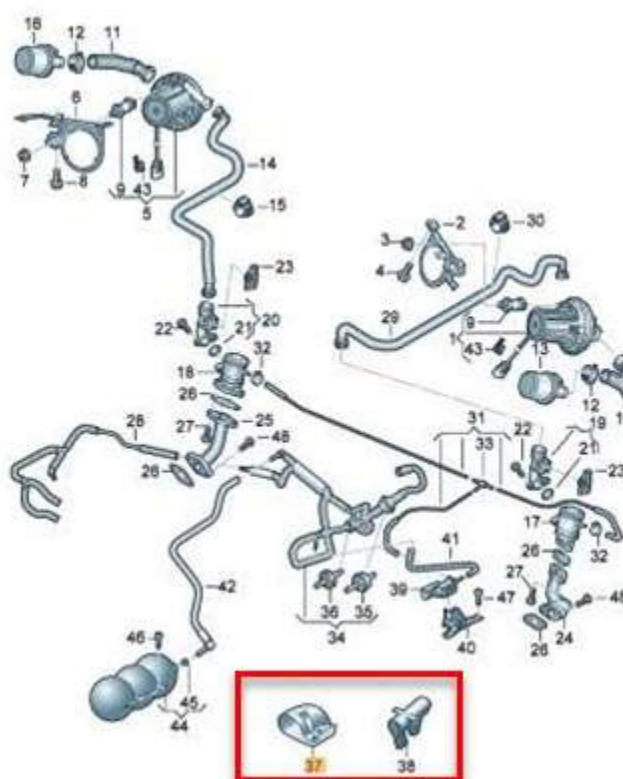
Figure 1. Replace the sender.

2. Then add the insulation (Figure 1, number 37 and 38) on the pressure sensor Bank 2.

At the end of the repair the pressure sensor and the combination valve should have the insulation on both banks (Figure 1, number 37 and 38). See Figure 2 for an example of installed insulation.

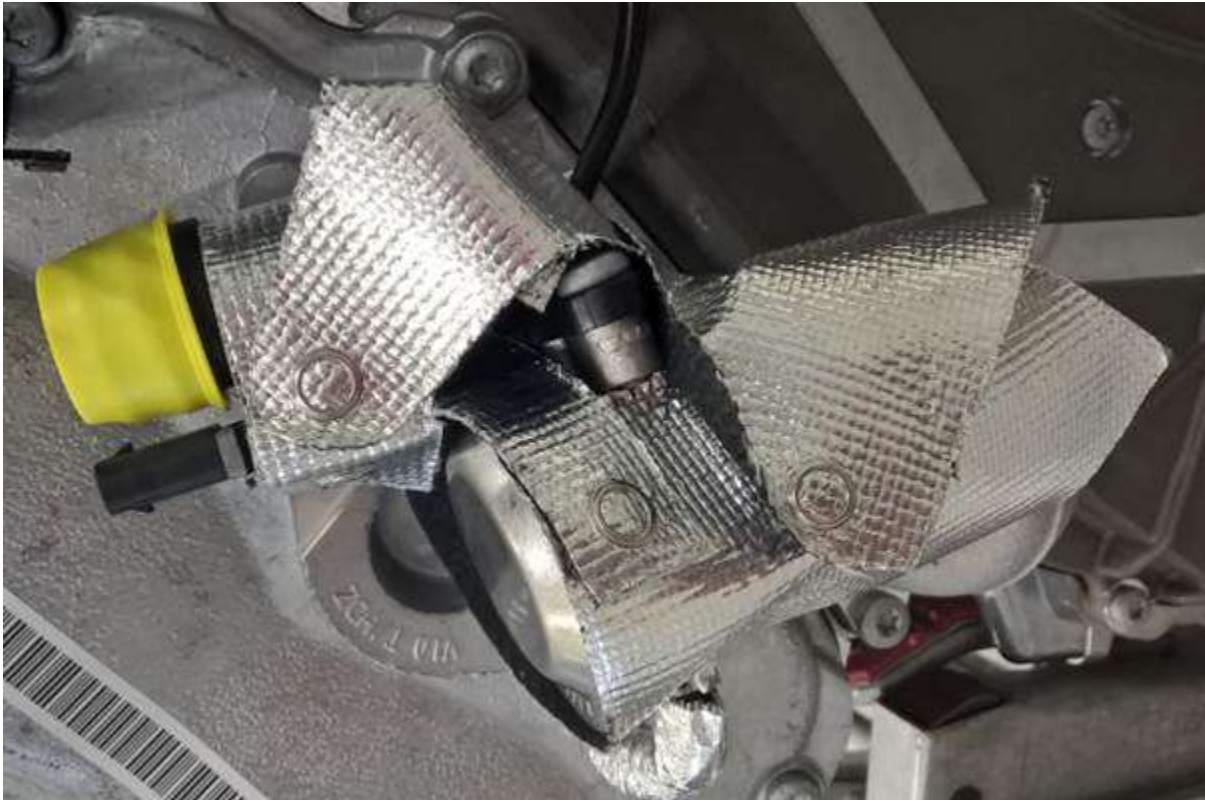
**Figure 2.** *Insulation on Bank 2 pressure sensor after installation.*
