# Technical Service Bulletin

## 91 SOS warning displayed in instrument cluster, DTC B191604 stored in the gateway control module

91 19 33 2051664/2 February 5, 2019. Supersedes Technical Service Bulletin Group 91 number 18-02 dated June 26, 2018 for reasons listed below.

| Model(s) | Year | VIN Range | Vehicle-Specific Equipment |
|---|---|---|---|
| A4, A5, Q5, and Q7 | 2018 | All | With connected gateway |

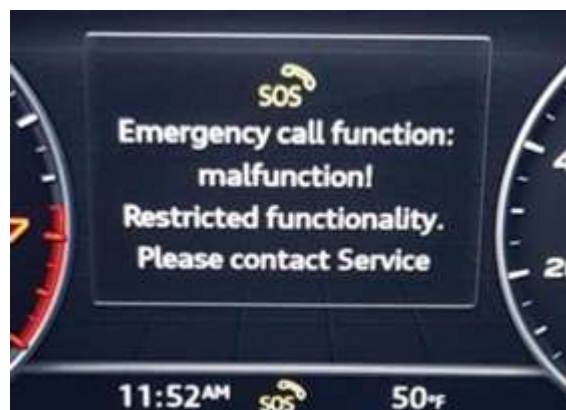
- A warning message appears on the instrument cluster. The message reads "Emergency call function: malfunction! Restricted functionality. Please contact Service" (Figure 1).

Figure 1. Warning message shown in instrument cluster.

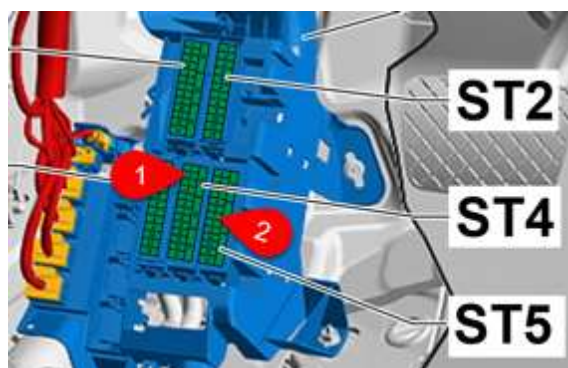
**Figure 2.** Q7 Driver's Side Footwell Fuse Box. 1: KL15 Fuse. 2: KL30 Fuse.

1. Perform a manual discharge of the connected gateway's back-up battery by removing constant power (KL30) and accessory power (KL15), while KL15 is switched on.

2. Gain access to fuse panel SB, located behind the driver's side footwell cover. Consult the repair manual for instructions on accessing fuse panel SB.
3. Locate the two fuses which supply constant power (KL30) and accessory power (KL15) to the connected gateway. Consult the wiring diagram, or owner's manual for fuse location and size.
4. Ensure that accessory power (KL15) is ON.
5. Remove the two fuses identified in Step 3.
6. Wait 30 seconds with both fuses removed.
7. Reinstall the two fuses.
8. Turn off accessory power (KL15).
9. Repeat steps 4 through 8 **six** additional times. This will result in a total of seven discharge cycles.
10. Following seven discharge cycles, clear the fault memory of the connected gateway module:
  - In ODIS GFF, recheck the fault memory of the connected gateway.

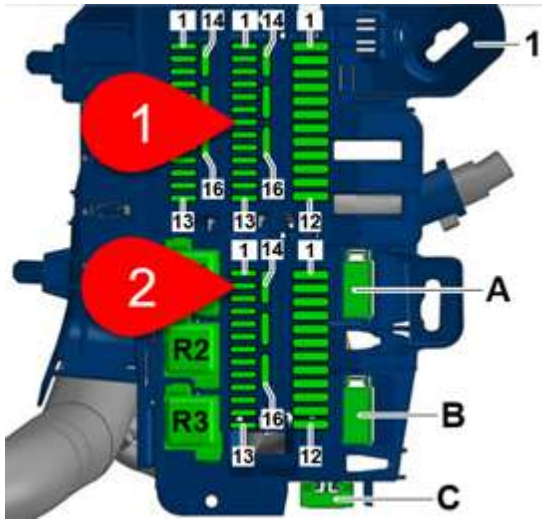
**Figure 3.** A4, A5, and Q5 Driver's Side Footwell Fuse Box. 1: KL30 Fuse. 2: KL15 Fuse.
