# Technical Service Bulletin

## 91 SOS Warning displayed in instrument cluster, DTC B18BE13 or B18BD13 stored in the telematics control module

91 19 41 2054038/1 February 28, 2019.

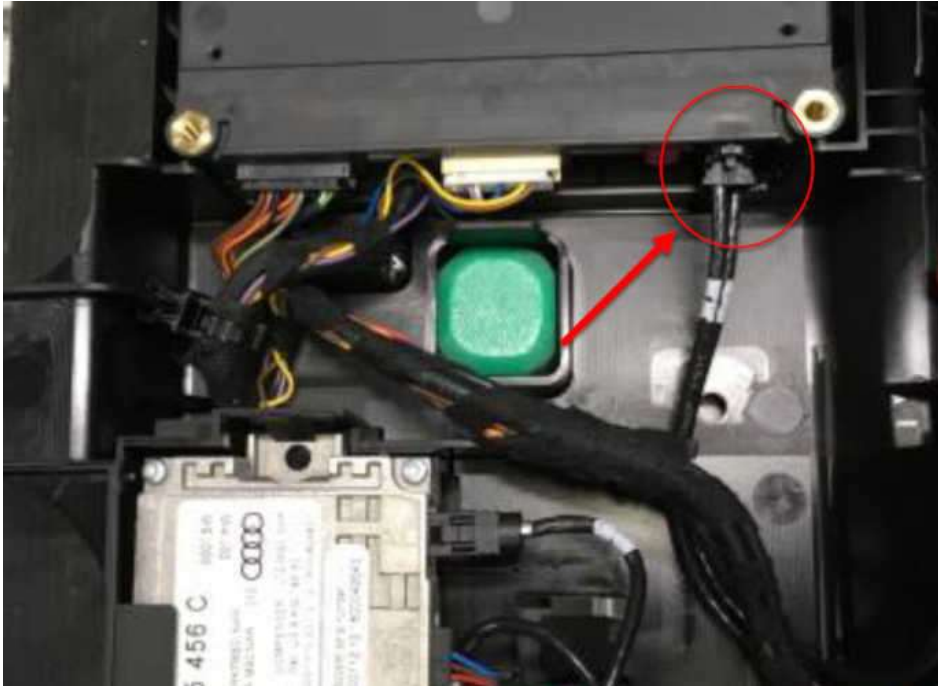
The 4 pole connector pins might have been widened during the assembly process.

**Figure 1.** Telematics Control Module (J949) Connector.

1. Remove the original 4 pole connector including its pins and remove a section of the vehicle's coaxial wiring for the applicable antenna circuit.

2. Replace the original 4 pole connector and cable with the new connector harness and pins.
3. Before plugging the new 4 pole connector in, make sure that the telematics control module, J949 (address word 0075) is mounted properly in its bracket.

Do not tilt the control module while plugging in the 4 pole connector. Tilting the control module while plugging the connector might damage the new pins.
