## Coolant / Vacuum / Temperature fault codes - Check Engine Light with DTCs P003313, P0299FA, P0299FB, P226100, P261F71, P012800, and P012809

| Topic number | LI07.09-N-063338 |
| Validity | OM651 |

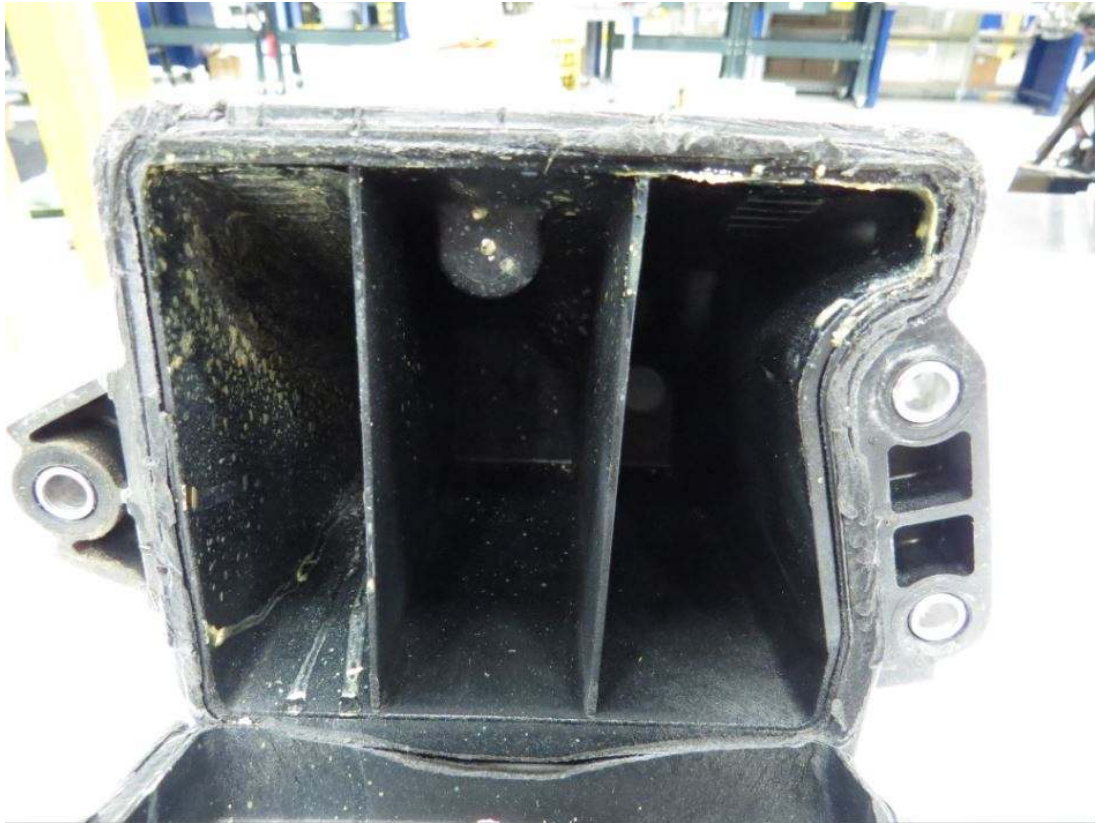
Vacuum reservoir 1 top.  
JPG:

| Vacuum reservoir 1 top.JPG | Vacuum reservoir 1 top |

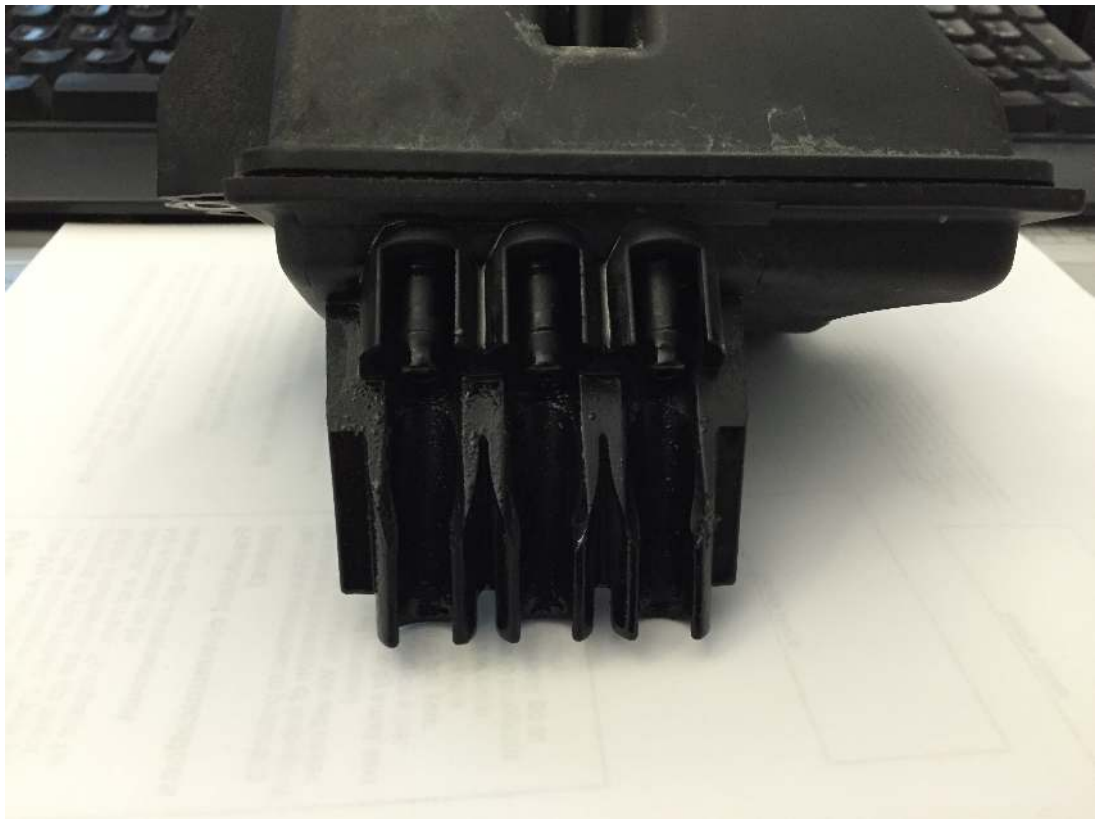
Liquid contamination vacuum reservoir.jpg:

| Liquid contamination vacuum reservoir.jpg | Liquid contamination coming from the vacuum reservoir |

5 - If coolant is found in the vacuum system replace the water pump, vacuum reservoir, change-over valve and clean the vacuum lines.

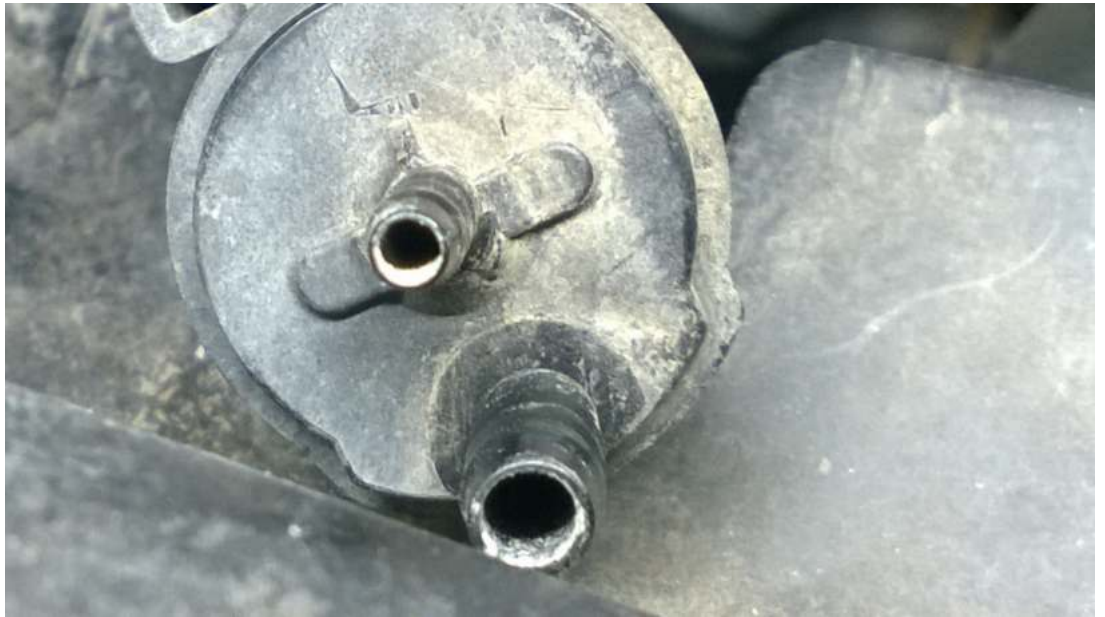
Contaminated EV Valve.  
jpg:

| Contaminated EV Valve.jpg | Contaminated EV Valve |
