## Technical product information

| <b>Topic</b> | Bentley Dynamic ride system fault within the DIP - DTC C129600 logged |
| <b>Transaction No.</b> | 2054300/1 |

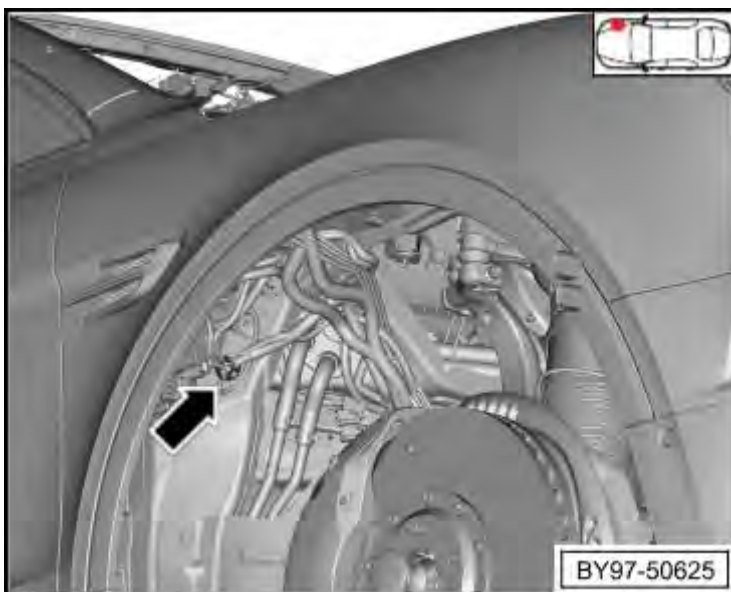
- Remove the right hand front wheel arch liner - Refer to Repair manual Rep. Gr 66
- Referring Figure 2 and Repair manual wiring diagrams locate earth point **number 13**

3) With care - Remove the earth point fixing - Carry out the following checks

- Check for any paint/dirt residue on the actual earth point – Use suitable abrasive material to remove any paint or dirt
- Check the earth cable terminal to ensure it is free from paint or dirt - Use suitable abrasive material to remove any paint or dirt
- Refit the earth cable terminal and fixing nut

- Torque the earth point fixing nut to **9 Nm**

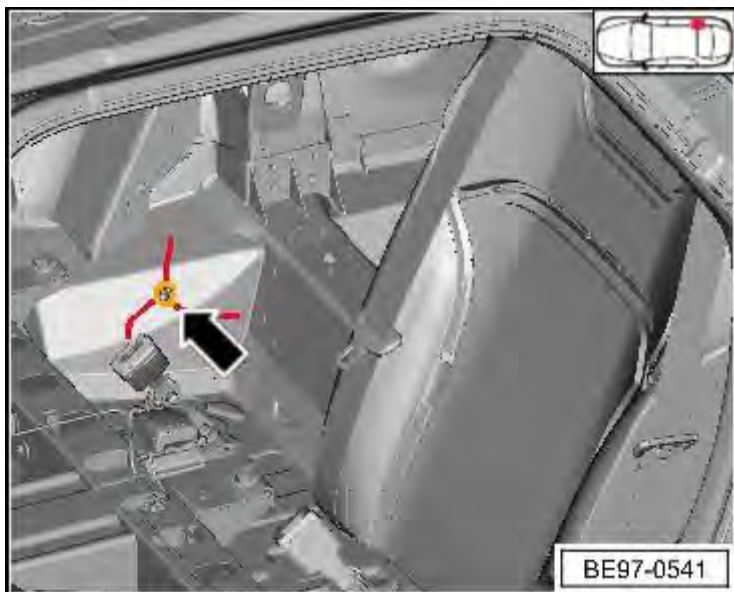
**IMPORTANT: Figure 3 shows the earth point (730) on 4/5 seat specification vehicles - Figure 4 shows the earth point location (53) for 7 seat specification vehicles**

- **4 and 5 seat variants** - Referring Figure 3 and the Repair manual wiring diagrams locate earth point **number 730**

5) With care - Remove the earth point fixing - Carry out the following checks

- Check for any paint/ dirt residue on the actual earth point - Use suitable abrasive material to remove any paint or dirt
- Check all earth cable terminals to ensure they are free from paint or dirt - Use suitable abrasive material to remove any paint or dirt
- Refit the earth cable terminals and fixing nut
- Torque the earth point fixing nut to **3Nm + 45°**
- Erase DTCC129600 using a suitable diagnostic tool
- Carry out a short road test

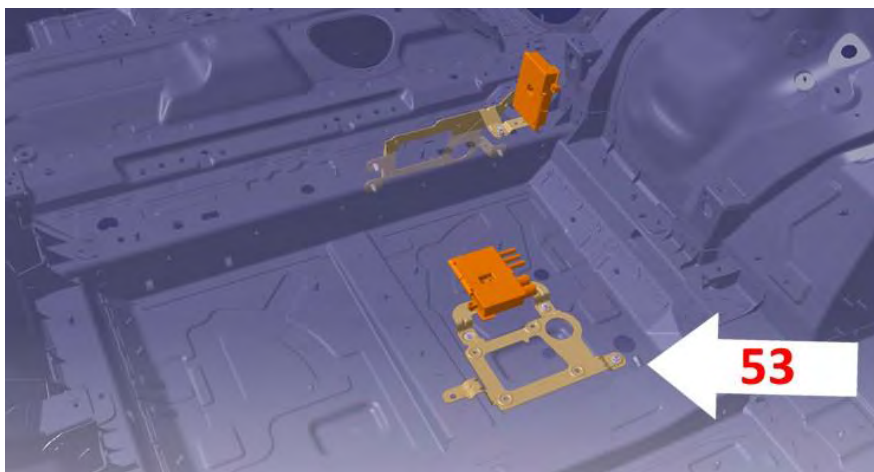
- **7 seat variants** - Referring Figure 4 - Locate earth point **number 53** (Situated to the right hand side of the rear floor panel) to gain access remove the rear bench assembly - 3rd row - Refer to Repair manual Rep. Gr 72 Rear bench seat assembly - 3rd row (7 seat) - to remove and fi
