| | NUMBER<br><b>PI1803W/X (Rev 4, 04/10/2019)</b> | DATE<br><b>November 2018</b> |
| <b>PRODUCT IMPROVEMENT CAMPAIGN</b> | | |
| <b>SUBJECT:</b> ENGINE REPLACEMENT INSTRUCTIONS<br>FOR DTC P1326 (PI1803W/X) | | |

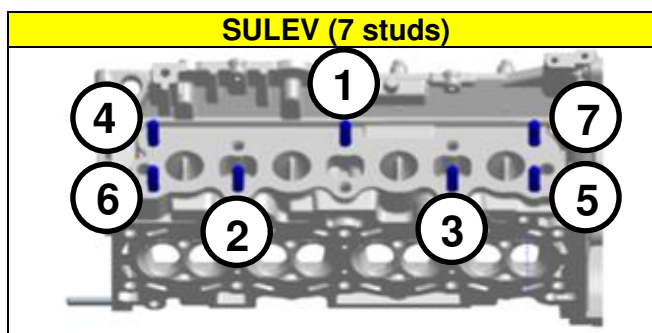
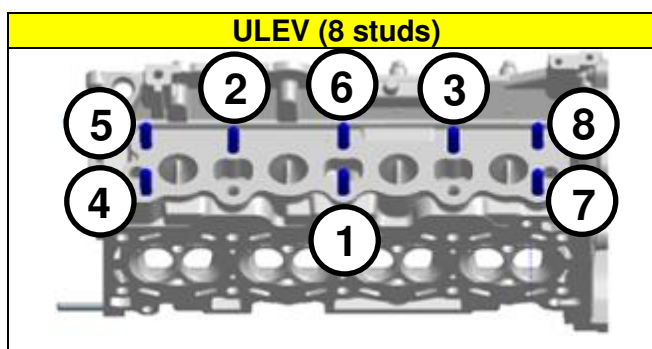
- All engines supplied under this Product Improvement Campaign have the exhaust manifold studs configured for SULEV engines.
- Using the pictures to the right, check the exhaust manifold stud location and quantity. Relocate as required for ULEV engines and obtain one (1) extra from the removed engine.
- Prior to installation, replace the exhaust manifold gasket and front muffler gasket.
- Torque nuts in the sequence shown.

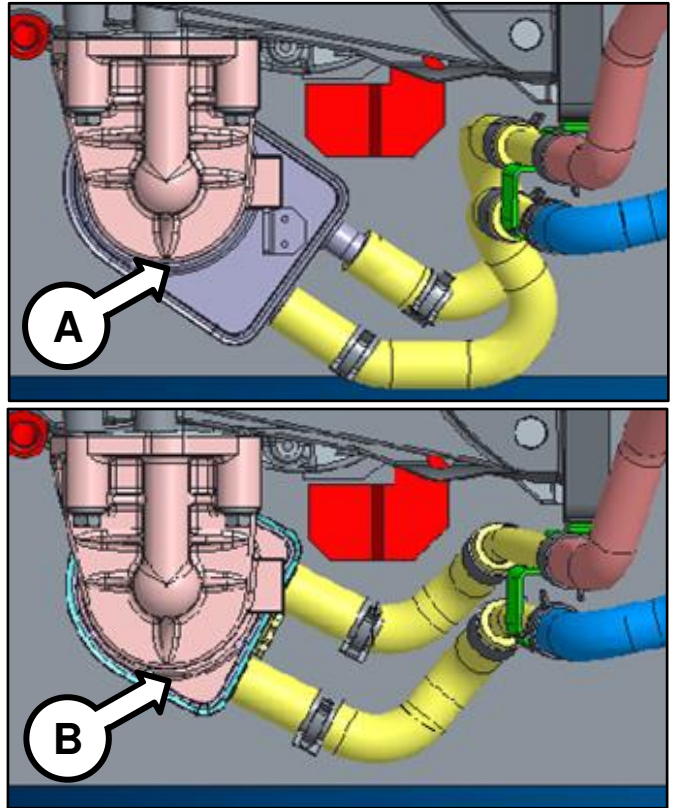
- If the new engine's (bigger) oil cooler (A) does not match the old engine's (smaller) oil cooler (B), replace the oil cooler tube assembly with the improved part. See parts table on page 23.
- If the new engine's (bigger) oil cooler (A) matches the old engine's (bigger) oil cooler (A), reuse the old engine's oil cooler tube assembly.
- If the new engine's (smaller) oil cooler (B) matches the old engine's (smaller) oil cooler (B), reuse the old engine's oil cooler tube assembly.

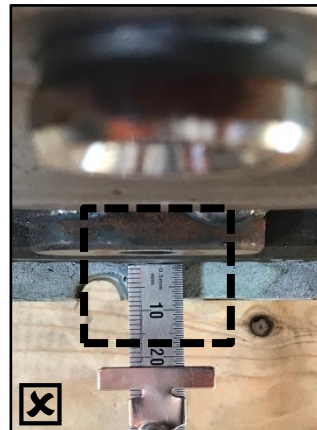
Not Fully Inserted

- If the torque converter has moved from the fully inserted position, carefully push inward while rotating the torque converter until it is recessed approximately 9/16 – 5/8" (14 – 16mm) (☑) into the transaxle case when reinstalling the automatic transaxle.
