# Technical Service Bulletin

## 91 SOS warning displayed in instrument cluster, DTCs B105313 and B153313 stored in the data bus diagnostic interface

91 19 54 2054812/1 April 25, 2019.

| Model(s) | Year | VIN Range | Vehicle-Specific Equipment |
|---|---|---|---|
| A4, A5 | 2018 - 2019 | All | With connected gateway and eCall |

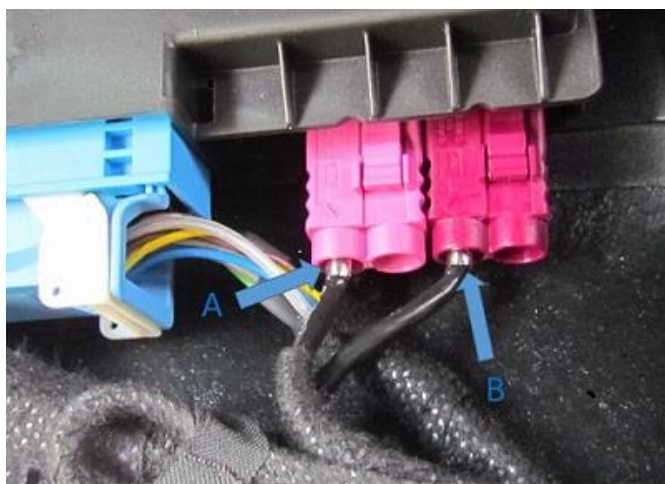
Poor contact at one of the coaxial wiring's FAKRA connections between data bus on board diagnostic interface, J533 (address word 0019) and one of the external antennas for emergency call services.

| DTC Reference Table | | | |
|---|---|---|---|
| DTC | Measured Value<br>Diagnostic Address 0019 | Cable Position<br>(Figure 1) | Vehicle<br>PR-Codes |
| B105313<br>GSM antenna Open circuit | Antenna for telephone<br>status<br>0x24E2 | A | IW3<br>IW5 + 4GR<br>IW5 + 4GY |
| B153313<br>GSM antenna 2 Open circuit | Status of antenna 2 for<br>phone<br>0x1836 | B | IW3<br>IW5 |

**Figure 1.** GSM antenna location reference at the data bus on board diagnostic interface, J533 (address word 0019).

1. If DTC B105313 or B153313 are found in the data bus on board diagnostic interface, J533 (address word 0019), then replace the coaxial wire from the applicable emergency call module antenna to the data bus on board diagnostic interface, J533 (address word 0019).
2. Utilize the VAS 6720 to build a single coaxial wire from the emergency call module to the data bus on board diagnostic interface, J533 (address word 0019).
  - **Do not** split the new wire at the TIM connection between T2dkx and T2dk.
  - Route the new wire along with the existing harness.
  - Ensure that there are no sharp bends.
  - Ensure there is no tension on the new contacts.
  - The cable should be 8.7ft (2.65m) in length.
