# Technical Service Bulletin

## 91 SOS warning displayed in instrument cluster, DTCs B105313 and B153313 stored in the data bus diagnostic interface

91 19 55 2054630/1 April 25, 2019.

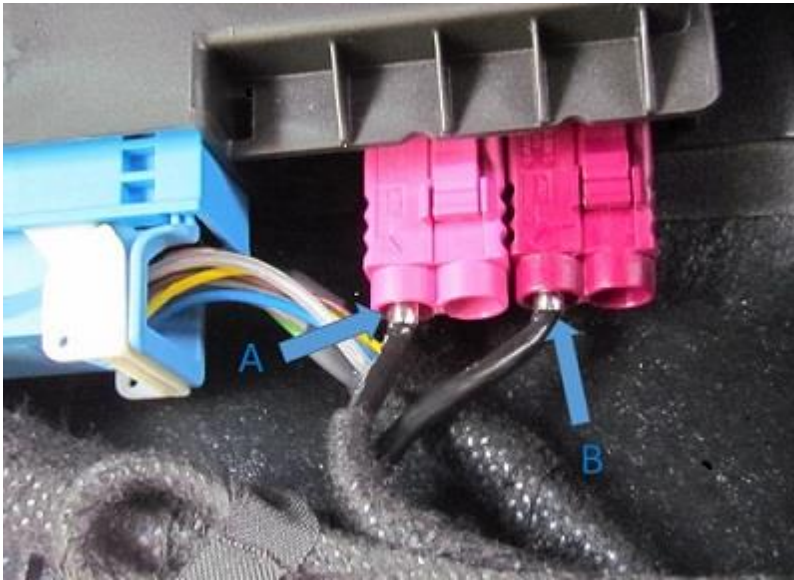
**Figure 1.** GSM antenna location reference at the data bus on board diagnostic interface, J533 (address word 0019).

Poor contact at one of the coaxial wiring's FAKRA connections between data bus on board diagnostic interface, J533 (address word 0019) and one of the external antenna's for emergency call services.

| DTC Reference Table | | | |
|---|---|---|---|
| B105313<br>GSM antenna Open circuit | Antenna for telephone<br>status<br>0x24E2 | A | IW3<br>IW5 + 4GR<br>IW5 + 4GY |
| B153313<br>GSM antenna 2 Open circuit | Status of antenna 2 for<br>phone<br>0x1836 | B | IW3<br>IW5 |

Inspect connection at the data bus on board diagnostic interface, J533 (address word 0019)

1. Perform a visual inspection of the cable and connector.

Replace the contact utilizing the VAS 6720 if:

- There is tension on the cable. The cable should have some slack.
- The pin is bent or cracked.
- The cable is bent or damaged.
- The connector is not fully connected.

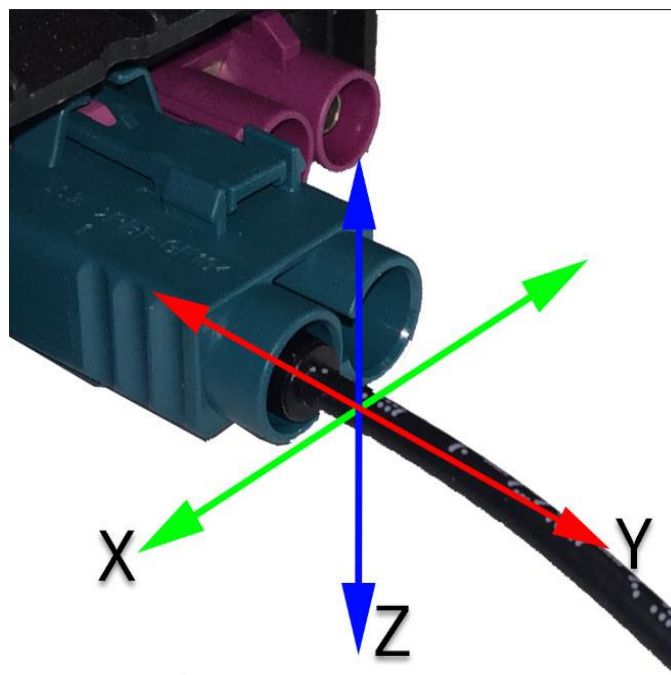
**Figure 2.** Coaxial cable X, Y, and Z axis.

- View the applicable measured value from the overview table above.
- Lightly pull, or push the applicable coaxial cable along its respective X, Y, and Z axis (Figure 2).
- As the fault detection is not real time, hold the cable in each position for 5 seconds and observe the measured value (Figure 3).

## 3. If a fault is detected during step 2 (“Open Circuit”), replace the contact on the wire harness at the data bus on board diagnostic interface, J533 (address word 0019) utilizing the VAS 6720.
