# Technical Service Bulletin

## 69 Airbag warning light on, DTC B1225F1 stored in the airbag control module

69 19 39 2051242/3 April 26, 2019. Supersedes Technical Service Bulletin Group 69 number 18-37 dated October 5, 2018 for reasons listed below.

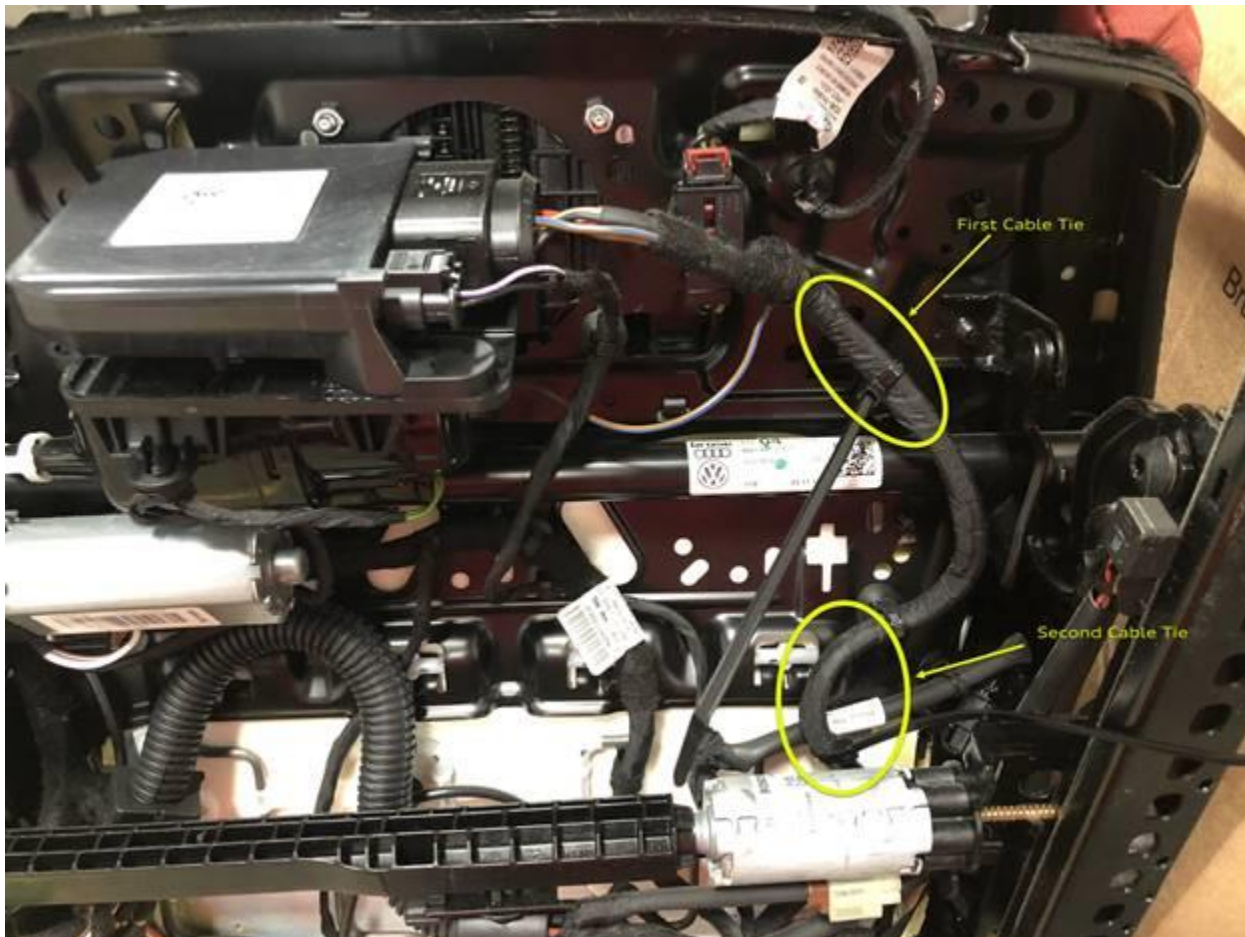
**Figure 1.** Positions of the cable ties.

Once the seat is adjusted to the above-mentioned position, you will see the need to attach the cable tie at two points on the harness as shown (Figure 1).

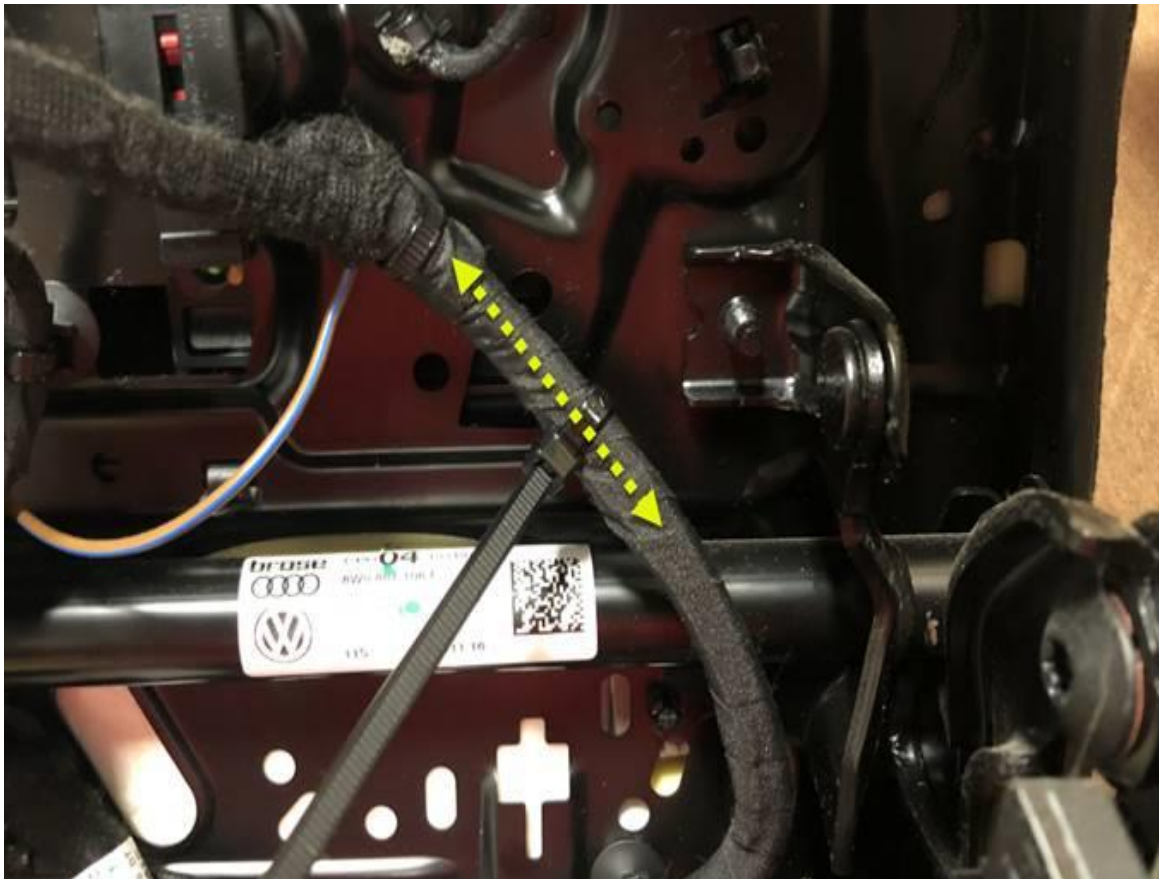
**Figure 2.** Attach the first cable tie in the yellow area.

2. You will attach the first cable tie in the yellow marked area on the harness between the cable tie clip and the crossbar tube as shown below (Figure 2).

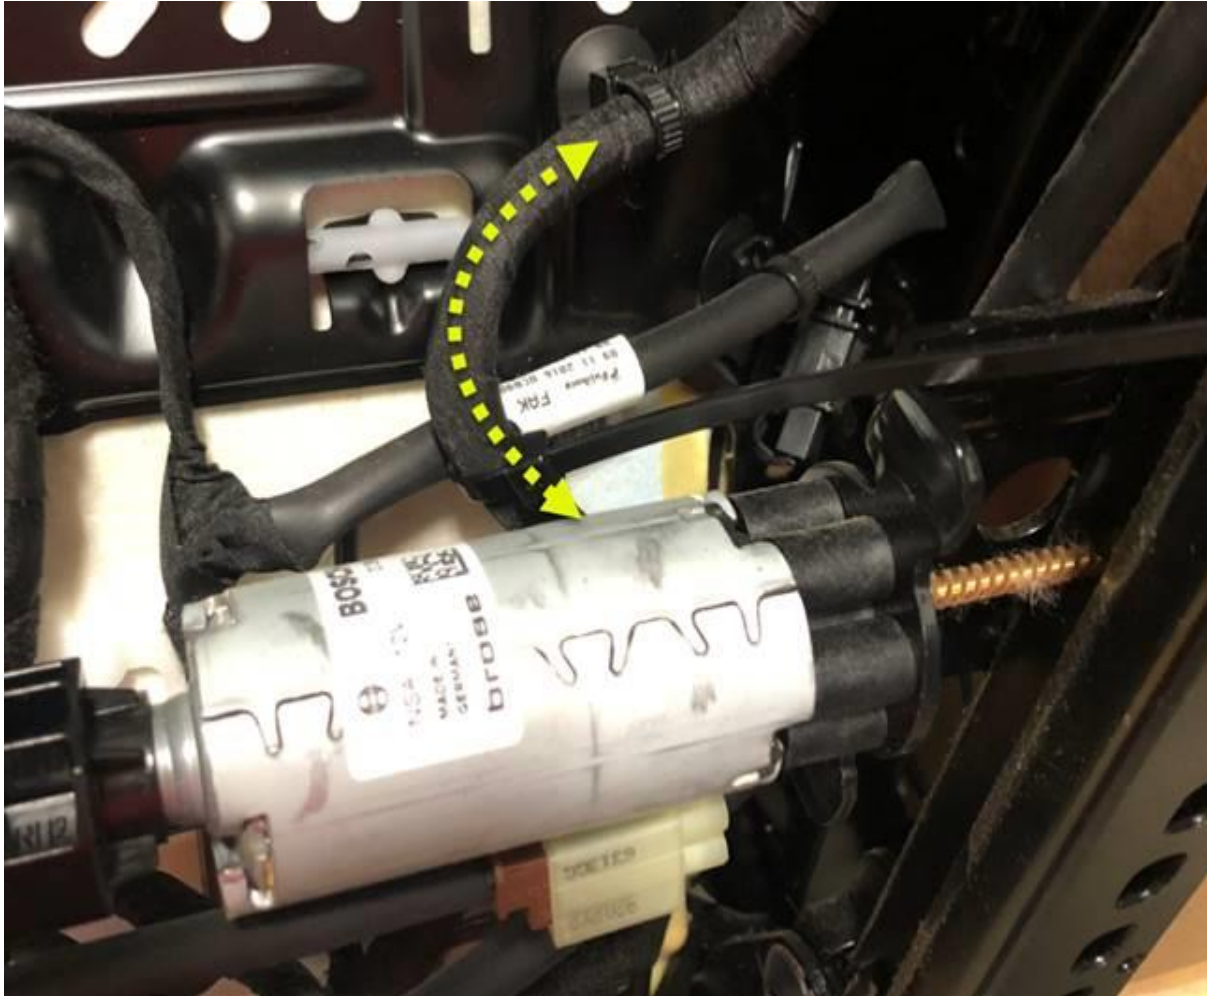
*Figure 3. Attach the second cable tie to the yellow marked area.*

3. The second cable tie position is to the rear of the crossbar tube where the harness drops down from the frame. Place the cable tie in the yellow marked area shown below (Figure 3).
