# Technical Service Bulletin

## 96 Lane change assist does not work, DTCs C1114F0 and C1114F3 stored in lane change assistance control modules

96 19 37 2048470/2 April 17, 2019. Supersedes Technical Service Bulletin Group 96 number 17-18 dated August 4, 2017 for reasons listed below.

| Model(s) | Year | VIN Range | Vehicle-Specific Equipment |
|---|---|---|---|
| Q5 | 2018 | All | With Audi pre sense |

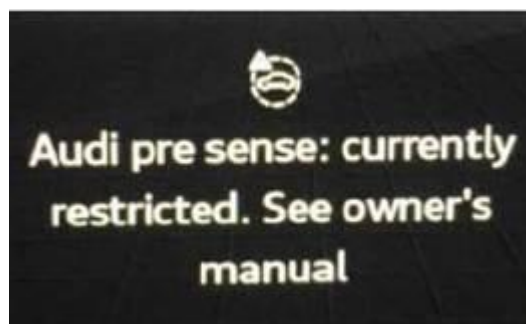
- Message in instrument cluster “Audi pre sense: currently restricted. See owner’s manual”

**Figure 1.** Message in the instrument cluster.

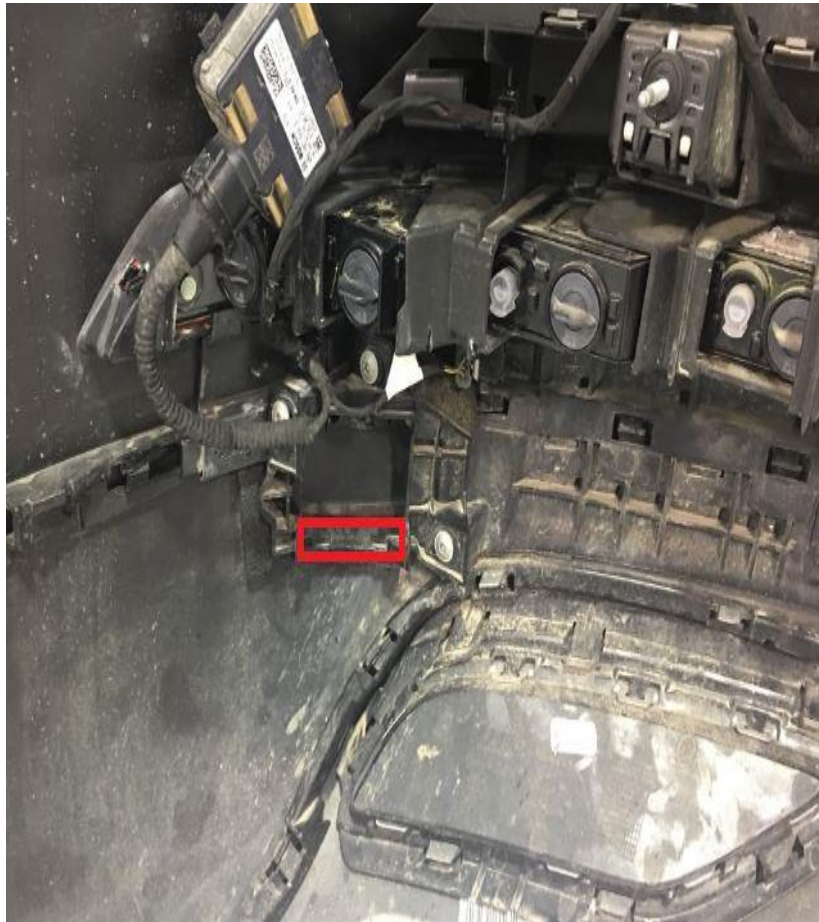
**Figure 3.** Bracket part number located on passenger's side.

1. Before removing the bumper, check the bracket part numbers (Figure 2 and 3). If they are not part numbers 80A 907 908 B and 80A 907 907 B then proceed with the instructions below.

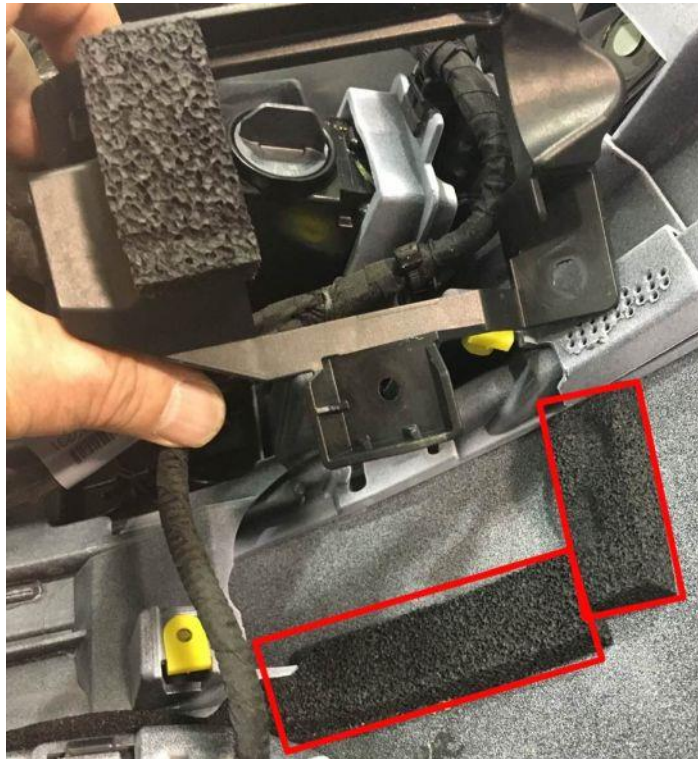
The fault most likely was caused by the improper installation of foam which interferes with the sensor's field of view.

*Figure 4. Foam to be stripped out.*

3. Strip out any foam that is glued to the bumper (Figure 4) marked in the red areas (Figure 5).

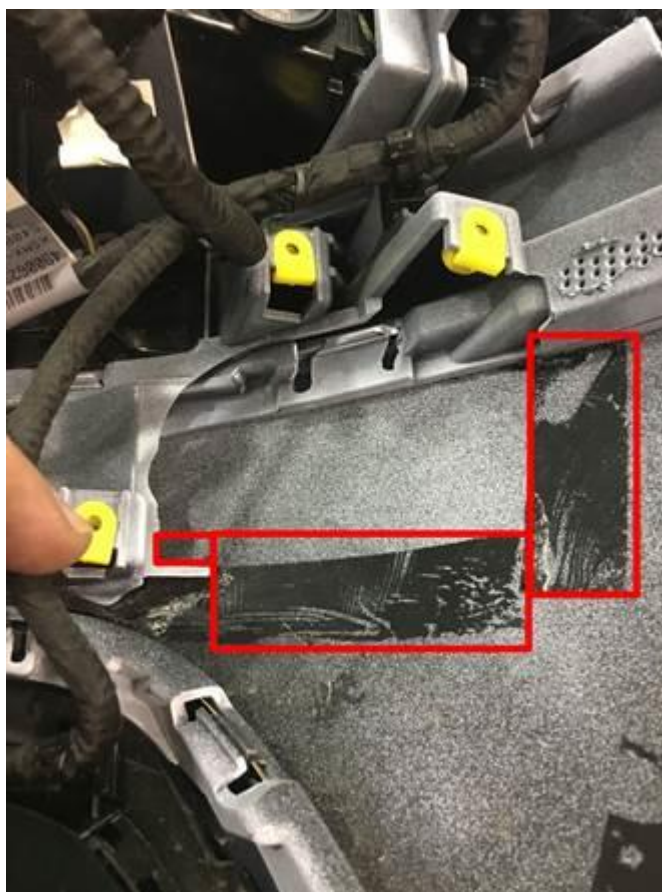
*Figure 5. Removed foam.*
