GLOBAL SAFETY FIELD INVESTIGATIONS  
DCS4992  
URGENT - DISTRIBUTE IMMEDIATELY

Subject: N182188910 - Special Coverage  
PPS Setting DTC For Airbag Light On

Models: 2017 Buick Verano

## N182188910 – PPS Setting DTC For Airbag Light On

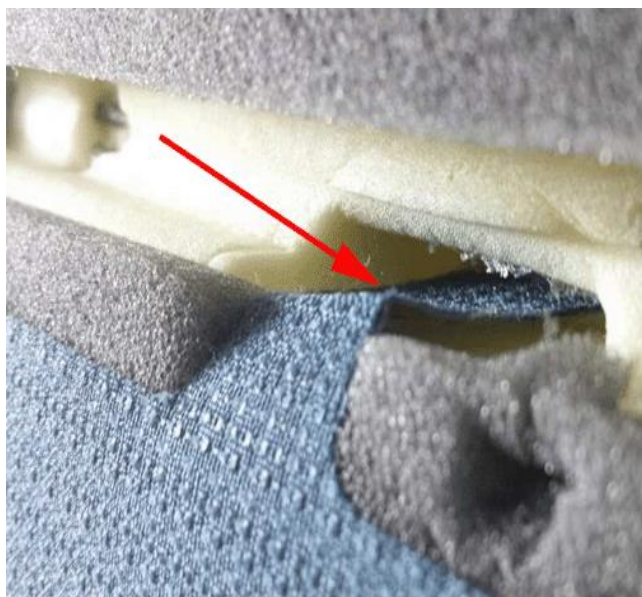
4502711

**Note:** Crease observed in tail area from top side.

2. Upon inspection of the sensor after trim removal, a sharp crease in the passenger presence sensor in the area where the sensor tail exits through to the bottom of the seat cushion assembly may be observed.

- If the airbag front passenger presence sensor requires replacement, replace the airbag front passenger presence sensor. Refer to *Airbag Front Passenger Presence Sensor Replacement* in SI.

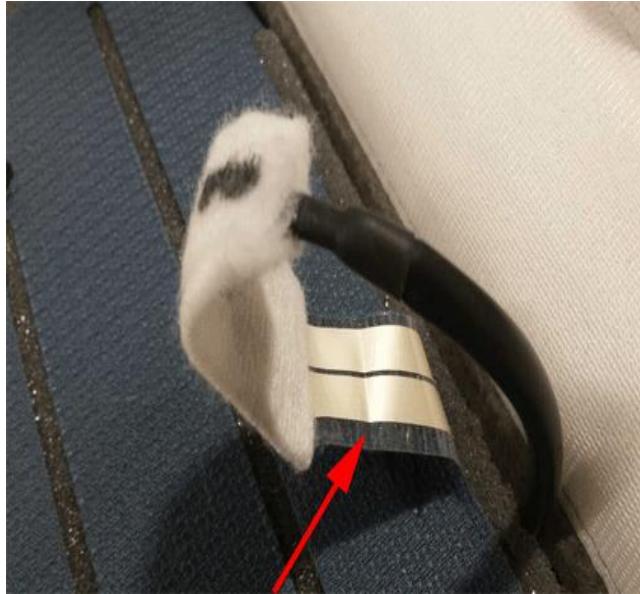
4505464

**Note:** Crease observed in tail area from bottom side.

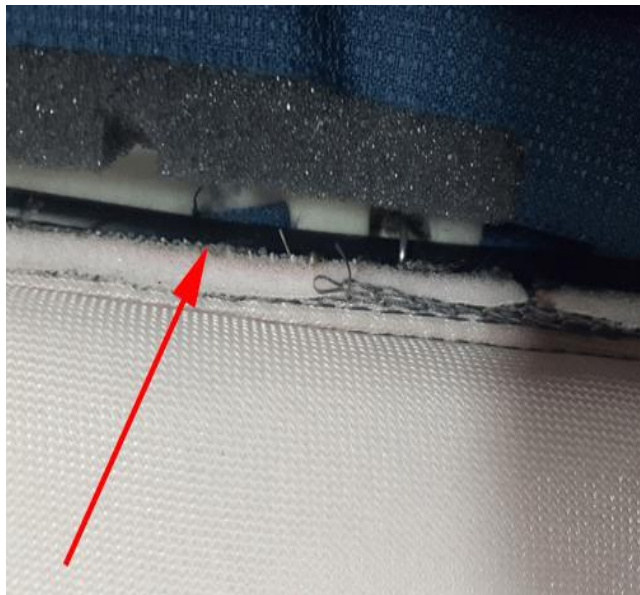
4505465

**Note:** Sensor tail observed trapped between seat trim tiedown feature and cushion pad.
