Subject: N182188910-01 - Special Coverage  
PPS Setting DTC For Airbag Light On  
Updated Customer Letter

Models: 2017 Buick Verano

## N182188910 – PPS Setting DTC For Airbag Light On

**Revision:** 01

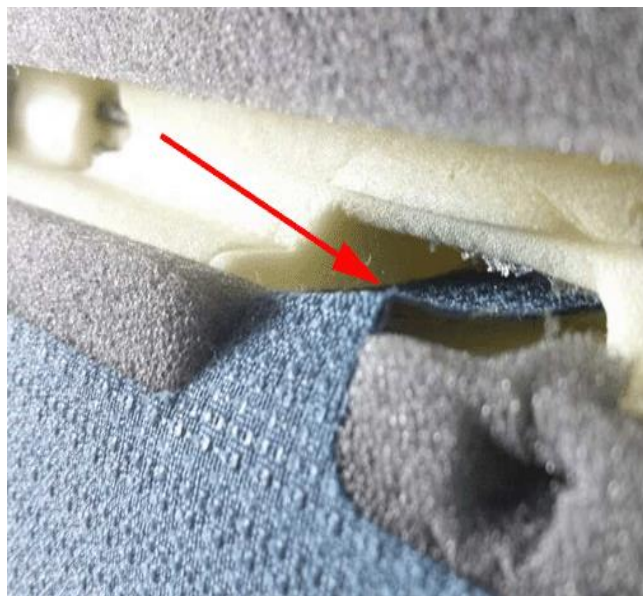
4502711

**Note:** Crease observed in tail area from top side.

2. Upon inspection of the sensor after trim removal, a sharp crease in the passenger presence sensor in the area where the sensor tail exits through to the bottom of the seat cushion assembly may be observed.
