**NUMBER:** 18-053-15 REV. A

Malfunction Indicator Lamp (MIL) Illumination P0344 - Camshaft Position Sensor Intermittent

2012 - 2015 (JK)

Jeep Wrangler (RHD)

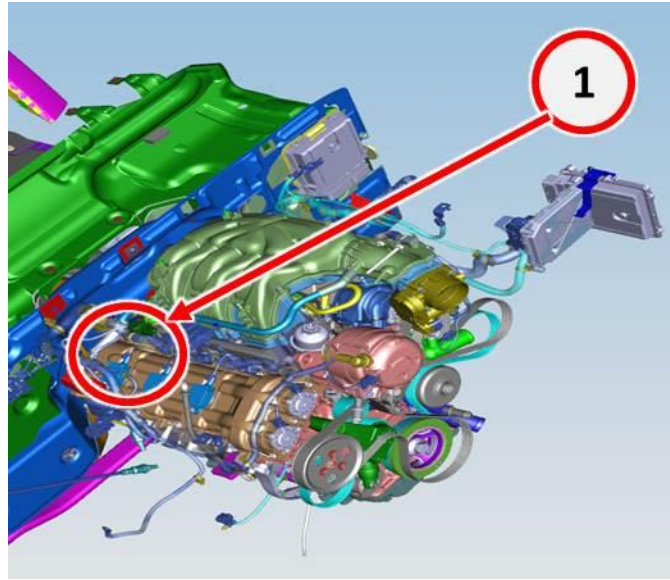
**Fig. 1 Underhood Engine View**

1 - Engine harness repair location

1. Remove the engine cover.
2. Locate the engine wire harness tower clip on the right side of the engine near the camshaft position sensor. See (Fig. 1).

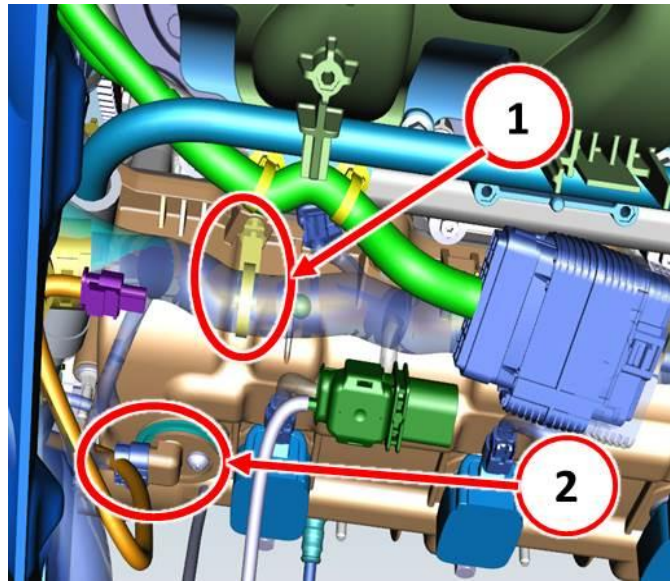
**Fig. 2 Engine Wire Harness**

- 1 - Engine harness tower clip
- 2 - Camshaft Position Sensor (CMP)

- 
3. Remove the existing wire harness tower clip and install P/N 68289129AA tower clip in the same location on the wire harness. See (Fig. 2). Engage the tower clip to the cylinder head cover. The new tower clip should be a tighter fit to the cylinder head cover than the removed clip.
