**NUMBER:** 18-095-15

Flash: 3.0L Powertrain Diagnostic And System Enhancements

2015 (WK) Jeep Grand Cherokee

**NOTE: This bulletin applies to vehicles equipped with a 3.0L diesel engine (Sales Code EXF) and 8 speed transmission (Sales Code DFD).**

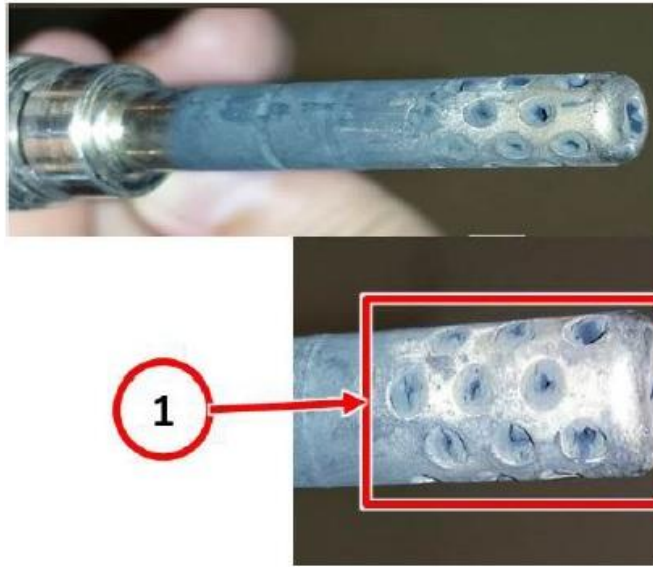
**Fig. 1 EGT Sensor Bank 1 Sensor 1**

11. Inspect the sensor body and probe for any signs of damage or excessive soot. See (Fig. 1).

1 - Excessive soot blocking sensor ports

- 
12. Was excessive soot found on the sensor?
- Yes>>> Proceed to [Step #13](#).
  - No>>> Proceed to [Step #14](#).
13. Using shop air set to a maximum of 80 psi, clean all excessive soot from the sensor probe.

14. Using a suitable multi-meter with appropriate test probes, test the resistance between the sensor connector terminals 1 and 2. With the sensor at room temperature, 65-75 °F (18-25 °C), the resistance should measure between 200 and 240 ohms.

15. Is the temperature sensor resistance within specifications?
- Yes>>> Install the original EGT sensor 1/2 and/or Catalyst Temperature Sensor. Refer to detailed installation procedures available in DealerCONNECT> TechCONNECT> Service Info Section 11 - Exhaust System> Sensor, Exhaust Temperature> Installation> Exhaust Gas Temperature Sensor 1/2.

- No>>> Install a new EGT sensor 1/2 and/or Catalyst Temperature Sensor. Refer to detailed installation procedures available in DealerCONNECT> TechCONNECT> Service Info Section 11 - Exhaust System> Sensor, Exhaust Temperature> Installation> Exhaust Gas Temperature Sensor 1/2.
