**NUMBER:** 18-094-15

**DATE:** November 25, 2015

Flash: 3.0L Powertrain Diagnostic and System Improvements

2014 (WK) Jeep Grand Cherokee

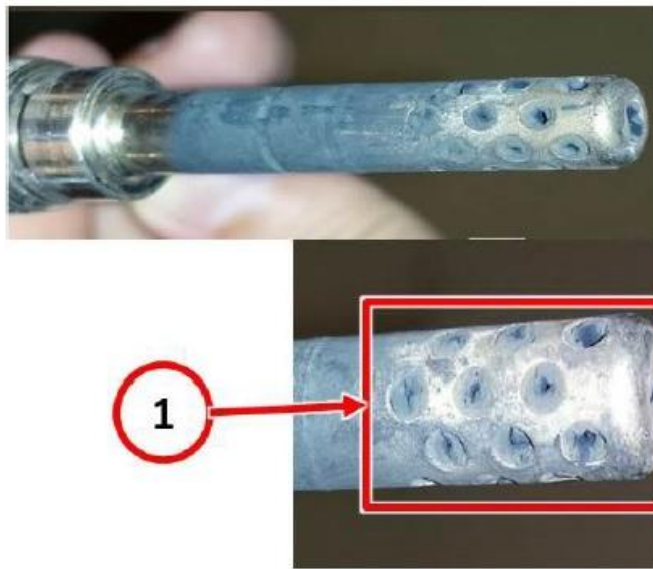
**Fig. 1 EGT Sensor Bank 1 Sensor 1**

10. Remove the EGT Sensor 1/2 located in the inlet of the Diesel Particulate Filter (DPF)/Diesel Oxidation Catalyst (DOC) assembly. Refer to detailed removal procedures available in DealerCONNECT> TechCONNECT> Service Info Section 11 - Exhaust System> Sensor, Exhaust Temperature> Removal> Exhaust Gas Temperature Sensor 1/2.
11. Remove the Catalyst Temperature Sensor located in the middle of the Diesel Particulate Filter (DPF)/Diesel Oxidation Catalyst (DOC) assembly. Refer to detailed removal procedures available in DealerCONNECT> TechCONNECT> Service Info Section 11 - Exhaust System> Sensor, Exhaust Temperature> Removal> Catalyst Exhaust Temperature Sensor.
12. Inspect the sensor body and probe for any signs of damage or excessive soot. See (Fig. 1).

1 - Excessive soot blocking sensor ports

- 
13. Was excessive soot found on the sensor?
    - a. Yes>>> Proceed to [Step #14](#).
    - b. No>>> Proceed to [Step #15](#).
  14. Using shop air set to a maximum of 80 psi, clean all excessive soot from the sensor probe.
  15. Using a suitable multi-meter with appropriate test probes, test the resistance between the sensor connector terminals 1 and 2. With the sensor at room temperature, 65-75 °F (18-25 °C), the resistance should measure between 200 and 240 ohms.
  16. Is the temperature sensor resistance within specifications?
    - a. Yes>>> Install the original EGT sensor 1/2 and/or Catalyst Temperature Sensor. Refer to detailed installation procedures available in DealerCONNECT> TechCONNECT> Service Info Section 11 - Exhaust System> Sensor, Exhaust Temperature> Installation> Exhaust Gas Temperature Sensor 1/2.

- b. No>>> Install a new EGT sensor 1/2 and/or Catalyst Temperature Sensor. Refer to detailed installation procedures available in DealerCONNECT> TechCONNECT> Service Info Section 11 - Exhaust System> Sensor, Exhaust Temperature> Installation> Exhaust Gas Temperature Sensor 1/2.
