**NUMBER:** 18-021-15 REV. F

Flash: 3.0L Powertrain Diagnostic And System Enhancements

2014 (DS) RAM 1500 Pickup

**NOTE: This bulletin applies to vehicles equipped with a 3.0L Diesel Engine (Sales Code EXF).**

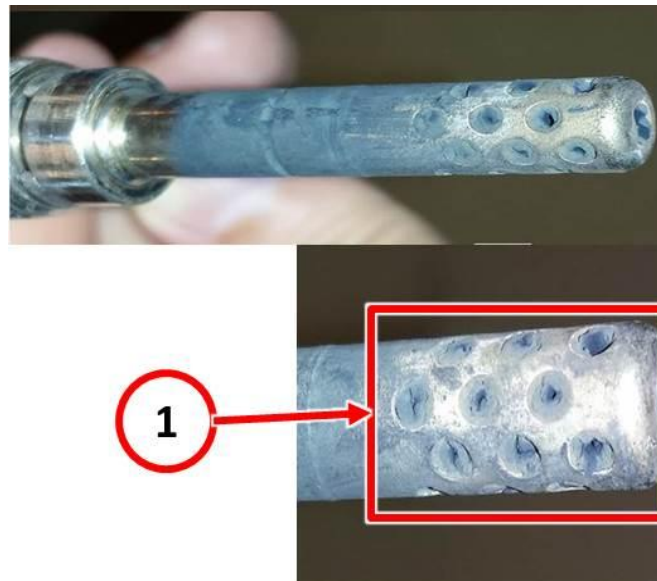
**Fig. 1 EGT Sensor Bank 1 Sensor 1**

13. Inspect the sensor body and probe for any signs of damage or excessive soot. See (Fig. 1).

1 - Excessive soot blocking sensor ports

- 
14. Was excessive soot found on the sensor?
- Yes>>> Proceed to [Step #15](#).
  - No>>> Proceed to [Step #16](#).
15. Using shop air set to a maximum of 80 psi, clean all excessive soot from the sensor probe.

16. Using a suitable multi-meter with appropriate test probes, test the resistance between the sensor connector terminals 1 and 2. With the sensor at room temperature, 65-75 °F (18-25 °C), the resistance should measure between 200 and 240 ohms.
