**NUMBER:** 21-070-15

**GROUP:** Transmission and Transfer Case

**DATE:** December 24, 2015

Flash: PTU Motor Position Enhancements

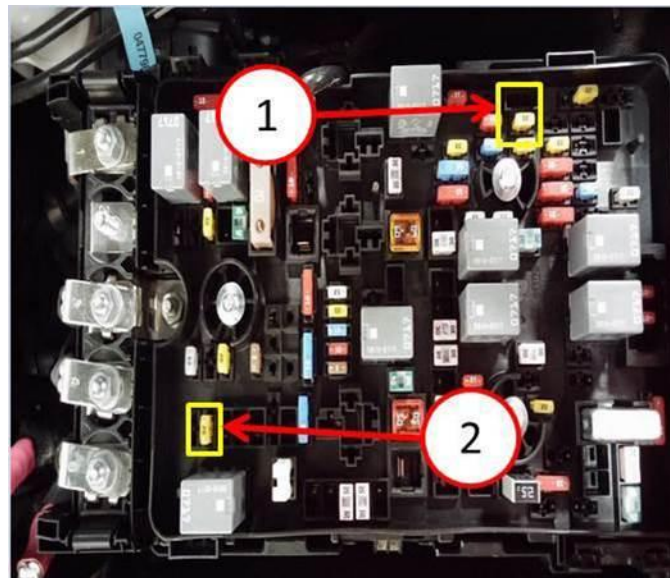
**Fig. 1 Module Fuse Locations**

- 1 - F76 RMD 4WD  
2 - F10 PTU 4WD

- a. Turn the ignition off.
- b. Pull fuse F76 (RDM 4WD, 20 amp) in the PDC (Power Distribution Center) ([Fig. 1](#)).
- c. Turn the ignition key to the RUN position and perform the PTU flash.
- d. When the flash is complete, turn the ignition key OFF and reinstall fuse F76.
