EC19-008

ITB19-010

April 4, 2019

## 2016-2018 QX60; MIL ON WITH DTC P2097, P2099, P0171 AND/OR P0174

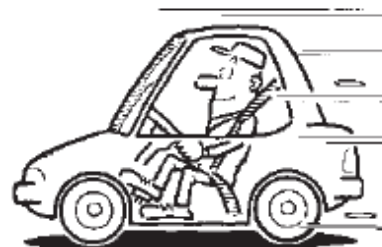
Figure A

- Connect the GR8 to the 12V battery and select ECM Power Supply Mode.  
If the vehicle battery voltage drops below 12.0V or above 15.5V during reprogramming, the ECM may be damaged.
- Be sure to turn OFF all vehicle electrical loads.  
If a vehicle electrical load remains ON, the ECM may be damaged.
- Be sure to connect the AC Adapter.  
If the CONSULT PC battery voltage drops during reprogramming, the process will be interrupted and the ECM may be damaged.
- Turn OFF all external Bluetooth® devices (e.g., cell phones, printers, etc.) within range of the CONSULT PC and the VI. If Bluetooth® signal waves are within range of the CONSULT PC during reprogramming, reprogramming may be interrupted and the ECM may be damaged.
