# Technical Service Bulletin

## 91 SOS warning displayed in instrument cluster, DTCs B105313 and B153313 stored in the data bus diagnostic interface

91 19 58 2054812/2 May 13, 2019. Supersedes Technical Service Bulletin Group 91 number 19-54 dated April 25, 2019 for reasons listed below.

| Model(s) | Year | VIN Range | Vehicle-Specific Equipment |
|---|---|---|---|
| A4, A5 | 2018 - 2019 | All | With connected gateway and eCall |

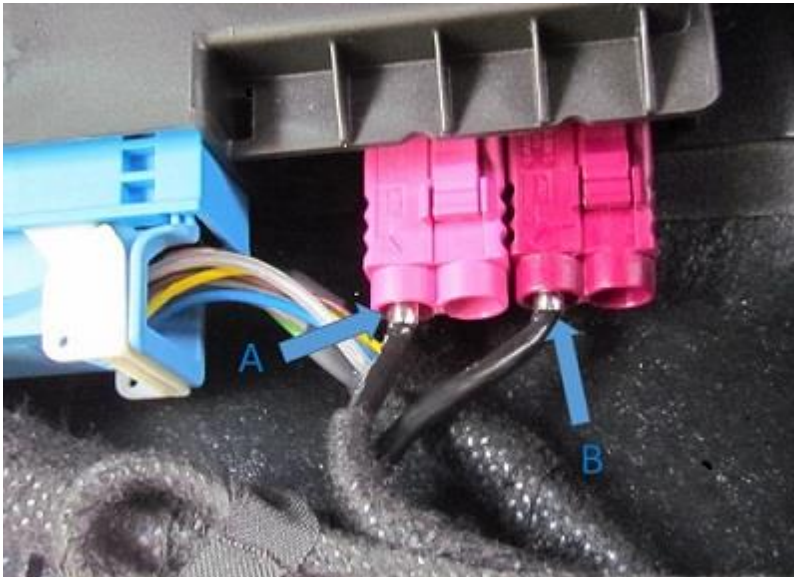
Poor contact at one of the coaxial wiring's FAKRA connections between data bus on board diagnostic interface, J533 (address word 0019) and one of the external antennas for emergency call services.

| DTC Reference Table | | | |
|---|---|---|---|
| DTC | Measured Value<br>Diagnostic Address 0019 | Cable Position<br>(Figure 2) | Vehicle<br>PR-Codes |
| B105313<br>GSM antenna Open circuit | Antenna for telephone<br>status<br>0x24E2 | A | IW3<br>IW5 + 4GR<br>IW5 + 4GY |
| B153313<br>GSM antenna 2 Open circuit | Status of antenna 2 for<br>phone<br>0x1836 | B | IW3<br>IW5 |

**Figure 2.** GSM antenna location reference at the data bus on board diagnostic interface, J533 (address word 0019).

1. If DTC B105313 or B153313 are found in the data bus on board diagnostic interface, J533 (address word 0019), then replace the coaxial wire from the applicable emergency call module antenna to the data bus on board diagnostic interface, J533 (address word 0019).
2. Utilize the VAS 6720 to build a single coaxial wire from the emergency call module to the data bus on board diagnostic interface, J533 (address word 0019).
  - **Do not** split the new wire at the TIM connection between T2dkx and T2dk.
  - Route the new wire along with the existing harness.
  - Ensure that there are no sharp bends.
  - Ensure there is no tension on the new contacts.
  - The cable should be 8.7ft (2.65m) in length.
