Bulletin No.: PIT5659B  
Published date: 04/1/2019

## PIT5659B Driver Side Power Seat Inoperative or Moves Unwanted

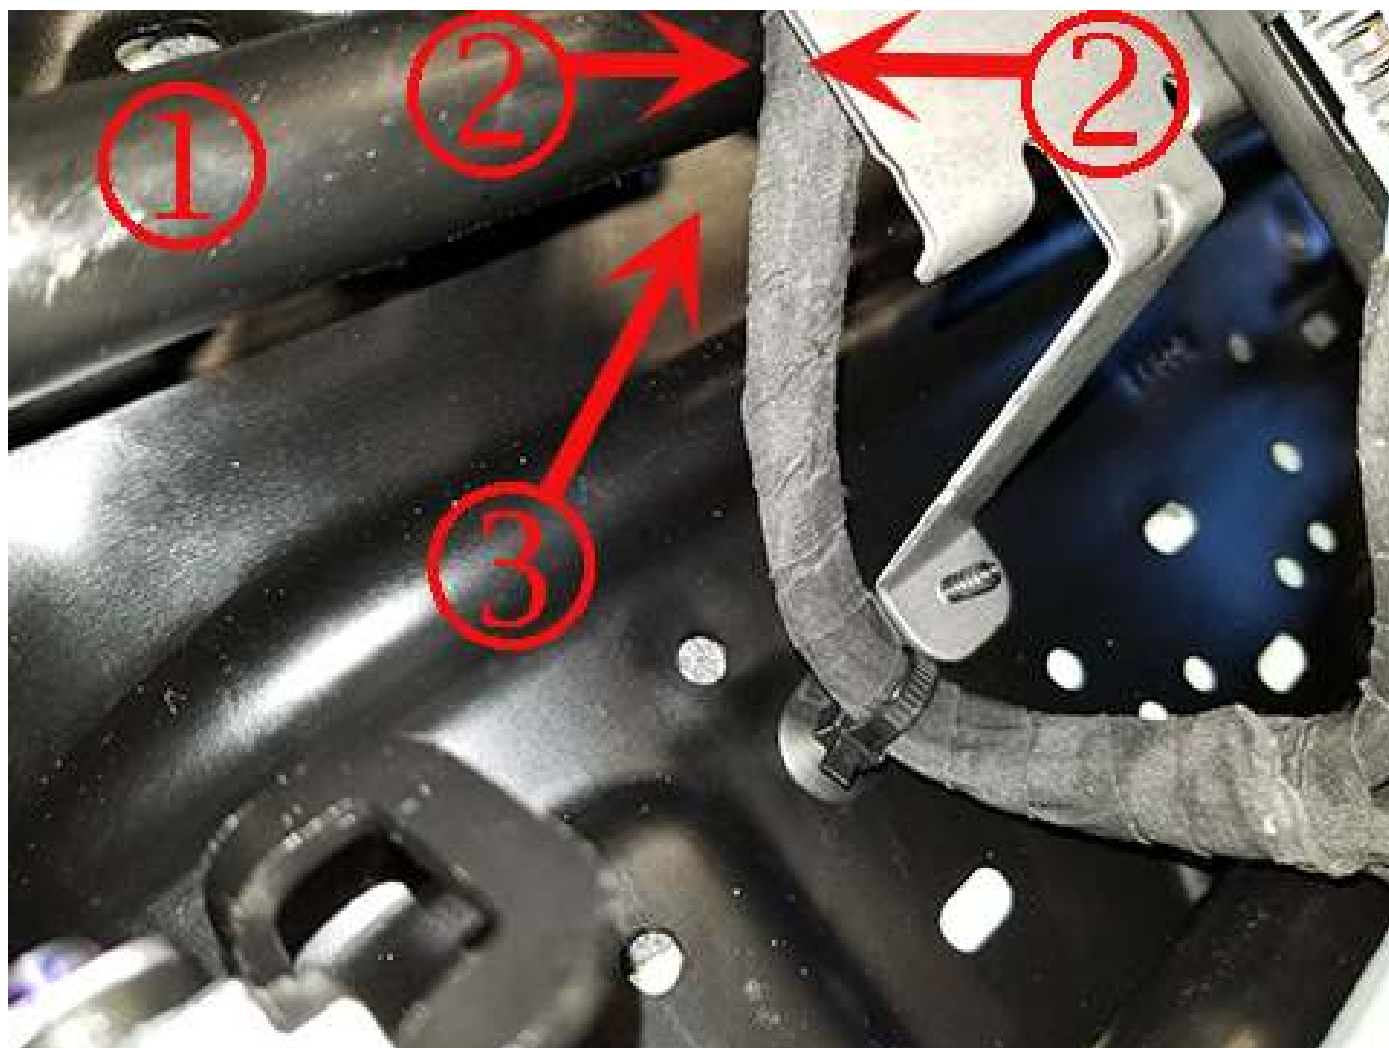
| Cause | The wire harness may be incorrectly routed below the seat frame tube and pinched between the memory seat module bracket and the seat cushion frame tube. |

- 1. Seat Frame Tube
- 2. Harness routed below seat frame tube allowing contact with MSM bracket
- 3. Proper routing of harness above seat frame tube.

**Re-route the harness above the seat frame tube so that it will not become pinched or damaged.**

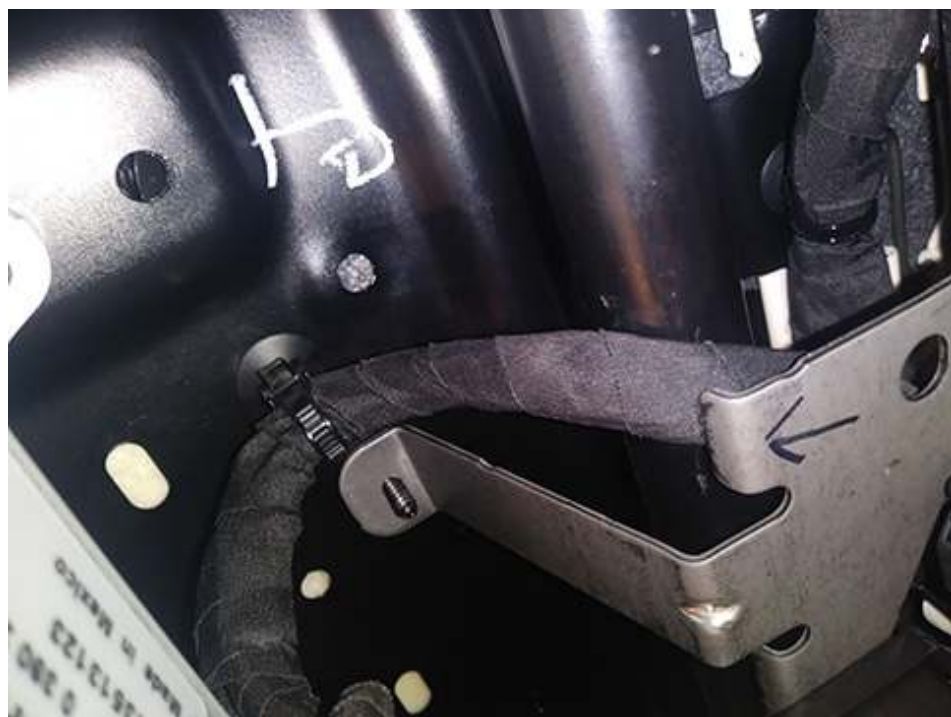
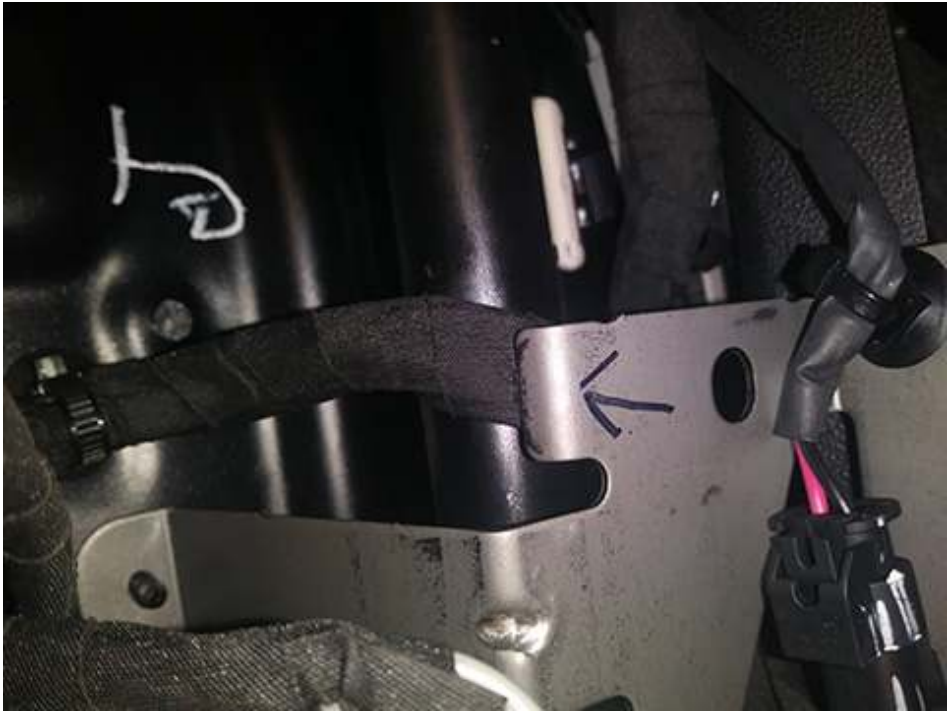
**If the harness is found to be routed below the seat frame tube inspect it for being pinched between the memory seat module bracket and the seat frame tube as shown below.**

Unbolt the seat and flip it up to gain access.

**Repair or replace the seat harness as needed.**

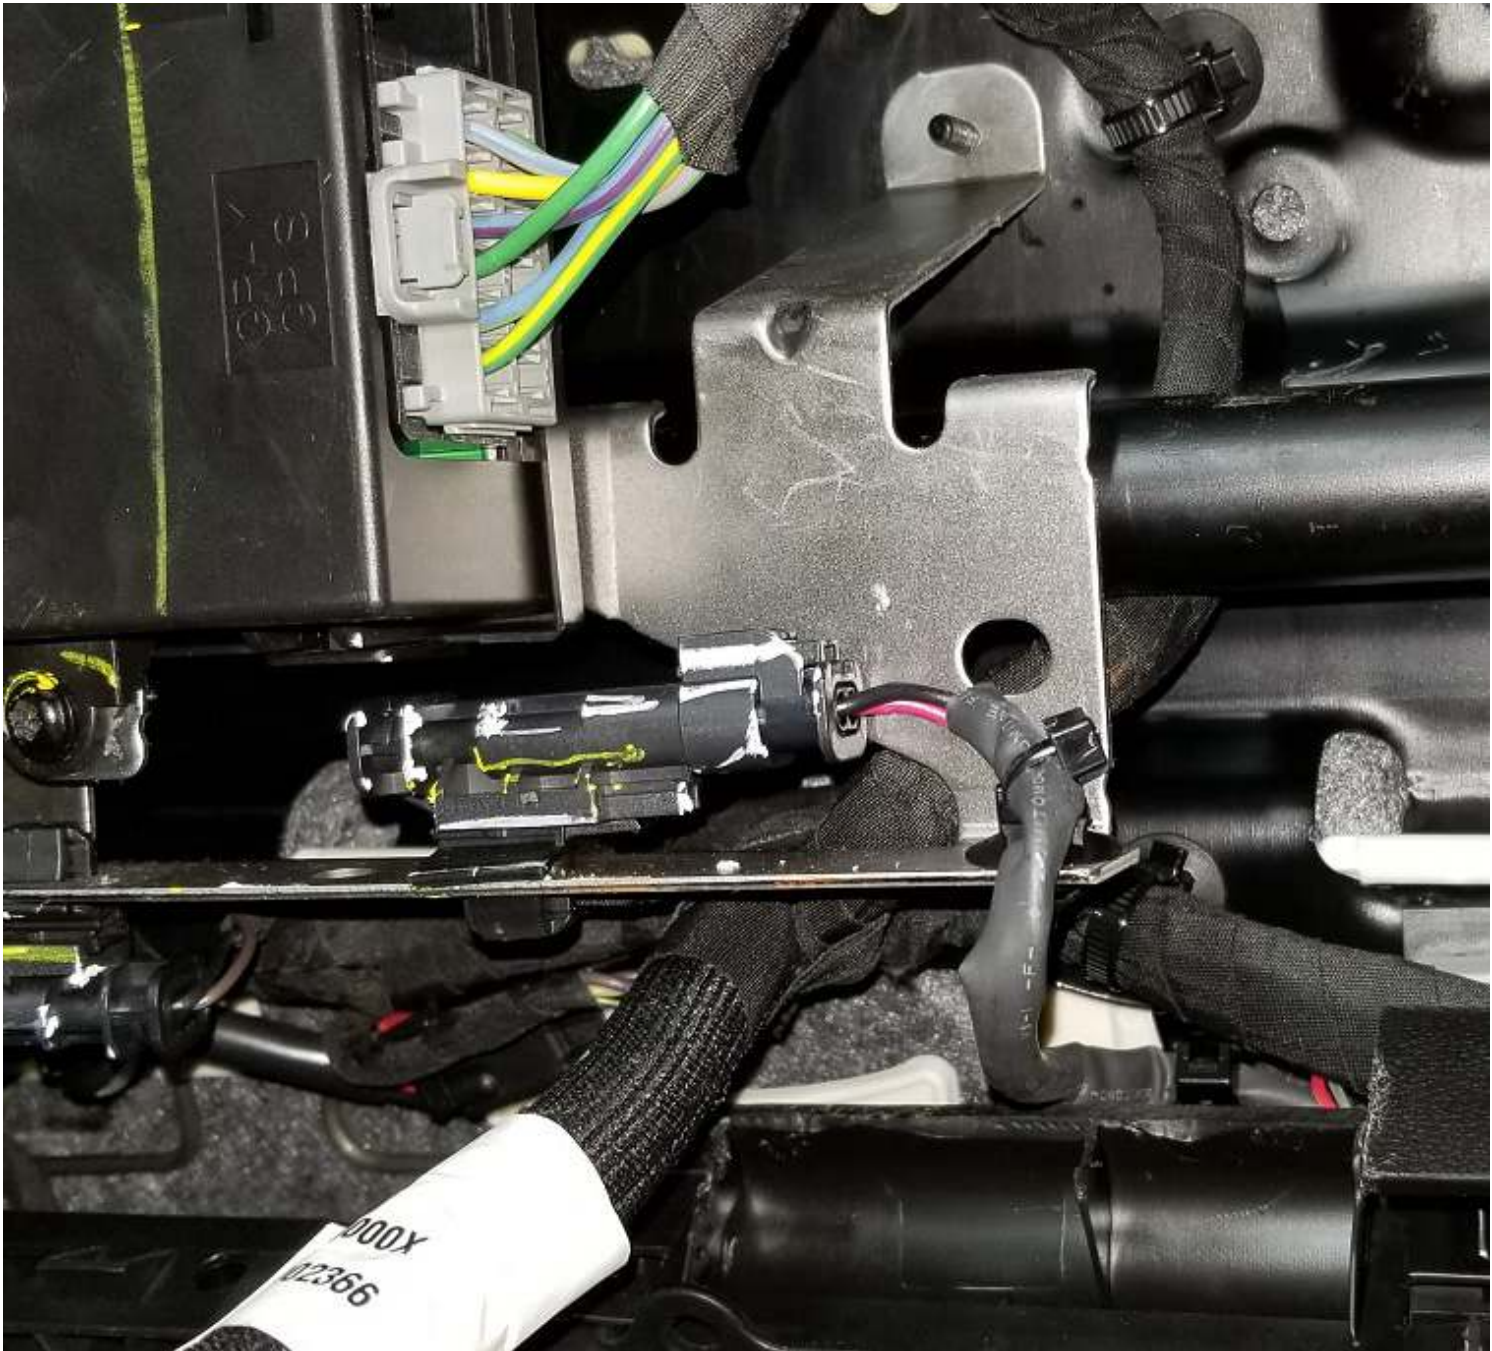
**See photo below showing harness properly routed above the seat frame tube.**
