# Preliminary Information

## PIP5202B (EREV) Diagnostic Tips for Intermittent MIL With DTC P0AB9

Models

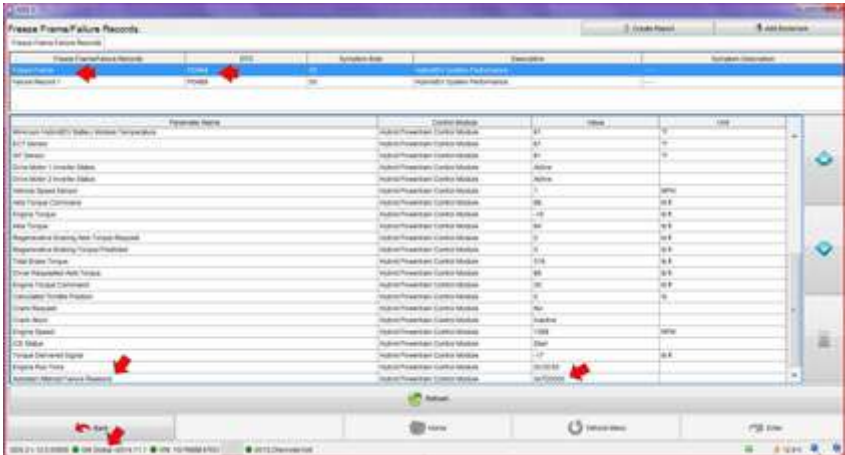
- 1) Review all modules for DTCs using GDS2 and select "Vehicle Wide DTC Check With Module Info" under the Vehicle Diagnostics Menu. DO NOT clear any DTC's. Review the HPCM and ECM Freeze Frame Data, then create a report. You can save the report or email it after doing so.
- 2) The HPCM Freeze Frame and Failure Records will include "Autostart Attempt Failure Reasons". In order to view them in the Freeze Frame Record, GDS2 must be updated to v12.0.0.00835 - Global v2014.11.1 or later.
