# Preliminary Information

## PIP5643 MIL Illuminated DTC P0299

| Brand: | Model: | Model Years: | VIN: | | Engine: | Transmissions: |
|---|---|---|---|---|---|---|
| Cadillac | XT4 | 2019 | All | All | 2.0L LSY | All |

| Condition: | MIL Illuminated DTC P0299 |

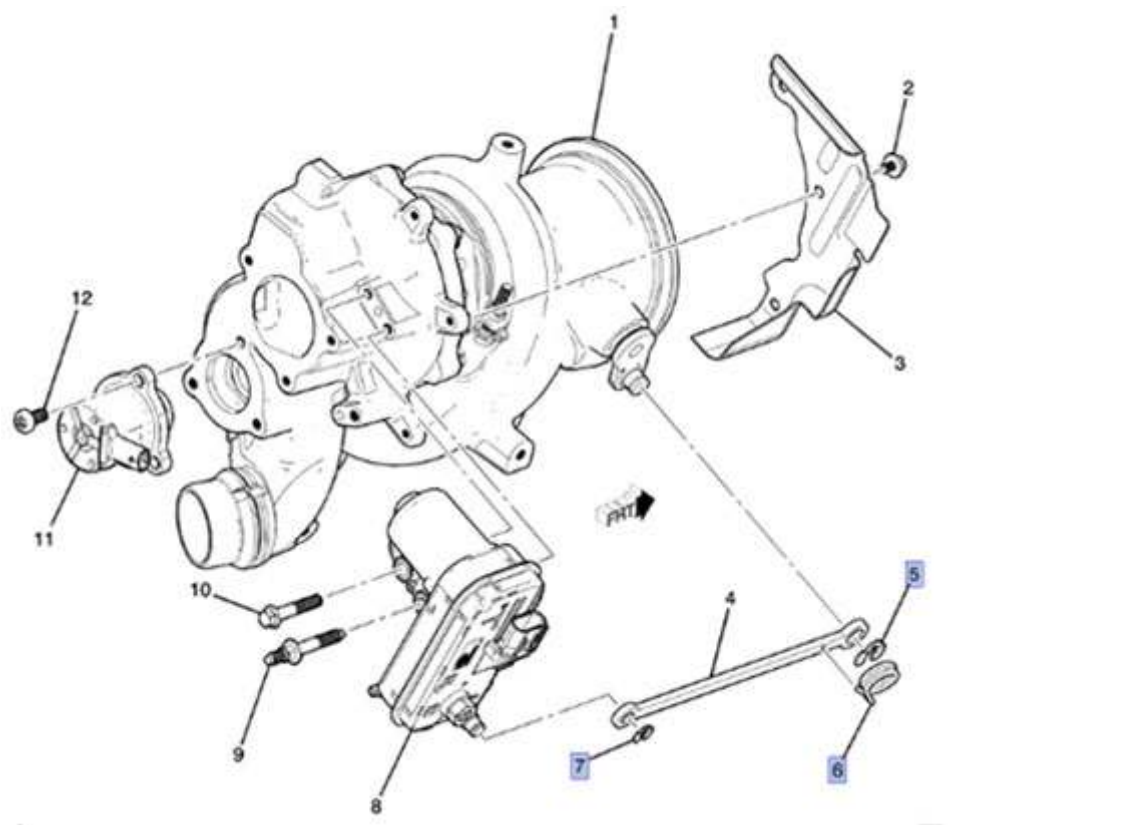
| Cause: | Possible missing turbocharger wastegate lever retaining clip |

If you encounter a vehicle with DTC p0299 inspect the wastegate lever for a possible missing retaining clip at the wastegate actuator or at the wastegate valve causing the lever to become disconnected. The wastegate lever side also has a anti-rattle spring that could be missing. (Call outs 5, 6 and 7 in the illustration below reference the anti-rattle spring and retaining clips.)

If you find a missing wastegate lever retaining clip either at the actuator or wastegate valve. These retaining clips and anti-rattle spring may be available through CCA Parts, if so, then install the missing retaining clip and anti-rattle spring if needed and evaluate.

**Note:** if the retaining clips or anti-rattle spring are not available turbocharger replacement would be required. Do not attempt to swap the retaining clips from the new turbo to the OE turbo. Install the new turbocharger assembly as the old parts will be requested back for further analysis to determine root cause for missing retaining clip.
