Preliminary Information

PIP5495J Check Engine Light On With P0299 Or P0234

| Cause: | Misdiagnosis Leading to Returned Turbochargers with NTF |

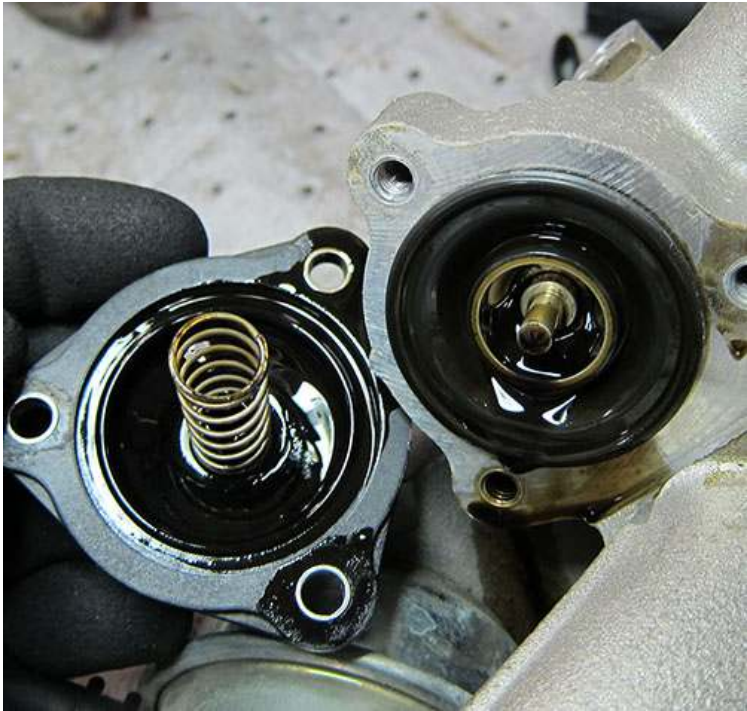
Bypass (recirculation) valve cover port broken or water/oil found inside the valve (clean the components, if necessary replace bypass (recirculation) valve assembly - released for service)

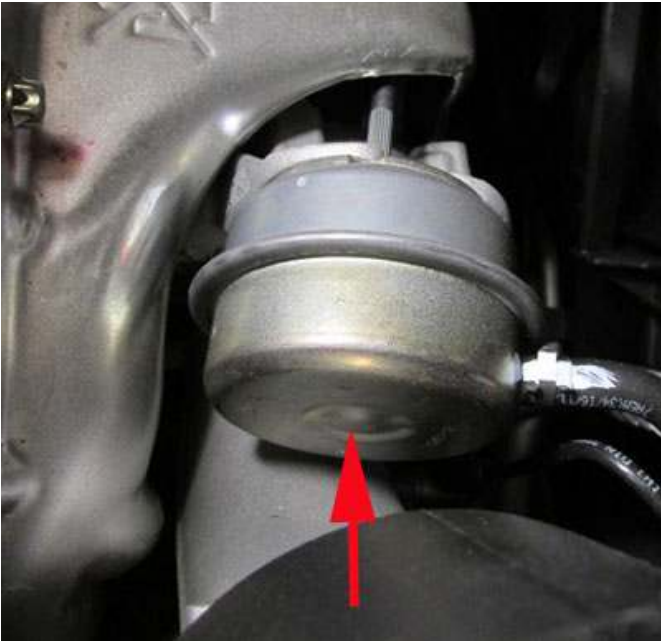
The updated design actuator show below has a stop that is not recessed and allows 5mm more travel in the closed direction.

With this updated design, it is very unlikely that an insufficient preload issue exists.

Updated design.
