Preliminary Information

PIP5498L SES Lamp P050D P0300 Setting On A Cold Start And/Or a Run Rough Warm with No codes

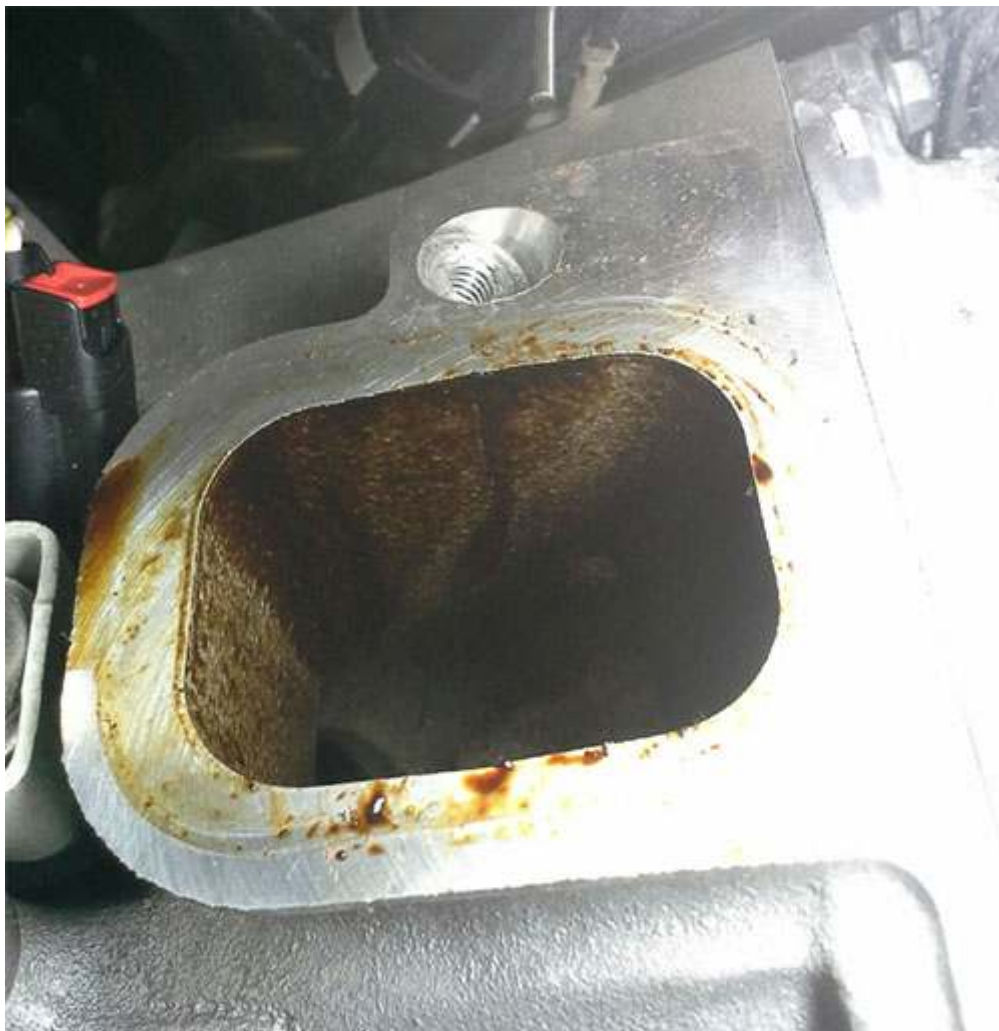
If the head casting line is the concern the intake port will be wet with a coolant oil mix.

This could be the cause of a running rough warm concern with or without codes.

The location of where the coolant is running down in the port will also look washed down.

If this is found the cylinder head will need to be replaced.

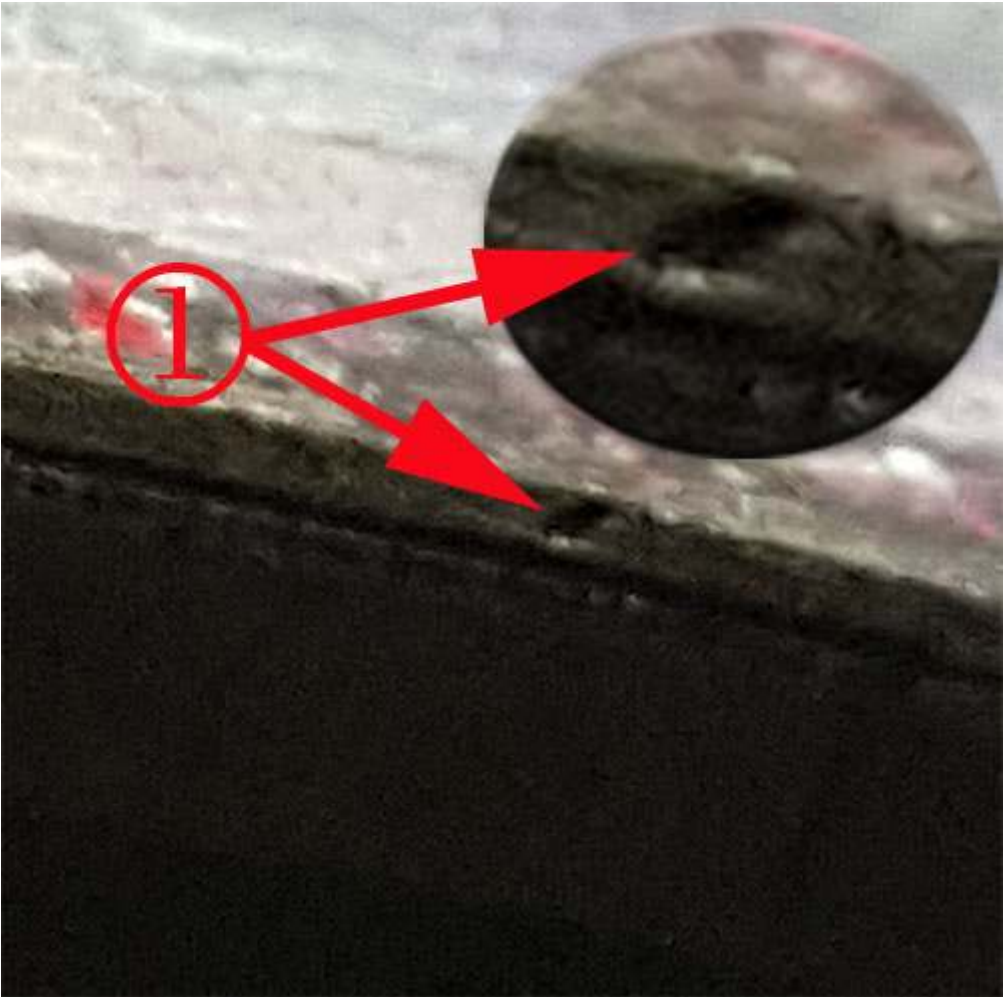
For coolant entry at the liner to deck face casting of the cylinder bore.

It is hard to see the actual source (pin hole) but it usually streams down the liner so that you can see it with a borescope.(Sometimes) The top of the piston will be steam cleaned.

Do not confuse residual fuel on the piston crown / surface as coolant. Some fuel residue may be present and can be mistaken as coolant (reason for the cooling system Dye to be added). Use black light to confirm the liquid is coolant. If this concern is present, do not replace the cylinder head because that will not repair this concern. Call PQC per the latest version of [16-NA-338](#), if required, reference this PI and replace the engine.
