# Preliminary Information

## PIP4825A DTC P0101 P0234 Low Power LAU 2 8L Turbocharged Models

| Brand: | Model: | Model Years: | VIN: | | Engine: | Transmissions: |
|---|---|---|---|---|---|---|
| Cadillac | SRX | 2010 | ALL | ALL | 2.8 LAU | ALL |

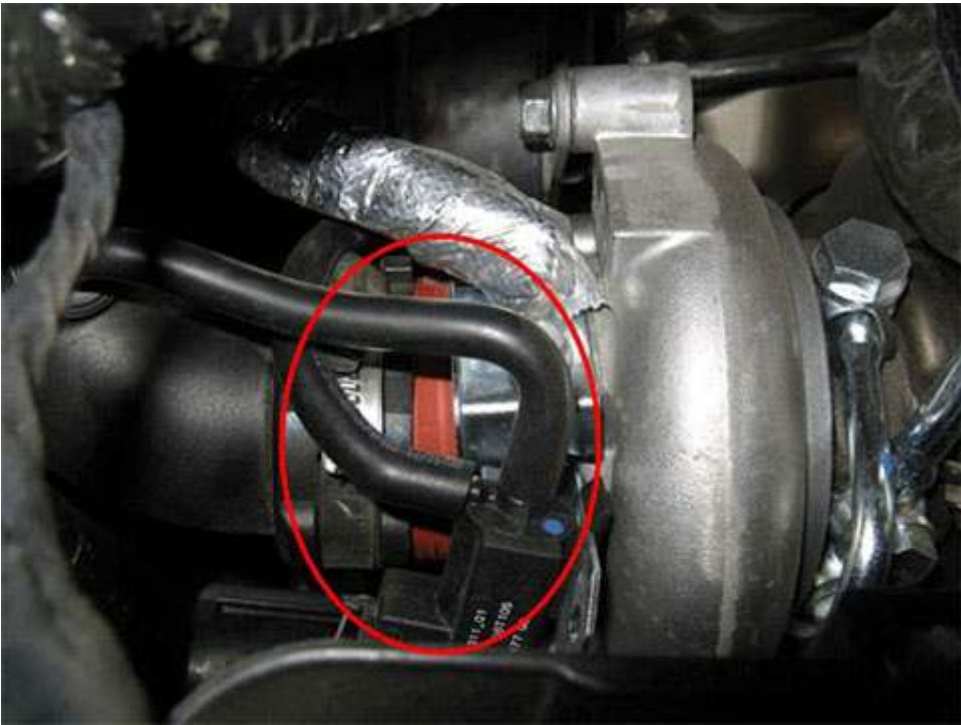
**Air cleaner outlet duct [ tube ] not fully seated to turbo.  
Vehicle may have DTC P0234 or P0101 (A thin line of the red seal may be showing on all vehicles,**

problem vehicles will have more showing, as seen here).

**Also have them inspect the Air Cleaner Outlet Tube fitting at the compressor inlet.**

**If they can see the orange seal, the snorkel is likely backing off and can impinge the wastegate pressure hose.**

**Any new air cleaner outlet tube ordered from SPO will be the new designed tube with a black seal instead of orange.**

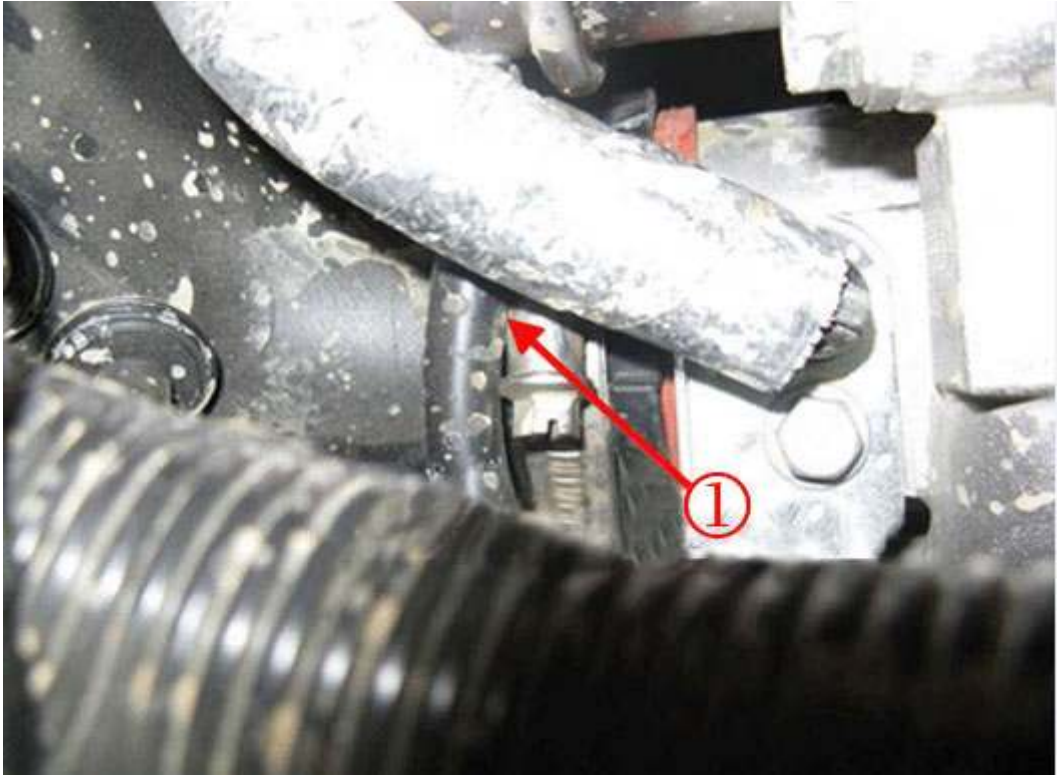
The retaining screw clamp on the Turbo, Air cleaner outlet duct [ tube ] was coming in contact and abrading against the under side surface of the rubber hose(creating hole & leak) between turbo-charger waste gate solenoid and waste gate valve.

**Remove and inspect the wastegate pressurhose.**

**Newer wastegate pressure hoses will be shielded with a nylon shielding to help prevent abrasion.**

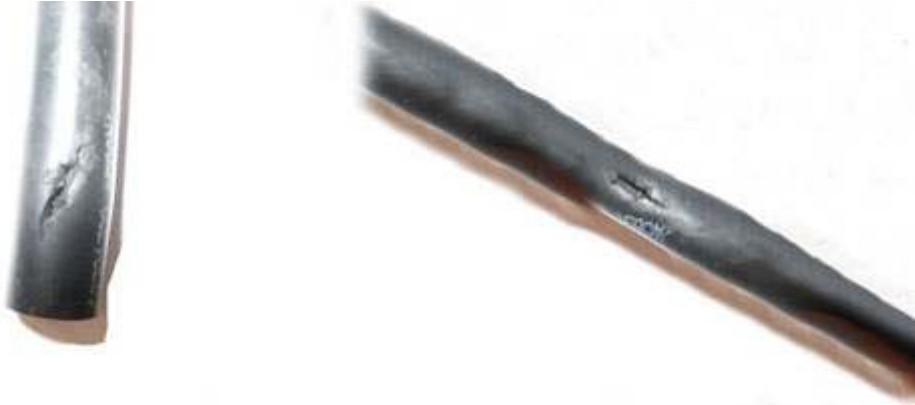
Rubber hose between turbo-charger waste gate solenoid and waste gate valve, abraded and leaking.
