Preliminary Information

PIP5298B SES Traction Control lamp on and Engine Runs Rough with DTC P0300

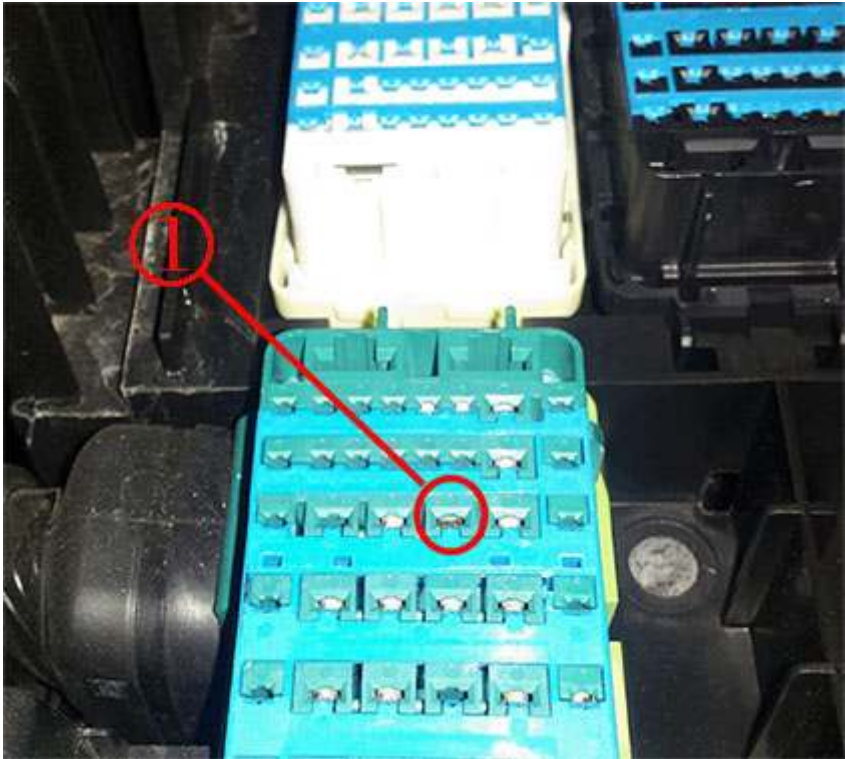
**X2 Terminal**

If SI diagnostics have been completed with no trouble found inspect for a possible terminal tension concern on both the ignition coil power feed for a possible cause of the DTC P0300 set and/or a rough running engine, and the X2 connector of the UBEC (Under hood Fuse Block) for an intermittent SES Traction control lamp concern and repair as necessary.
