# Various Drivability Concerns, and/or DTCs, Corrosion Present in A43 or A9 Connector

**Service Category** Engine/Hybrid System

| YEAR(S) | MODEL(S) | ADDITIONAL INFORMATION |
|---|---|---|
| 2014 - 2018 | Highlander, Highlander HV | |

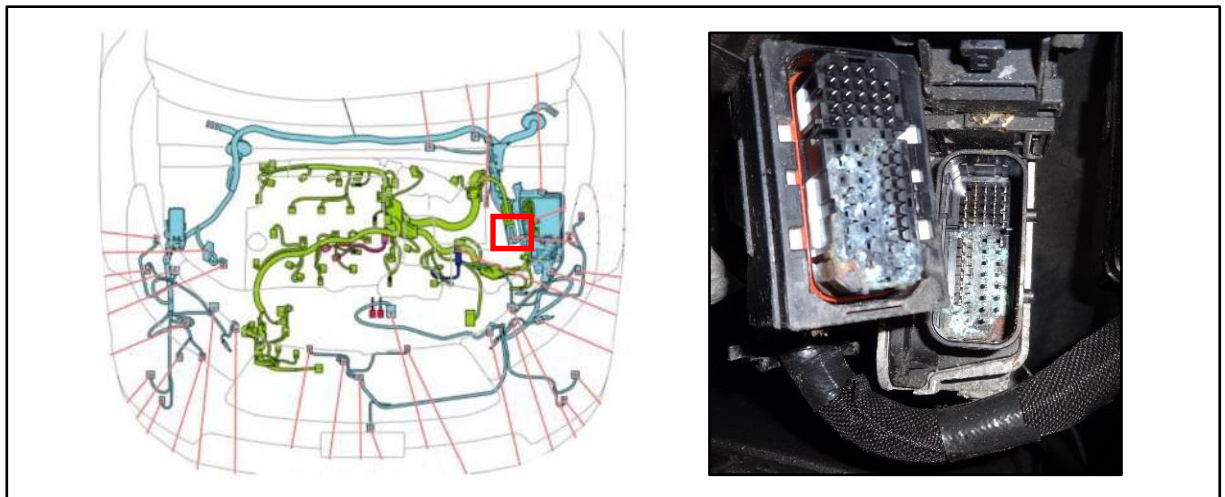
**Figure 1. A43 Connector Location and Corrosion**

These conditions may be caused by corrosion/water in the A43 ECM connector (Highlander) or the A9 inverter water pump connector (Highlander HV). The corrosion in the A43 and A9 connectors is due to poorly sealed or damaged aftermarket windshield deicer harnesses. Follow the Repair Procedure in this bulletin to address these conditions.

3. Check for corrosion in the A43 ECM connector.  
Remove the A43 ECM connector.

6. Replace the components listed in the table below.

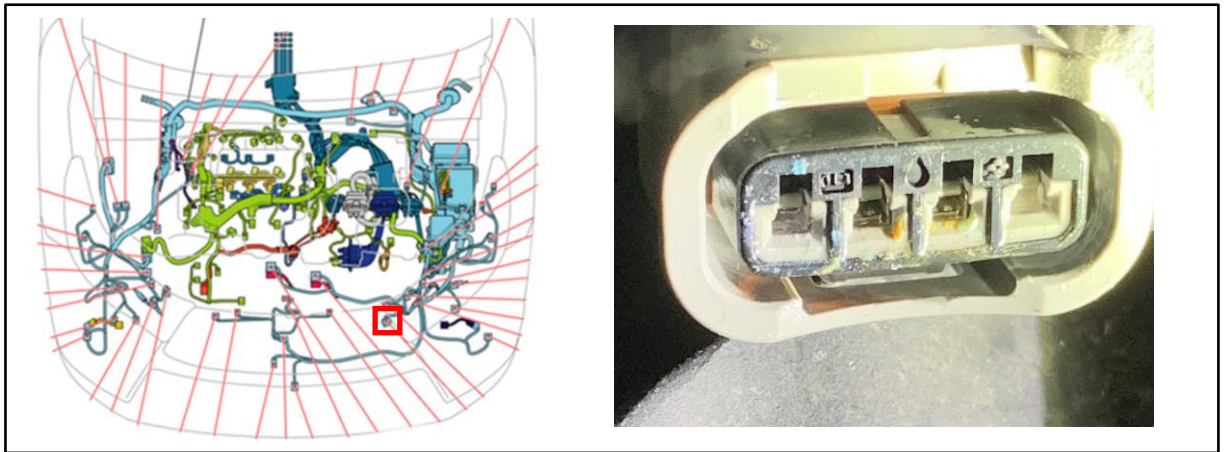
**Figure 2. A9 Connector Location and Corrosion**

4. Remove the A9 inverter water pump with motor assembly connector.

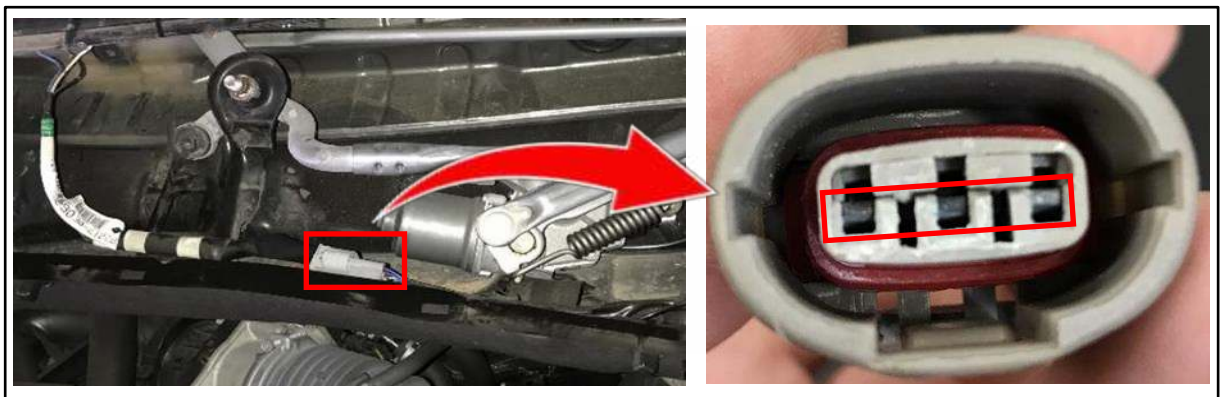
**Figure 3. A33 Connector Location and Corrosion**

5. Check for corrosion in the A33 front wiper deicer (windshield glass) connector (Highlander and Highlander HV).

Remove the A33 front wiper deicer (windshield glass) connector.

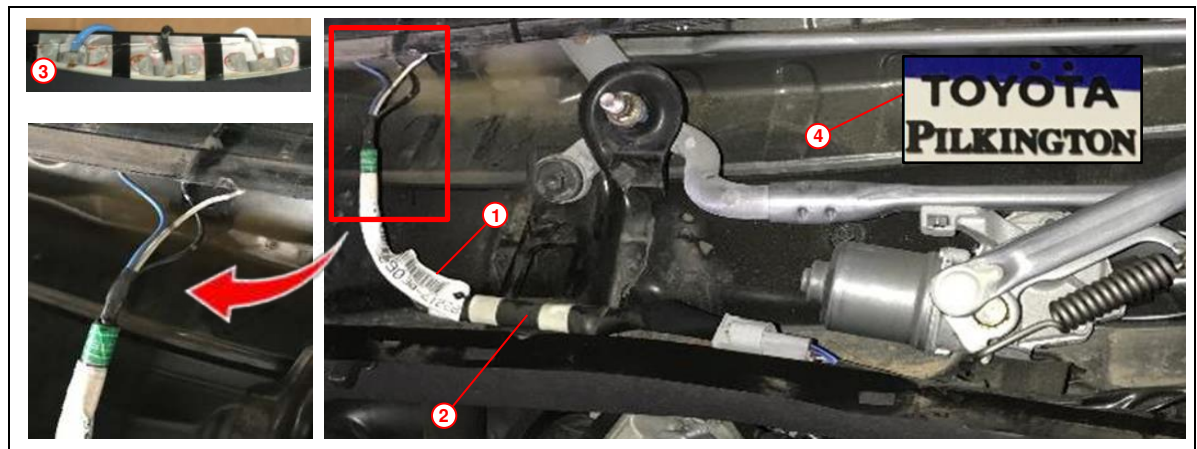
**Figure 4.**

It is strongly recommended to replace the windshield with a Toyota genuine windshield. Toyota windshields utilize special seals to prevent water/moisture from entering the engine room main wire harness. Some aftermarket windshields do NOT have these seals.
