**APPLICABILITY:** 2010-14MY Legacy and Outback Models

**NUMBER:** 07-84-14R

**SUBJECT:** Revised B1650 Diagnostics and ODS  
 Rezeroing Procedure

**DATE:** 03/13/14

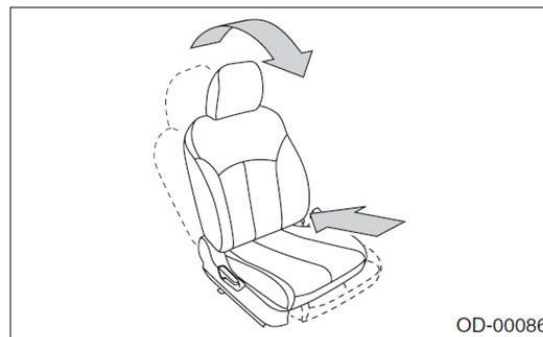
OD-00086

- Park empty vehicle on a level surface.
- Check that seat temperature is in a range from 0 to 40°C (32 to 104°F).
- Remove any weighty objects from the vehicle.
- Check and adjust the following items on the vehicle:
  - Verify that all ODS-related harnesses and connectors are fully seated.
  - Verify that the seat assembly is correctly installed in the vehicle.
  - Adjust the seat backrest to be fully upright.
  - Adjust the seat slide position all the way back.
