# Technical Service Bulletin

CHECK ENGINE LIGHT ON WITH DTC P2096:00

**Bulletin No.:** 01-011/19

**Last Issued:** 07/24/2019

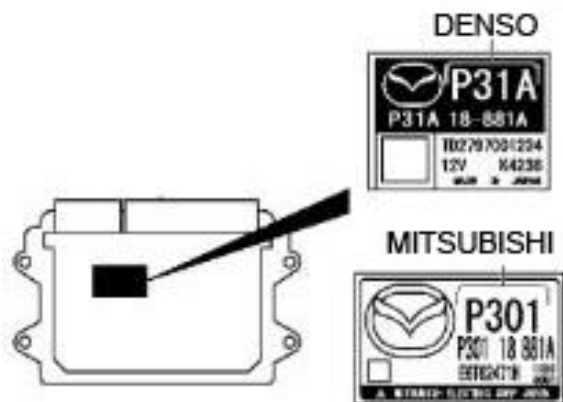
### PCM Identification

**NOTE:** This concern occurs only on vehicles with PCMs manufactured by MITSUBISHI.

Due to improper control logic of the PCM, a false error may be detected. To eliminate this concern, the PCM software has been modified.

1. Verify the customer concern.
2. Using the image above, verify the PCM in the subject vehicle is manufactured by MITSUBISHI, if yes, **read all cautions and notes below then proceed to "PCM REPROGRAMMING"**.
