# Technical Service Bulletin

| <b>Subject:</b><br><br><b>CHECK ENGINE LIGHT ON WITH DTC P0300:00, P0301:00, P0302:00,<br/>P0303:00, AND/OR P0304:00</b> | <b>Bulletin No.:</b> 01-012/19 |
| | <b>Last Issued:</b> 07/02/2019 |

2012-2013 Mazda3 (with SKYACTIV)

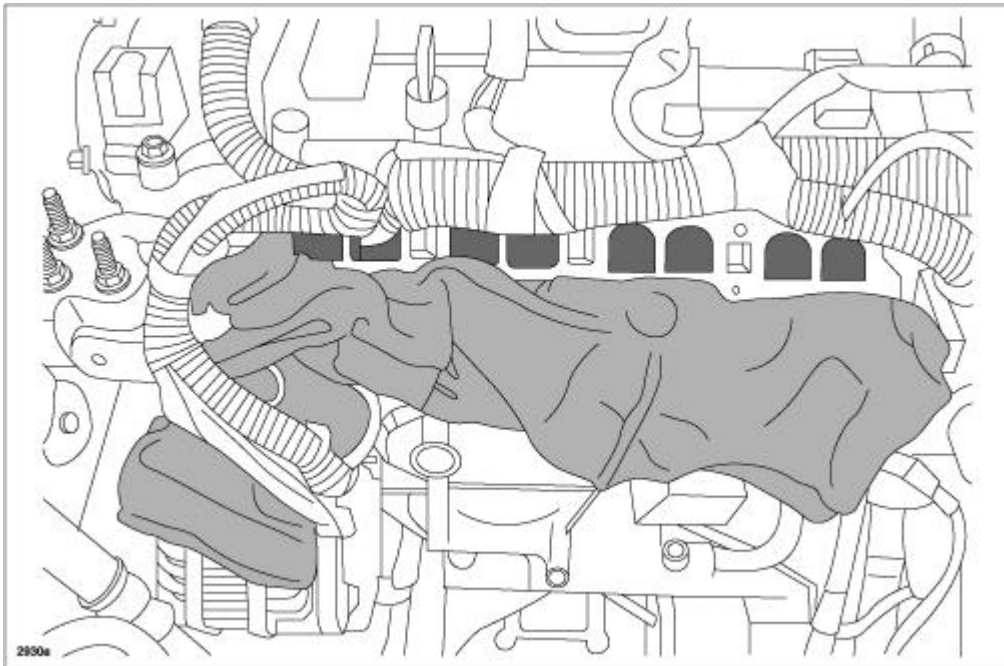
b. Check for carbon deposit around the intake valves.

c. Spread shop towels under the intake ports to protect components from cleaner overflow.

**CAUTION:** Take care not to damage the alternator.
