Preliminary Information

PIT5535D Service Front Camera / Service Lane Departure Warning / Service Lane Keep Assist Message with DTC B1008 SYM4B / IntelliBeam Headlight / Windshield Wind Rush Noise

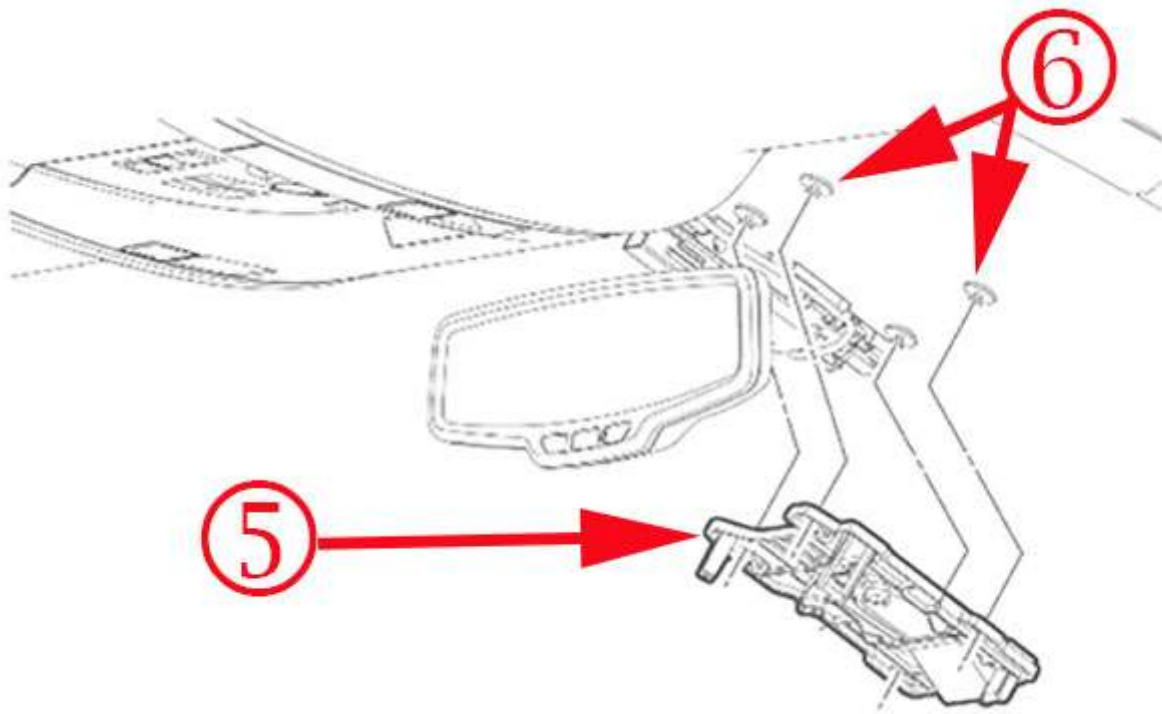
- Verify the front view camera module bracket (5) is fully seated down and secured on the windshield pins (6), shown below.

**Do NOT** replace the Front View Camera Module if it is only setting DTC B1008 SYM4B. Perform the following checks and repair as necessary:

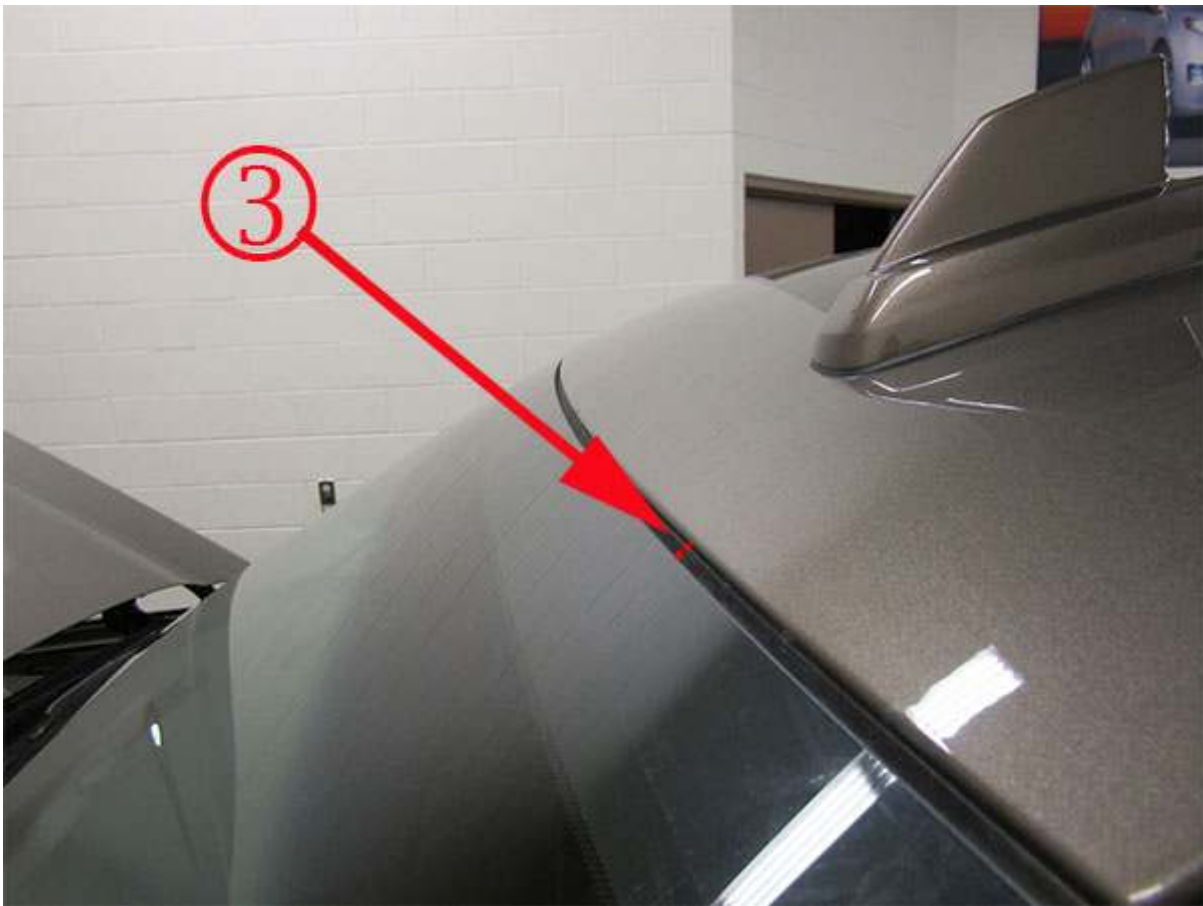
Inspect the gap between the top of the windshield and roof sheet metal (3), shown below. This gap should be 3.6 mm (+/- 1 mm).

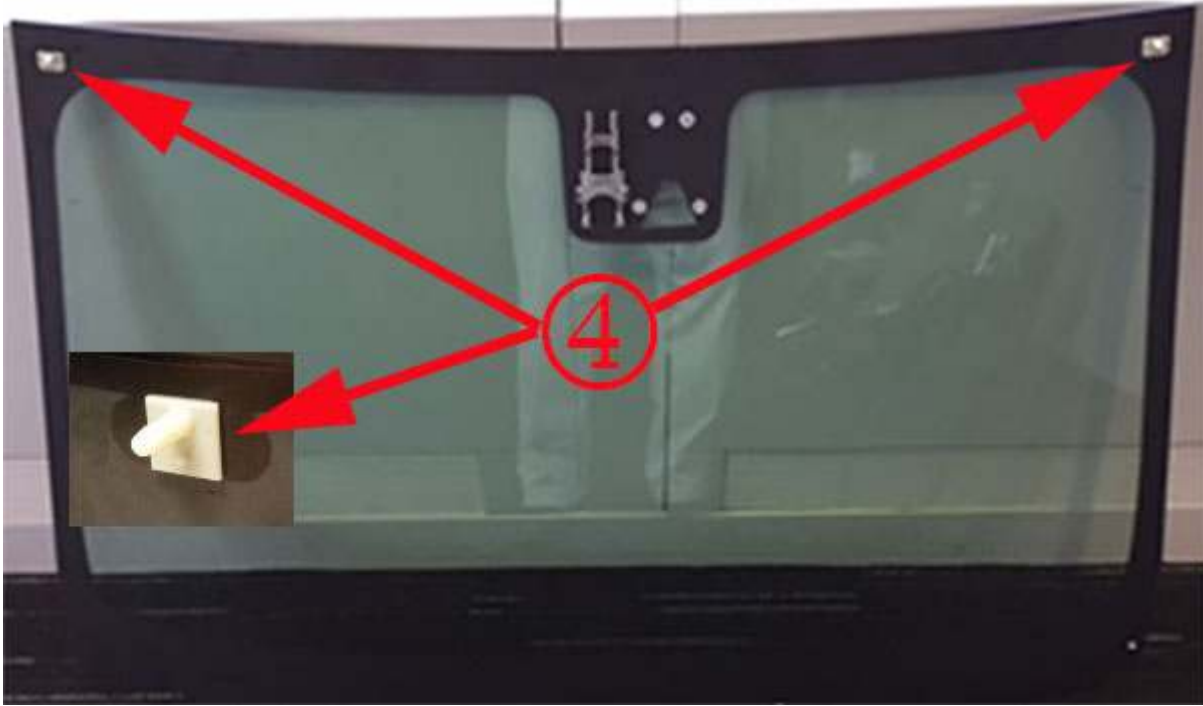
Factory GM windshields use alignment/locating pins (4) in the upper corners of the windshield, which makes it much easier to properly align the windshield to the body opening, shown below. Most aftermarket windshields do not use these alignment/locating pins, which can make it more difficult to ensure a proper installation.

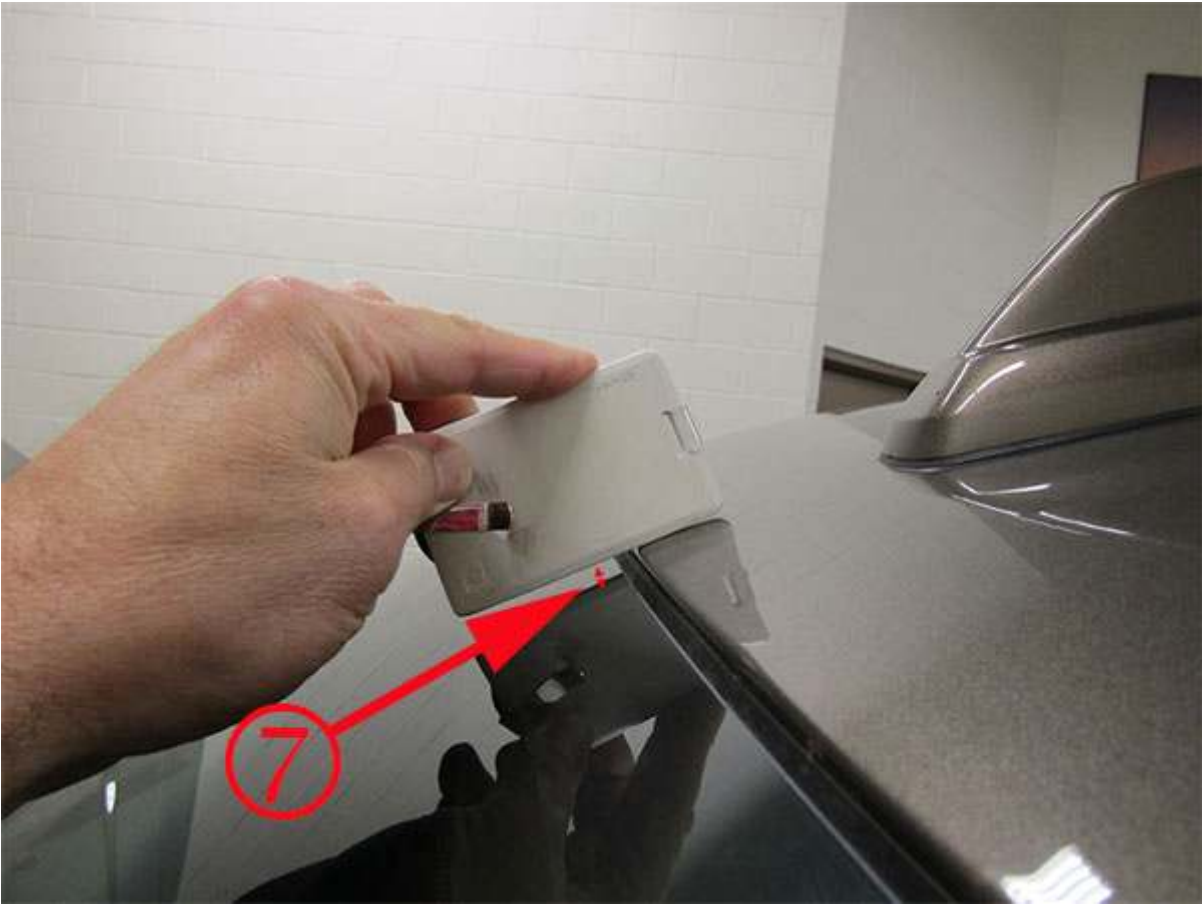
Also, inspect to make sure the windshield is sub-flush to the roof sheet metal (7), as shown below. If the windshield is proud of the roof sheet it could indicate:

- The old urethane adhesive bead was not cut low enough and left excessively thick.
- Windshield alignment/locating pin(s) are not fully in the alignment hole(s).
- During windshield installation it was not firmly pressed around the entire outside edge in order to wet-out the urethane adhesive bead.
- The urethane adhesive bead dried before the windshield was installed.

**NOTE: A windshield proud of the roof sheet metal could cause excessive wind noise.**

Either of these windshield mounting issues could cause the camera to be misaligned and

unable to complete the learn.

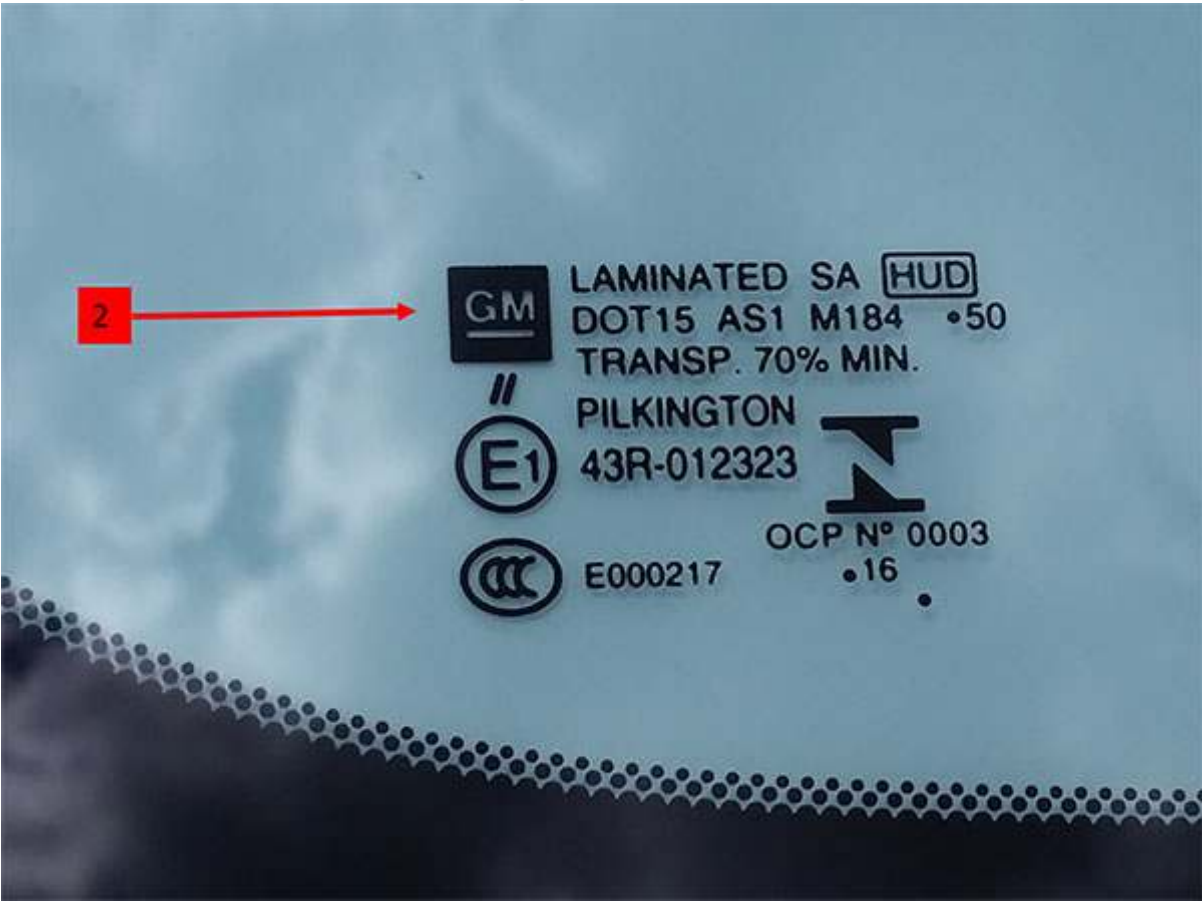
- If, after performing the checks listed above and the root cause of the camera not completing the calibration/learn is still not found, inspect for an aftermarket windshield being installed in the vehicle. To determine whether or not the windshield is an aftermarket or factory windshield, inspect for the "GM" Logo in the lower right corner of windshield, as shown below (2). If the "GM" Logo is not present, then the windshield is aftermarket.

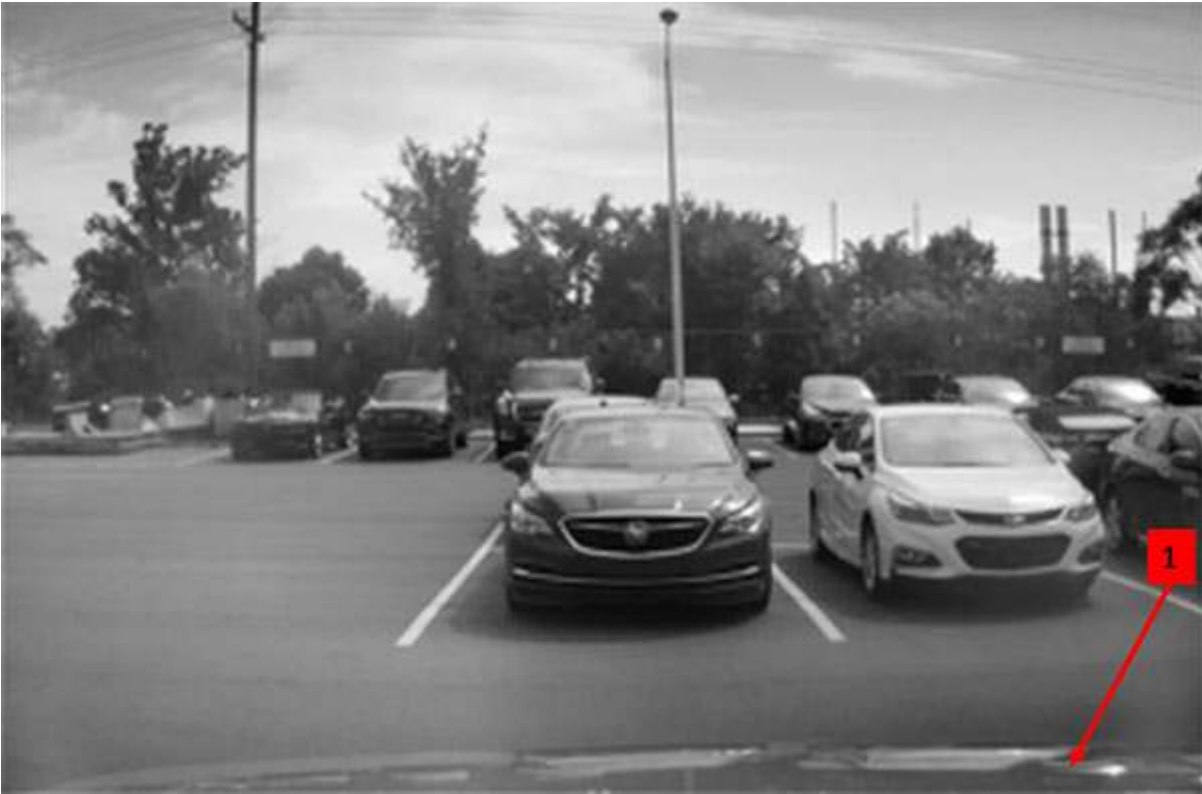
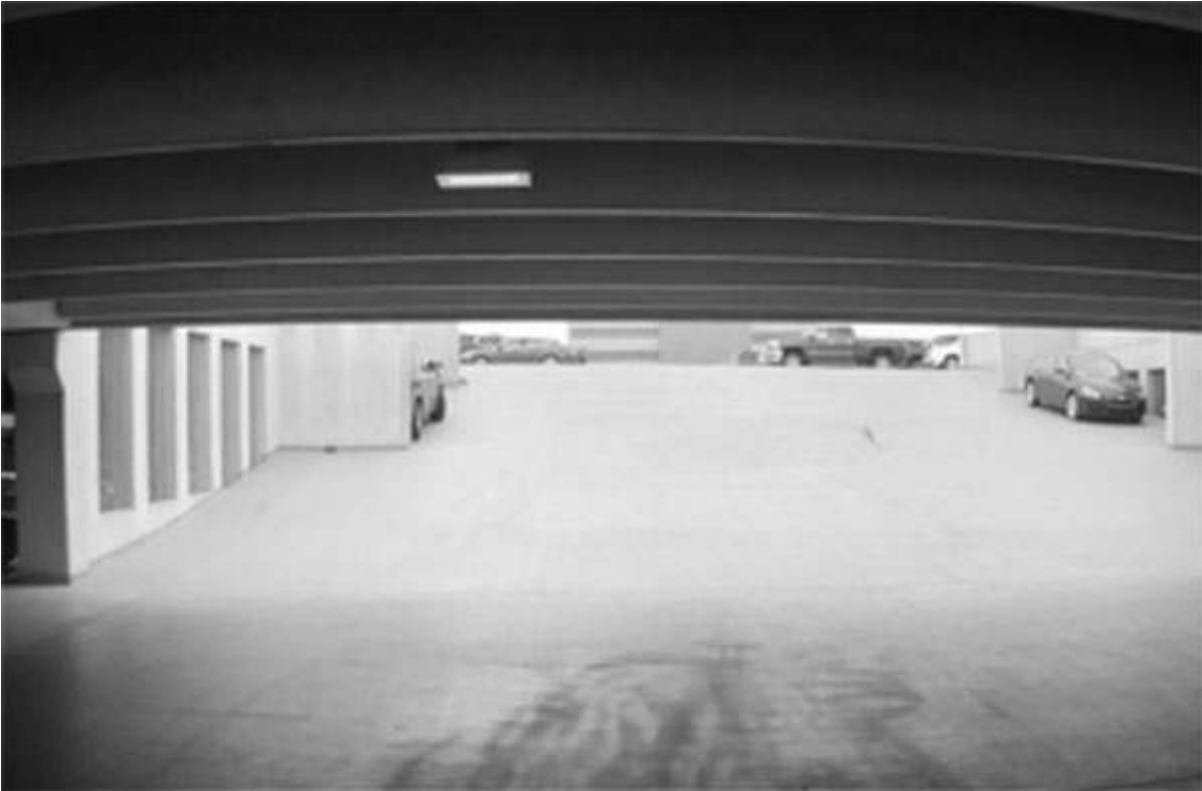
It has been found that some aftermarket windshields do not properly mount/position the front view camera. Shown below are some images, taken with engineering tools (see note below), of what the front view camera is actually seeing. The first image is taken from a truck with an aftermarket windshield. As shown below, the camera is seeing part of the hood (1). Because of this, the camera is not seeing movement in the area of the hood and can not complete the learn. The second image below is from a truck with a factory windshield and there is no hood seen by the front view camera.

**Note: The images shown below can only be seen using engineering tools and there is NO way for the dealership's service tools (GDS2) to see the front view camera images.**

**NOTE: If the windshield has to be removed/replaced for any of the above reasons, it is suggested that a factory GM windshield be installed.**
