## PIP5571A MIL / SES Lamp On After Engine Repairs, P0016 Set and Rough Idle

| Brand: | Model: | Model Years: | VIN: | | Engine: | Transmissions: |
|---|---|---|---|---|---|---|
| Chevrolet | Colorado | 2017 - 2020 | All | All | 3.6 LGZ | All |
| GMC | Canyon | 2017 - 2020 | All | All | 3.6 LGZ | All |

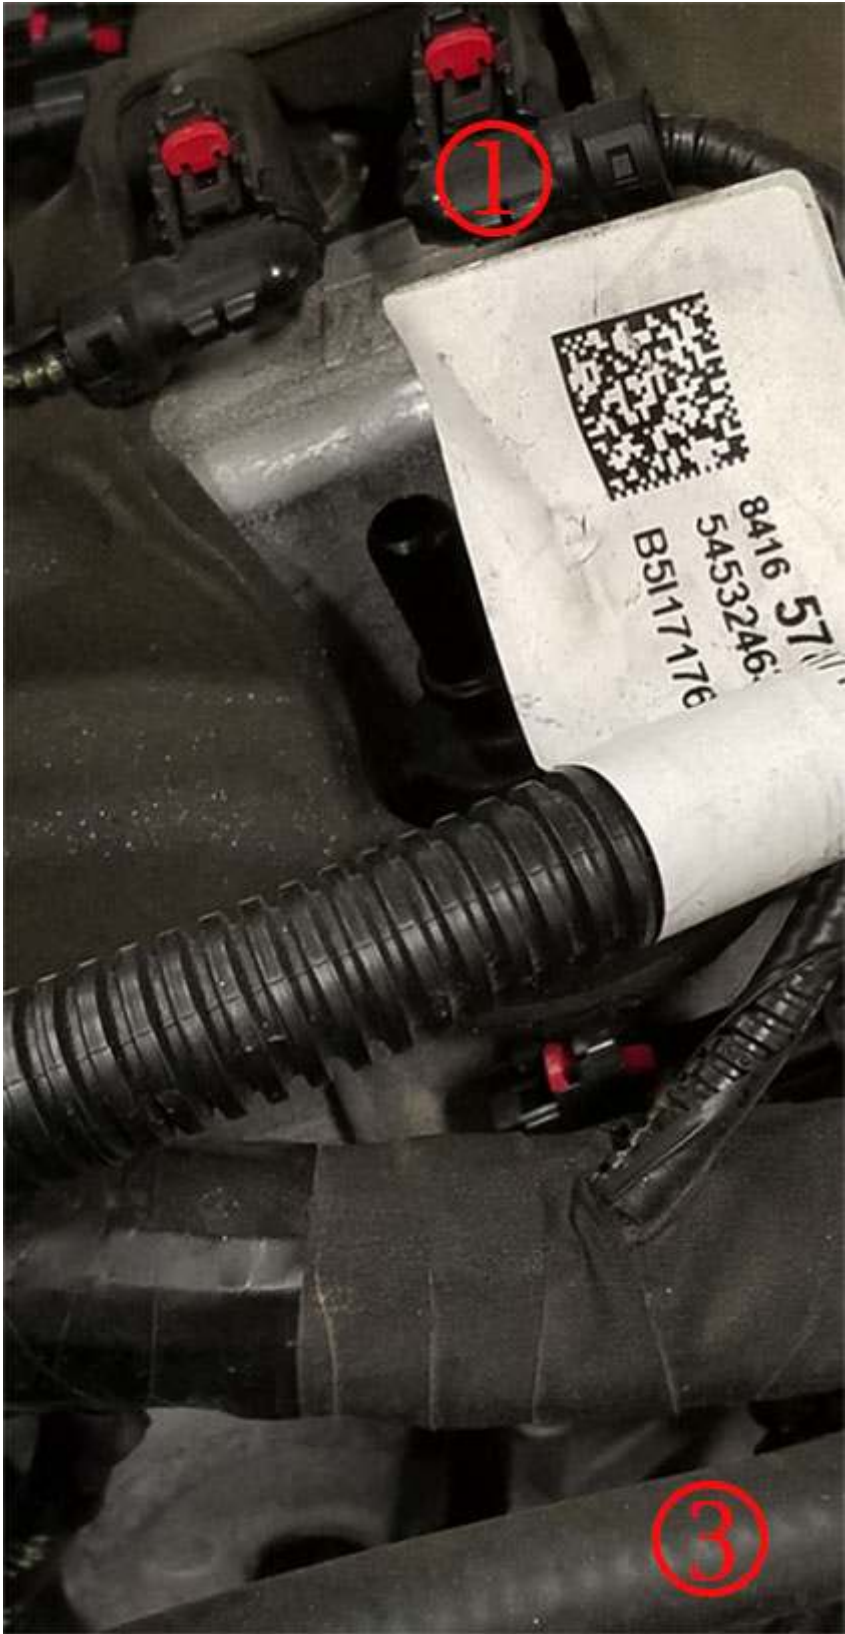
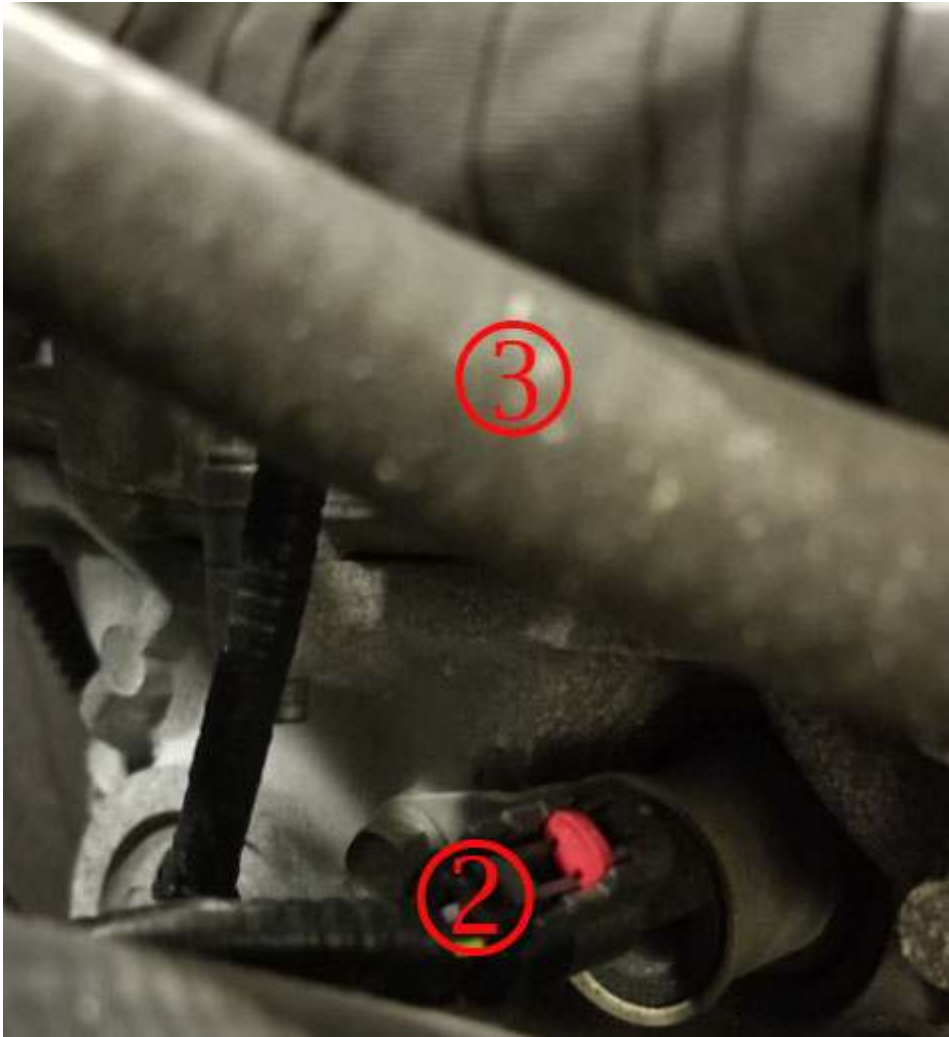
| Cause | What we are seeing is the wiring connectors for the intake camshaft actuator solenoid bank one on top of the engine and the connector for the intake actuator park lock solenoid in the front of the engine for bank one, have been swapped.<br>These two connectors are identical and can only be identified by wire color in the connector. |

- 1) Bank 1 intake actuator
- 2) Bank 1 intake park lock solenoid
- 3) Same hose in both pictures for relativity.

**Remove the connector and look at the schematic in eSI to compare and ensure the correct connector is plugged into the actuator and lock solenoid. (See pictures below)**

If they are incorrect swap them back and clear the code to verify repair.  
If they are already in the correct places then refer to the correct eSI diagnostics for this code.
