Preliminary Information

PIP5661 2019 2.0 LTG Engine Runs Rough with Malfunction Indicator Lamp (MIL) ON, Low Compression on Cylinder with Misfire, DTC P0300 Set

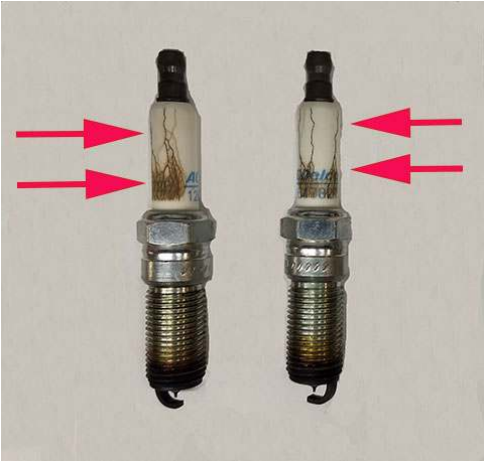
Visually inspect all the spark plugs for signs of carbon tracking on the portion of the spark plug being covered by the coil boot.

If any carbon tracking is seen replace all four spark plugs and ignition coils.

Important: Be sure to apply dielectric grease to the spark plug boot as directed in SI for ignition coil replacement.

Apply a thin coating of dielectric grease to the inside of the ignition coil rubber boot, up to a depth of 15 mm from the end of the boot. Refer to Adhesives, Fluids, Lubricants, and Sealers.

Remove any excess grease from around the end of the boot, and ensure there is not an excessive amount within the boot.

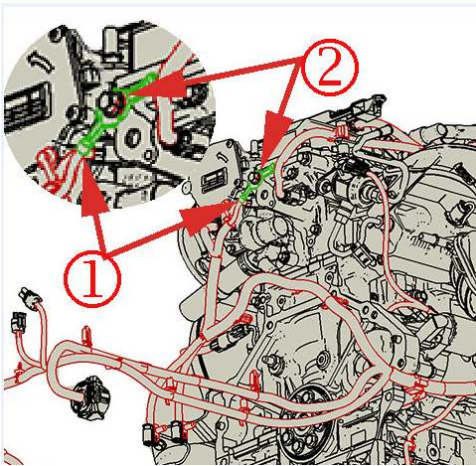
Check grounds G120 (item#2) and G130 (item#1) for proper torque and verify the ground eyelets can not be rotated under the bolt.

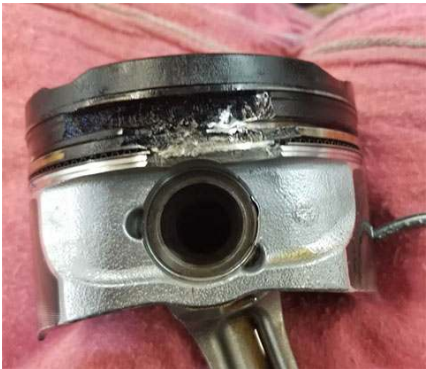
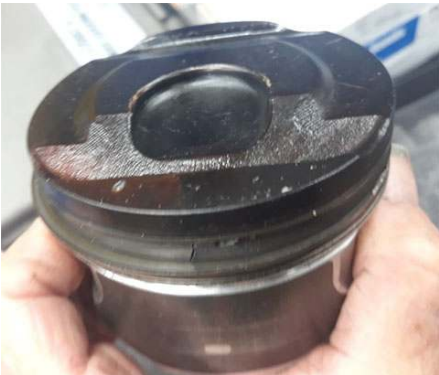
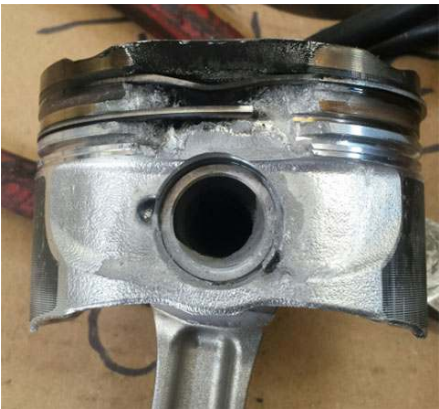
If the cylinder walls are not damaged, remove the pistons and inspect for a fractured piston between the top and second rings.

The pictures below are some examples of what might be found.

If cylinder walls are not damaged and one or more of the pistons are found fractured, replace all four spark plugs, all four ignition coils (apply dielectric grease to the spark plug boots), the fuel injector of the cylinder(s) that had damaged pistons, all four piston kits, all ring sets for all four pistons, all rod bearings, all four connecting rod assemblies and other components necessary when pistons are replaced.

**Note:** When installing pistons, make sure to use the tapered ring compressor J-43953 special tool. Use care when installing the piston assemblies into the cylinder so the rings are not damaged.
