# Preliminary Information

## PIP4905E Vehicle Will Not Charge DTC P0D26

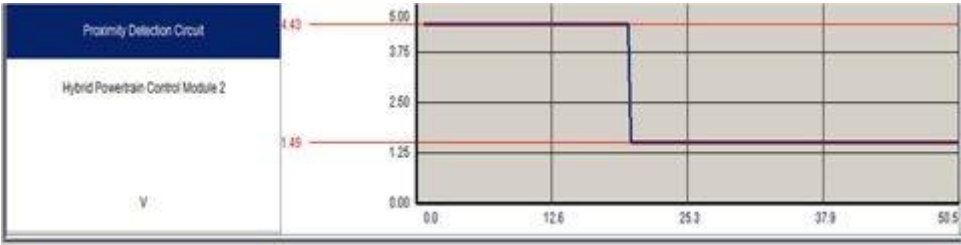
#### Good Signal

- 5) Review the two pictures below. One shows a Proximity signal that is good and the other shows a proximity signal that is erratic.
