# Technical Service Bulletin

**01 MIL on, DTC P20E8, P249C, and/or P218F are stored in the ECM or AdBlue residue is found on the injector**

01 19 20 2044927/2 August 7, 2019. Supersedes Technical Service Bulletin Group 01 number 16-70 dated July 27, 2016 for reasons listed below.

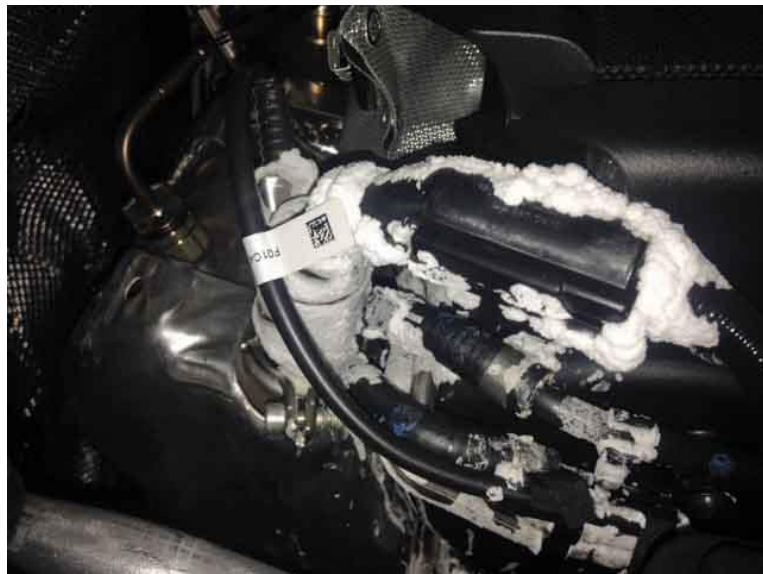
- Leaking AdBlue and/or dried residue may be noticeable under the hood near the AdBlue injector.

AdBlue supply lines may have a quality deviation that causes a leak near the AdBlue injector.

**Figure 1.** Evidence of leak—AdBlue residue.

1. Before replacing the pump or performing additional diagnosis for these faults, verify if any signs of leakage are found near the AdBlue injector.
2. If any leakage is found (Figure 1), replace the AdBlue supply line according to the Elsa Repair Manual and check system operation.

Dried AdBlue residue on any additional components can be cleaned off with warm water and a soft brush and allowed to air dry.
