# Technical Service Bulletin

## 91 SOS warning displayed in instrument cluster, DTC B105313 stored in the data bus on board diagnostic interface

91 19 75 2048360/5 August 7, 2019. Supersedes Technical Service Bulletin Group 91 number 18-93 dated April 26, 2018 for reasons listed below.

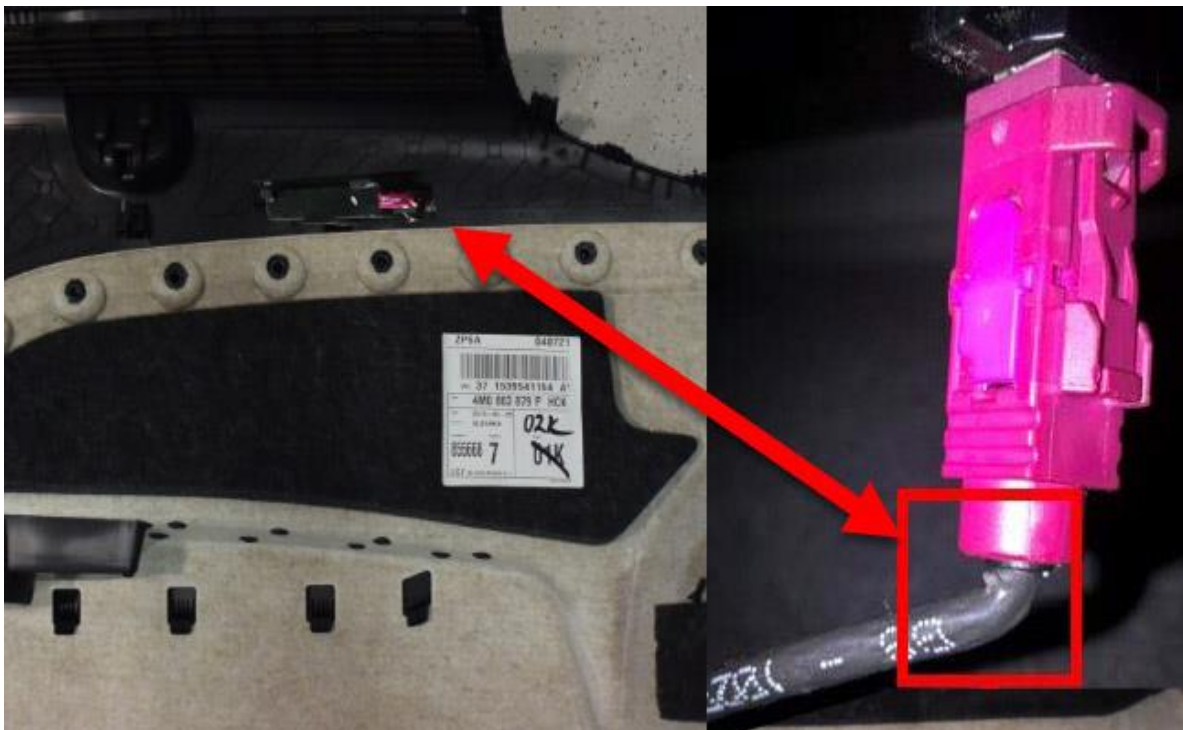
The contact on the wiring of the emergency call aerial may have been damaged in production.

**Figure 2.** Coaxial wire kinked at R263 SOS Antenna.

3. Repair existing coaxial harness:
  - Unplug the FAKRA connector from the R263 SOS Antenna.
  - Remove 250mm (9 3/4 inches) of coax wire from the existing harness. Measure from the front of the FAKRA connector (Figure 3).

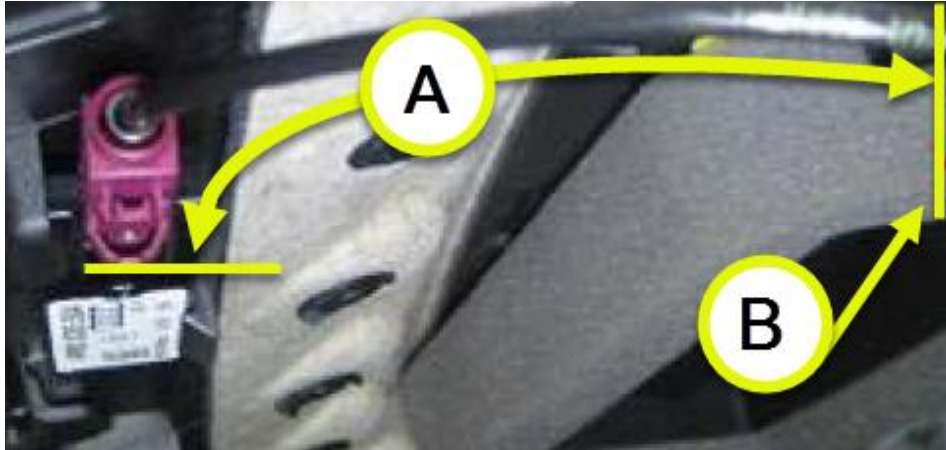
**Figure 3.** Cut the coaxial harness (B) 250mm (9 3/4 inches) (A) from the start of the Fakra connector.

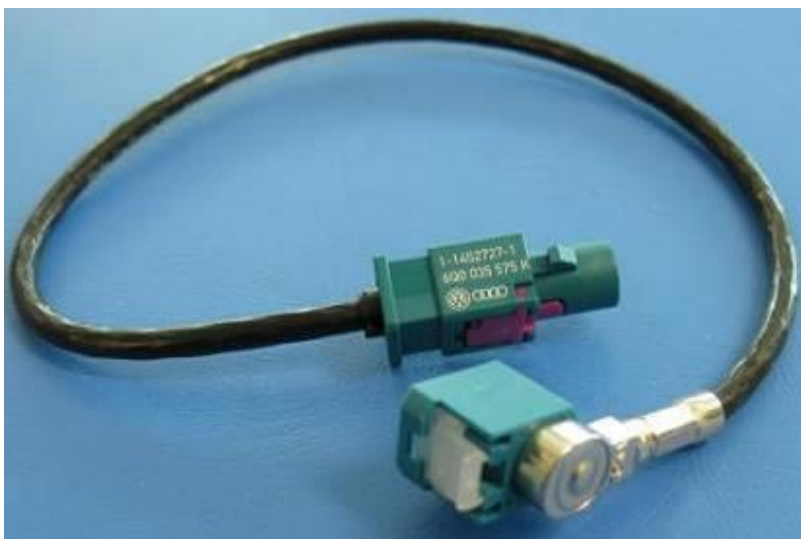
**Figure 5.** Right Angle Adapter Antenna Cable 000098710A.

- Install the right angle adapter antenna cable (Figure 5) between the newly installed Fakra connector from step 3 and the SOS antenna. Re-install all components.
- See Figure 6 for optimal wire routing path.

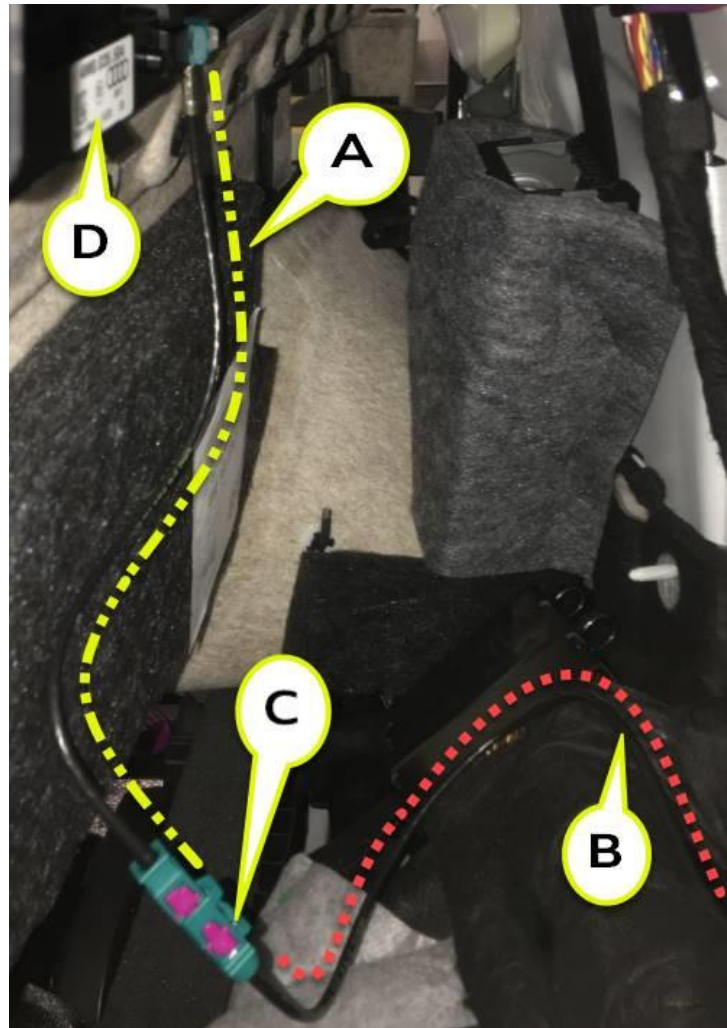
**Figure 6.** Modified R263 antenna wiring. A: Right Angle Adapter Antenna Cable 000098710A. B: Vehicle Coax Harness. C: New FAKRA connector. D: R263 SOS Antenna.

**Tip:** The cable must be free of tension around the area of the connector.
