Subject: N192210230 - Special Coverage  
Camshaft Cover Replacement

Models: 2015-2016 Chevrolet Cruze  
2015 Chevrolet Sonic  
Equipped with 1.4L 4 Cyl. turbo (RPO LUV)

# Special Coverage Adjustment

## N192210230 – Camshaft Cover Replacement

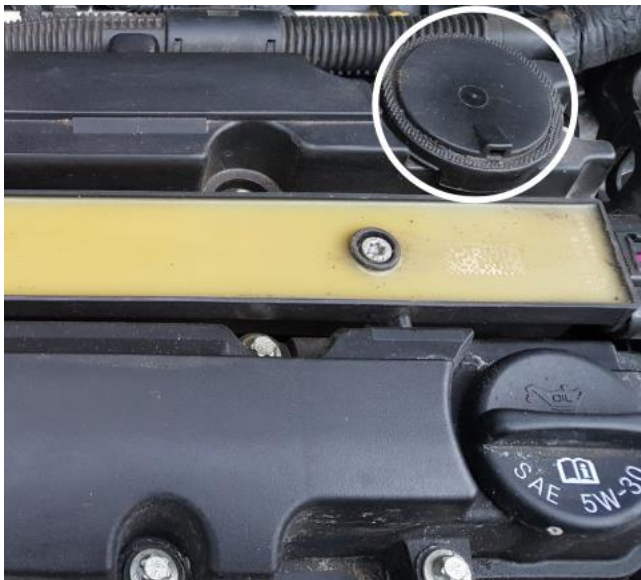
5354610

- 2.3 With the engine running, listen for noise coming from the PCV valve, shown above. If noise is heard, check to see if the noise gets quieter or disappears with the engine oil dipstick removed.
- 2.4 Reinsert the dipstick.

2.5 Check to see if there is vacuum at the PCV vent at the front of the PCV valve by placing a piece of tissue near it. The tissue will be sucked against the vent and held if vacuum is present.

- If the PCV valve is making noise and there is vacuum present at the PCV valve vent, replace the Camshaft Cover. Refer to *Camshaft Cover Replacement* in SI.
- If the PCV valve does NOT make noise or leak vacuum, no further diagnosis or repair is covered under this special coverage. Claim diagnostic time and inform the customer that any further diagnostics or repair will have to be covered by customer pay, warranty, or good will.
