## Technical product information

| <b>Topic</b> | DTC P14AB00 and/or other related exhaust flap DTC's - Warning lamp evident within the DIP |
| <b>Brand</b> | Bentley |

### Bentayga V8 Kovomo and Bentayga W12TSI

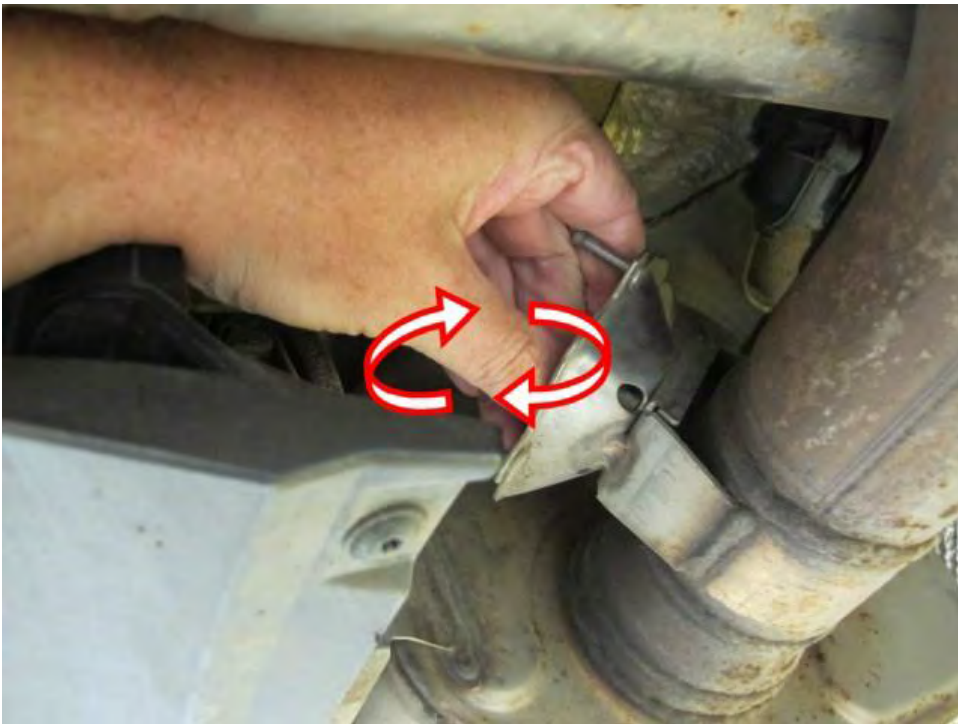
Figure 1

- Check and confirm the exhaust flap can be rotated by hand (clockwise and anti-clockwise) without the control unit fitted (Figure 1)

- Should no issue be evident with the exhaust flap and it can be freely rotated by hand - Replace the defective exhaust flap control unit Refer to Rep.Gr 26
