# Technical Service Bulletin

## 37 Transmission malfunction, DTC P17F600, U008000, and/or U010100 stored in the TCM or ECM

37 19 88 2053878/4 August 14, 2019. Supersedes Technical Service Bulletin Group 37 number 19-86 dated March 21, 2019 for reasons listed below.

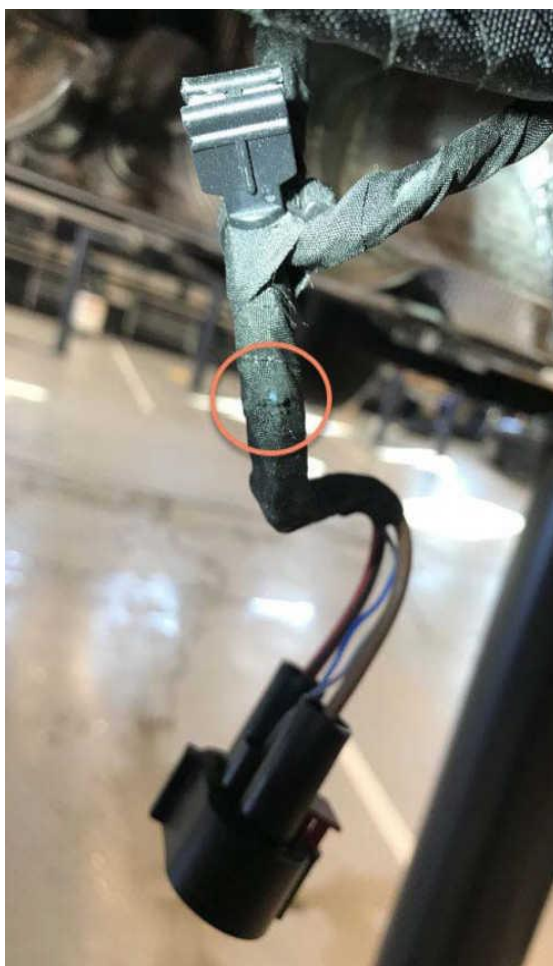
**Figure 3.** The damage on the harness might be difficult to spot.

2. Replace the transmission harness with a new part and reroute the transmission harness. The transmission harness should not be repaired.
  - Remove the old transmission harness in the vehicle.
  - Wrap the exposed wires on the new transmission harness as shown in Figure 5.
  - Mount and route the new transmission harness as shown in Figure 6.
