# Technical Service Bulletin

## 91 SOS Warning displayed in instrument cluster, DTC B18BE13 or B18BD13 stored in the telematics control module

91 19 82 2054038/2 August 26, 2019. Supersedes Technical Service Bulletin Group 91 number 19-41 dated February 28, 2019 for reasons listed below.

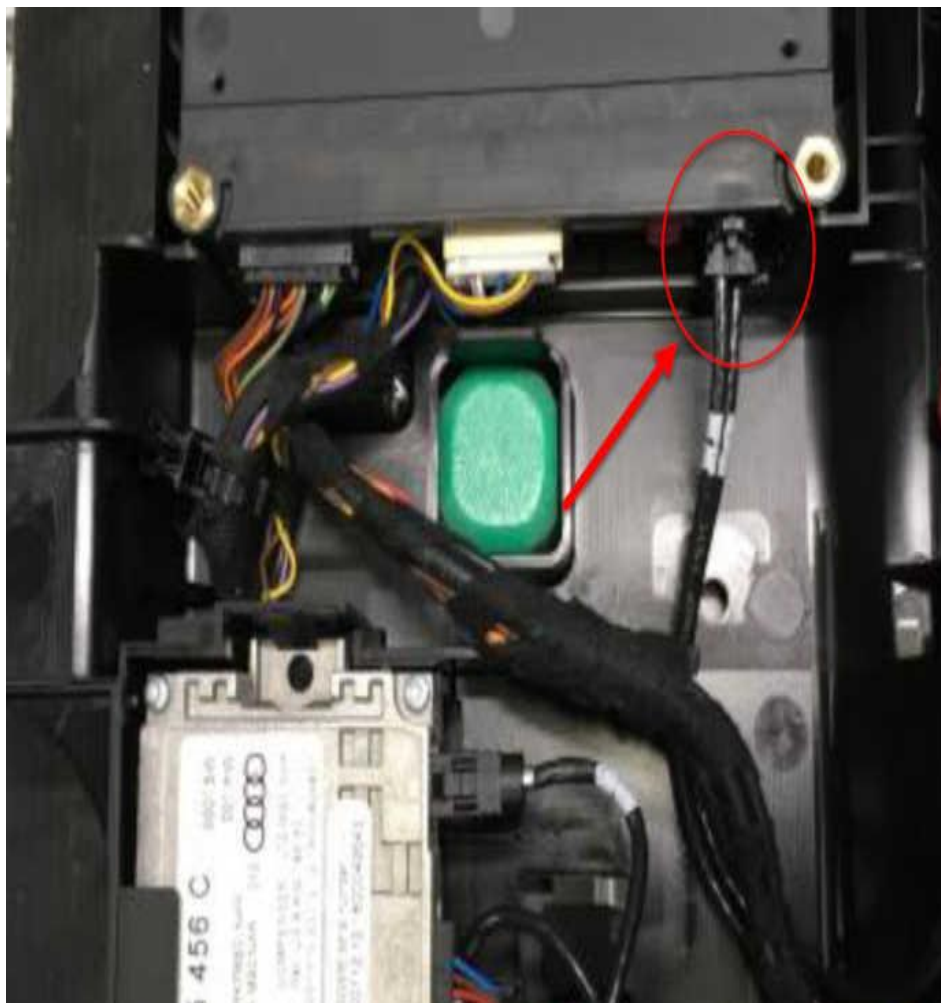
**Figure 1.** Telematics Control Module (J949) Connector.

The 4 pole connector pins might have been widened during the assembly process.

1. Remove the original 4 pole connector including its pins and remove a section of the vehicle's coaxial wiring for the applicable antenna circuit.

2. Replace the original 4 pole connector and cable with the new connector harness and pins.
3. Before plugging the new 4 pole connector in, make sure that the telematics control module, J949 (address word 0075) is mounted properly in its bracket.
