## 93 Various warning messages about drive in the cluster, DTC U029200 stored in the ECM or the electric drive module

93 19 13 2055804/1 August 19, 2019.

| Model(s) | Year | VIN Range | Vehicle-Specific Equipment |
|---|---|---|---|
| Audi e-tron quattro | 2019 | All | Not Applicable |

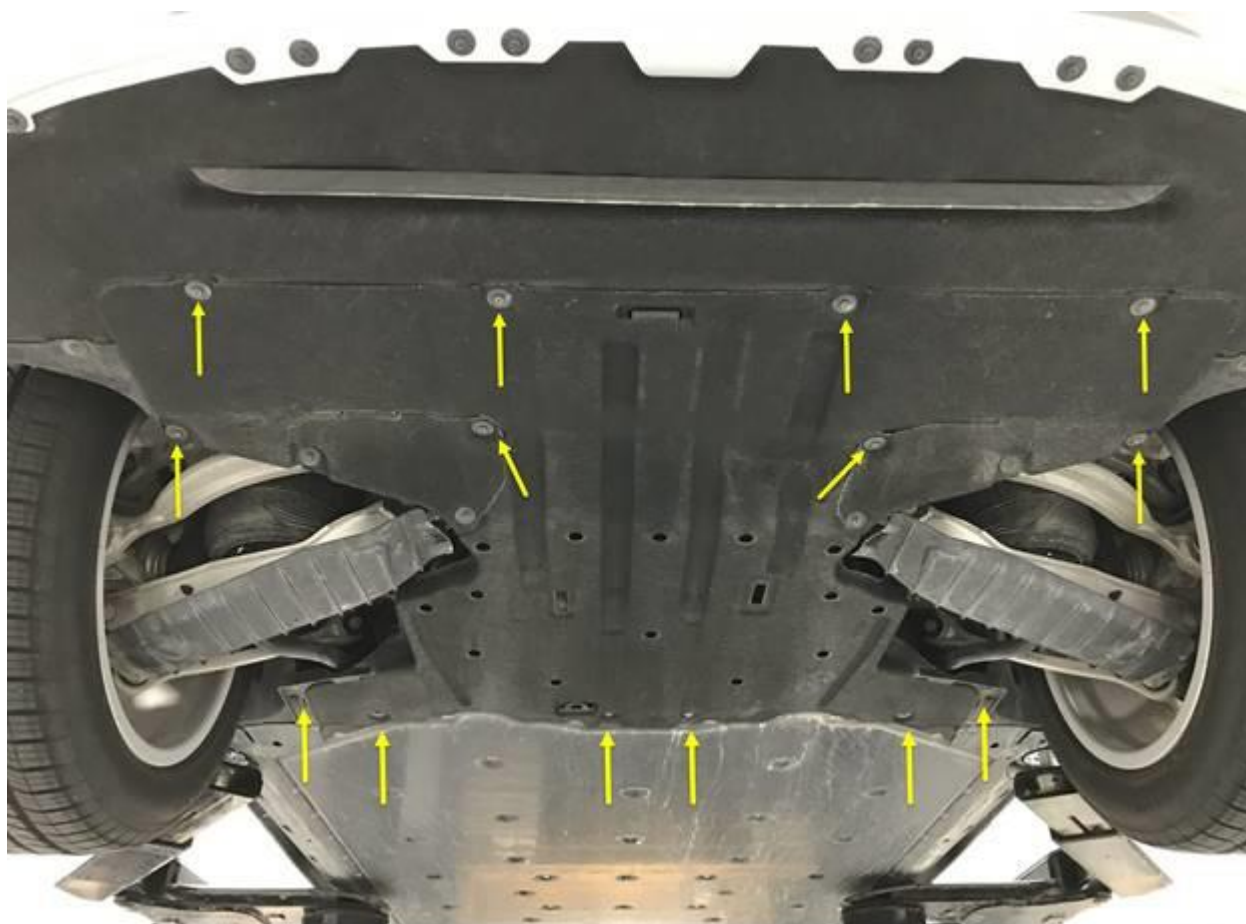
**Figure 1.** Remove the lower shield.

1. Remove the lower under shield from the rear of the vehicle and gain access to the rear electric drive harness for inspection (Figure 1).

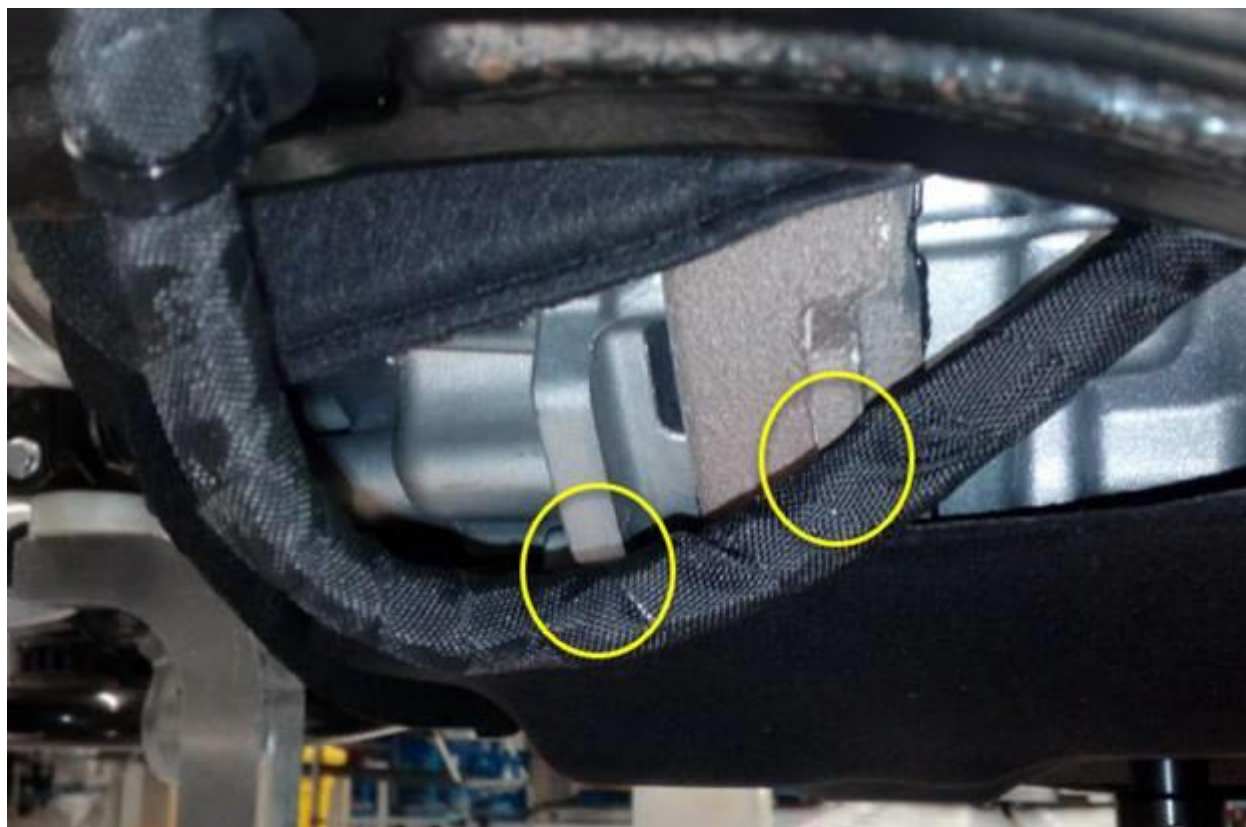
The low voltage wiring harness for the rear electric drive motor may be damaged due to incorrect routing.

**Figure 3.** *Inspect for potential chaffing between the transmission lugs and the harness.*

3. If damage is found repair the affected cables as needed with the VAS1978B.
