**August 28, 2019**

Version 2

## Horn Does Not Work

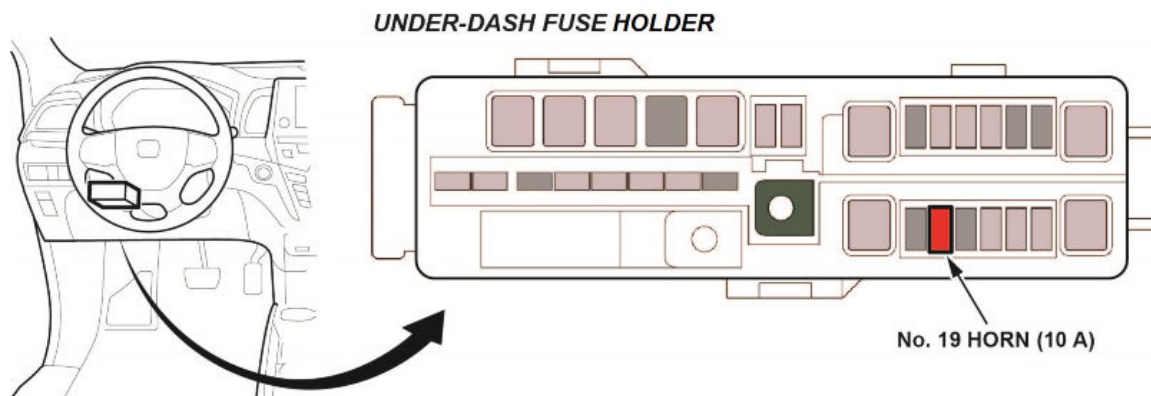
The No. 19 HORN (10 A) fuse is blown or DTC B26AE (horn overload failure) is set.

1. Check the No. 19 HORN (10 A) fuse in the under-dash fuse holder.
