EC19-026

ITB19-022

## 2017-2019 QX60; MIL ON WITH DTC P0087 STORED

APPLIED VEHICLES: 2017-2019 QX60 (L50)

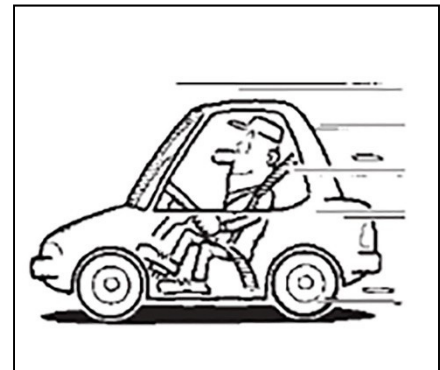
Figure 1

- If you are not familiar with the reprogramming procedure, *click here*. This will link to the "CONSULT- III PLUS (C-III PLUS) ECM Reprogramming" general procedure.
- Take the vehicle for a 10 minute drive in order to meet the following Idle Air Volume Learn (IAVL) conditions:
  - Engine coolant temperature: 70-100°C (158-212°F)
  - Battery voltage: More than 12.9V (At idle)
  - Transmission: Warmed up
- After reprogramming is complete, it is required to perform Throttle Valve Closed Position, Idle Air Volume Learn, Accelerator Closed Position, and DTC Erase.
