Preliminary Information

PIT5288G RKE / Passive Entry And Start / No Audio / SWC / Touch Screen / Display Blank/ Rear Wiper And Rear Power Windows Inoperative / Dead Battery / Service Tire Pressure System / SES MIL DTC B3101 B144C C0710 C0544 P0106 P0107 P2122 P2123 P2127 P2128 P2138 U0028 U0029 U0077 U0126 U0151 U0415 U1548 U1549 U154A

Product Investigation Review Required

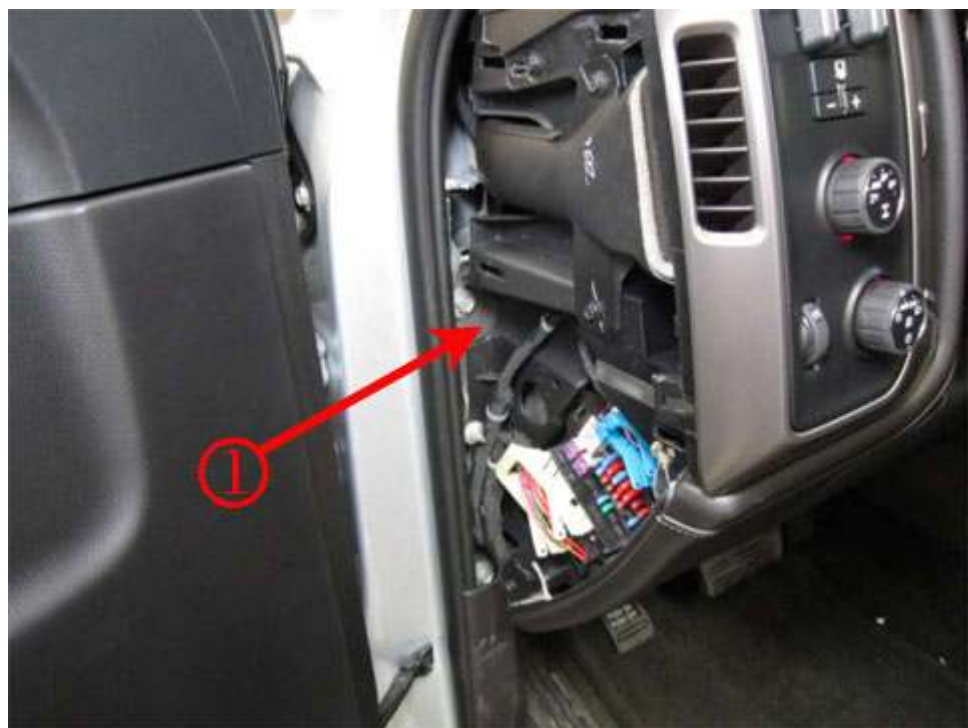
These concerns could be caused by the dash harness being pinched between the left I/P dash mounting bracket (1) and the body. Shown below, is the left I/P mounting bracket (1) as seen when the I/P fuse block cover is removed from the end of the dash. This picture is for reference only and the wiring must be inspected from under the dash.

**To repair this concern, loosen the left I/P dash mounting bracket bolts and pull the harness free. Open the harness and repair any damaged wires as necessary.**

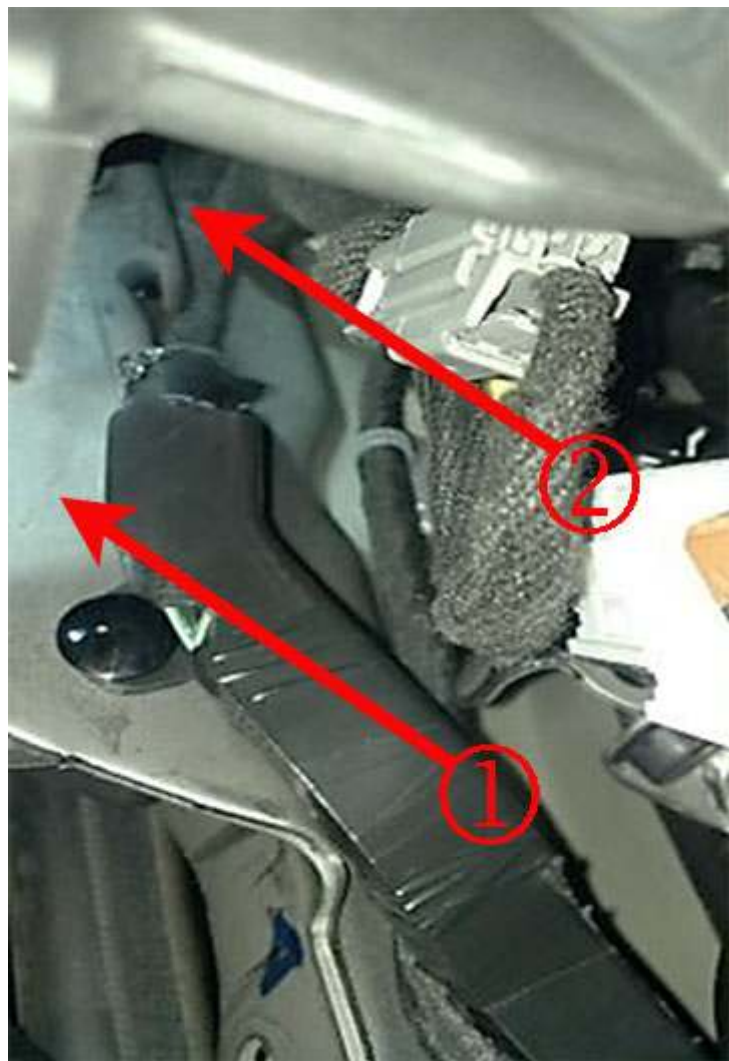
As shown below, the wiring harness (2) is pinched at the upper portion of the I/P mounting bracket (1). In many cases, the complete harness may not be pinched and it can be difficult to see that the harness is damaged. When inspecting for a pinched harness, make sure the harness can be moved freely away from the bracket to body interface.

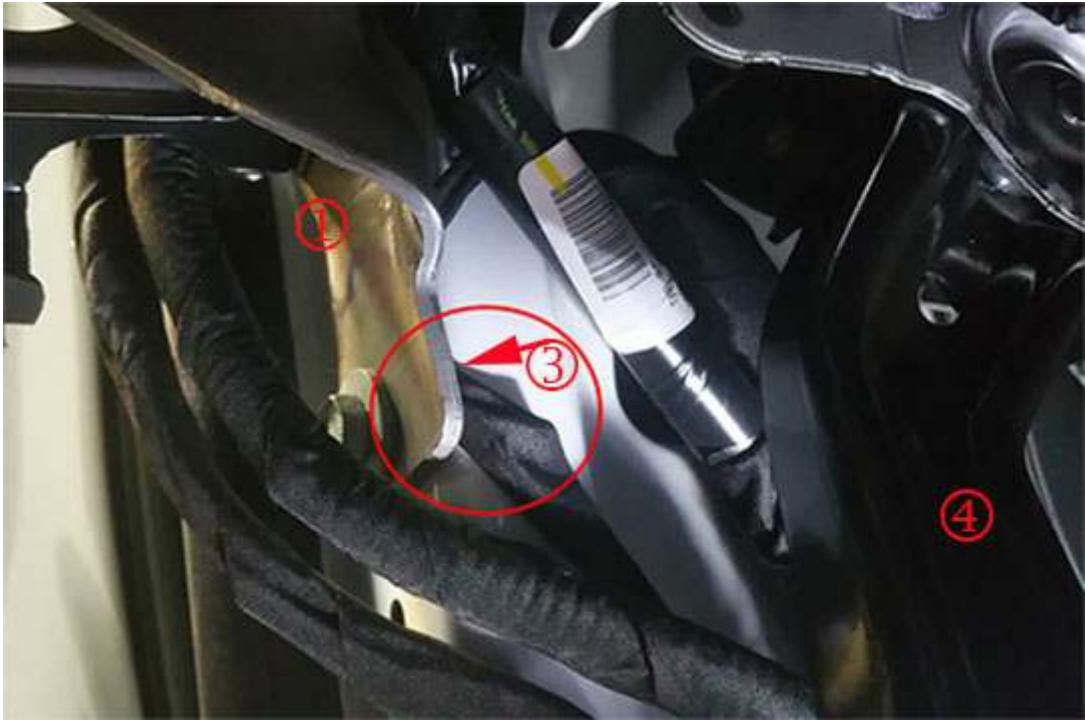
As shown below, the wiring harness (3) is pinched at the lower portion of the left I/P mounting bracket (1). For reference only, call out (4) is the parking brake pedal.
