PIP5651D Possible Charge Air Cooler Outlet Hose Disconnected From Throttle Body And One or More of The Following DTCs P0172, P0299, P0101, P0506, P1101

Proactive  
Product Investigation Review Required  
Models

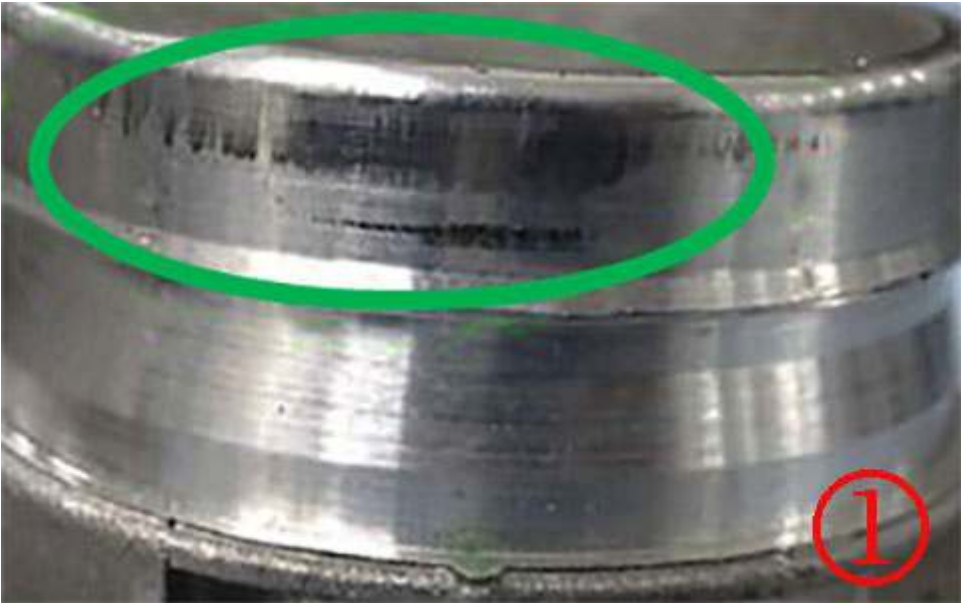
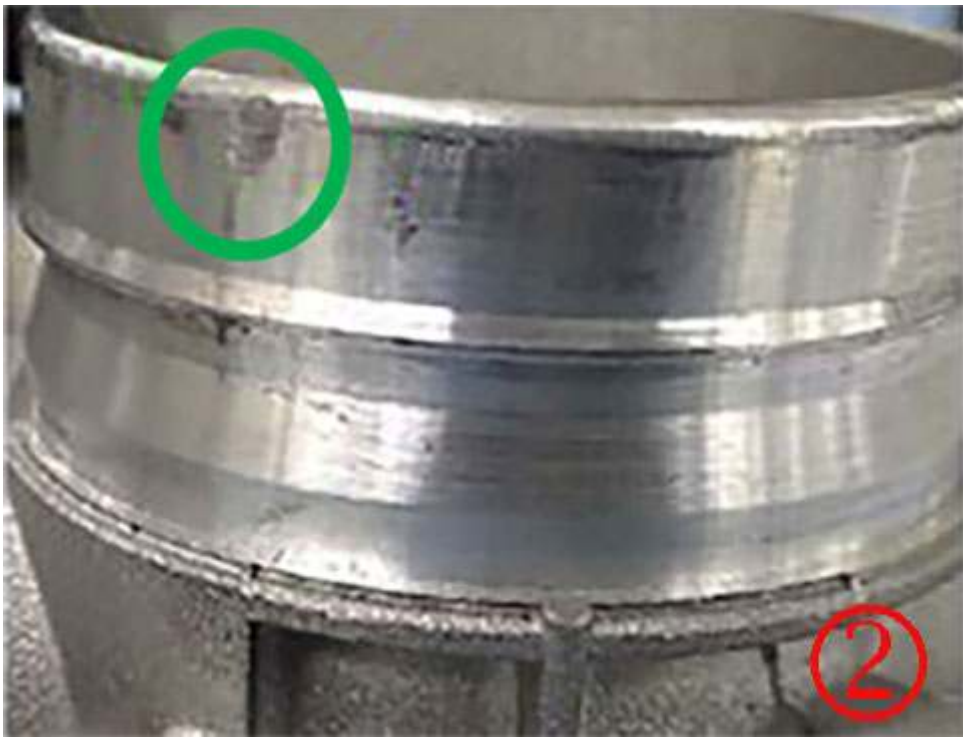
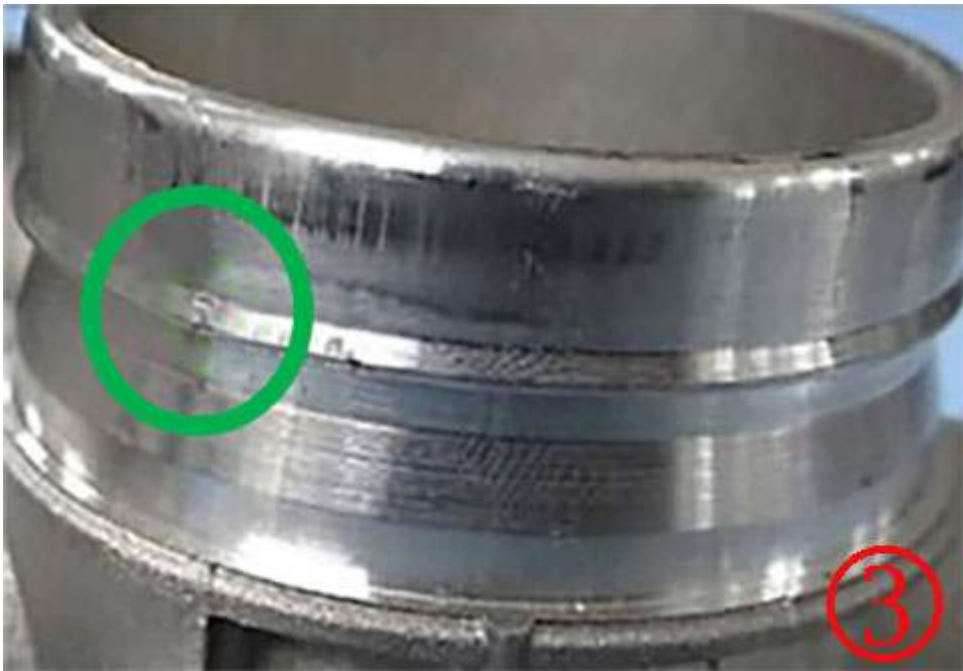
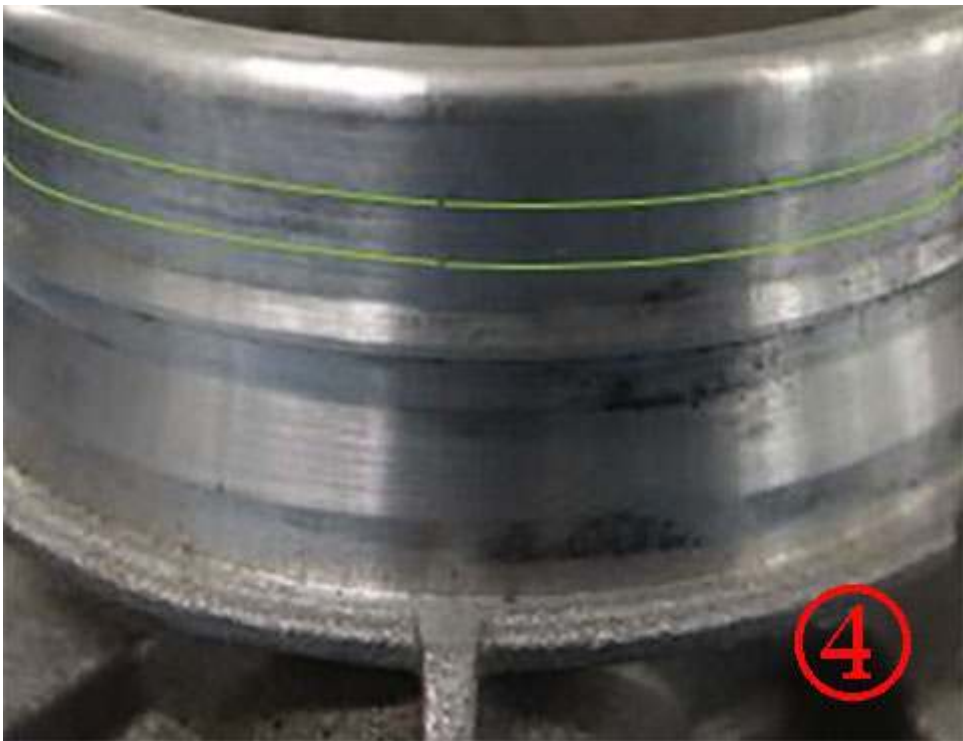
Photos 1-4 below show normal witness marks on the throttle body and normally will not require replacement.

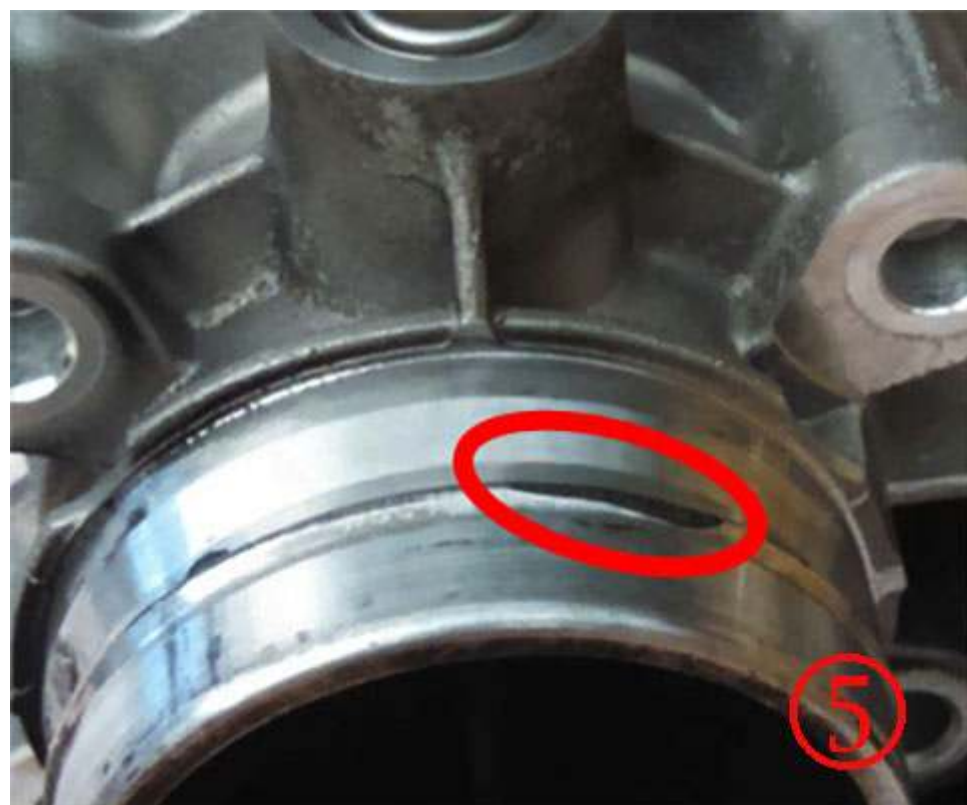
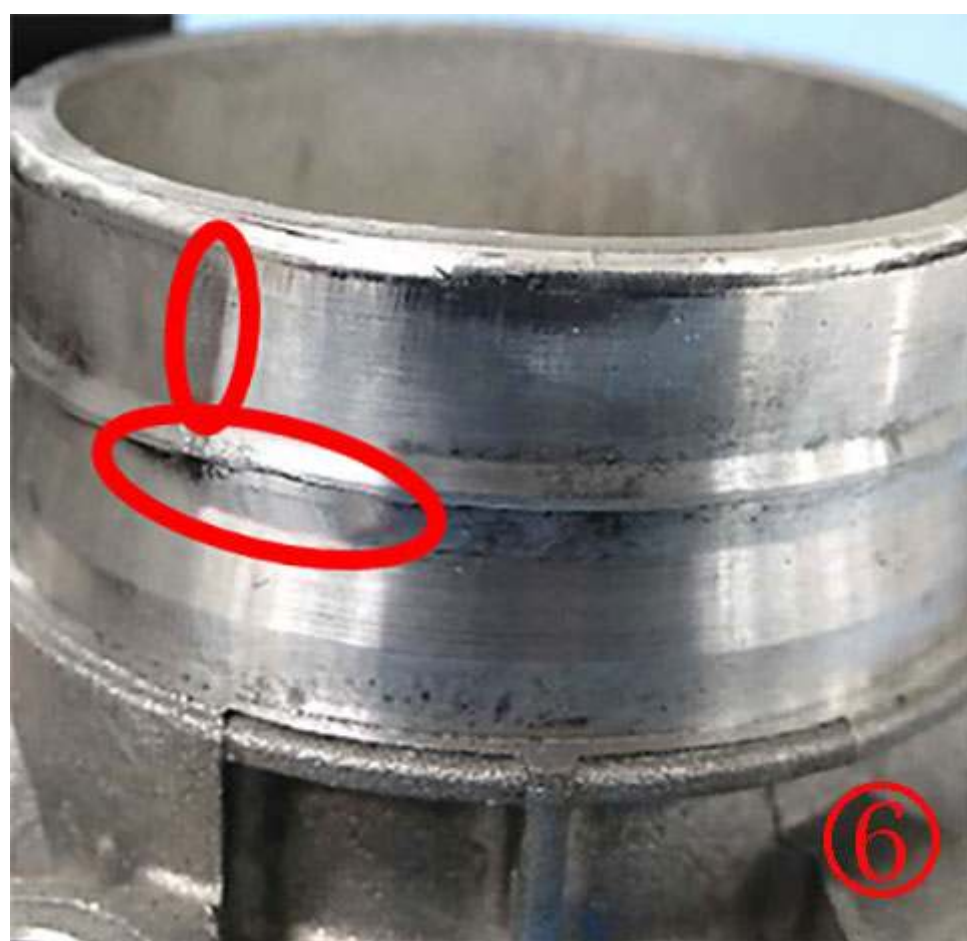
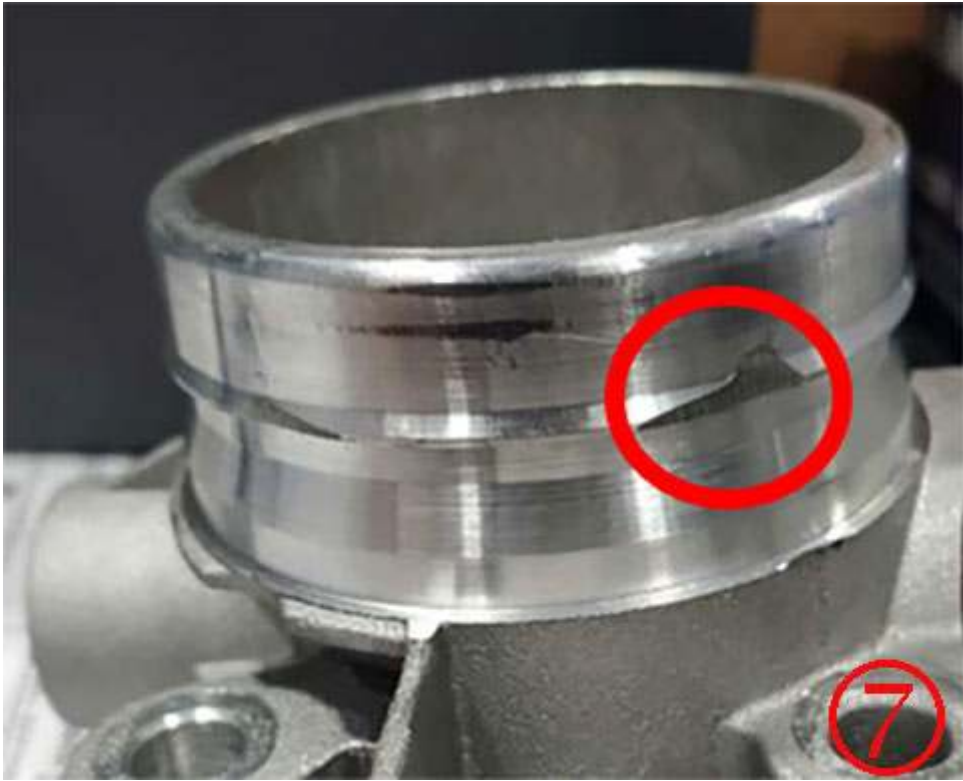
Photos 5-7 below show abnormal witness marks or damage to throttle body and replacement would be required.

If the tube is disconnected from the throttle body, inspect the charge air cooler tube and throttle body for damage. In rare cases either are damaged then replace the damaged part (reference photos below showing).The throttle body and mass airflow (MAF) sensor associated with the listed codes should only be replaced if they are damaged or found to be the cause of the code.
