LTB01309NAS1

# TECHNICAL BULLETIN

Rattling Noise From Engine And Malfunction Indicator Lamp (MIL) Illuminated

| MODEL: | MODEL YEAR: | VIN: | ASSEMBLY PLANT: | APPLICABILITY: |
|---|---|---|---|---|
| Range Rover Sport (LW) | 2019 | 813622-871409 | Solihull | INGENIUM I6 3.0L Petrol |

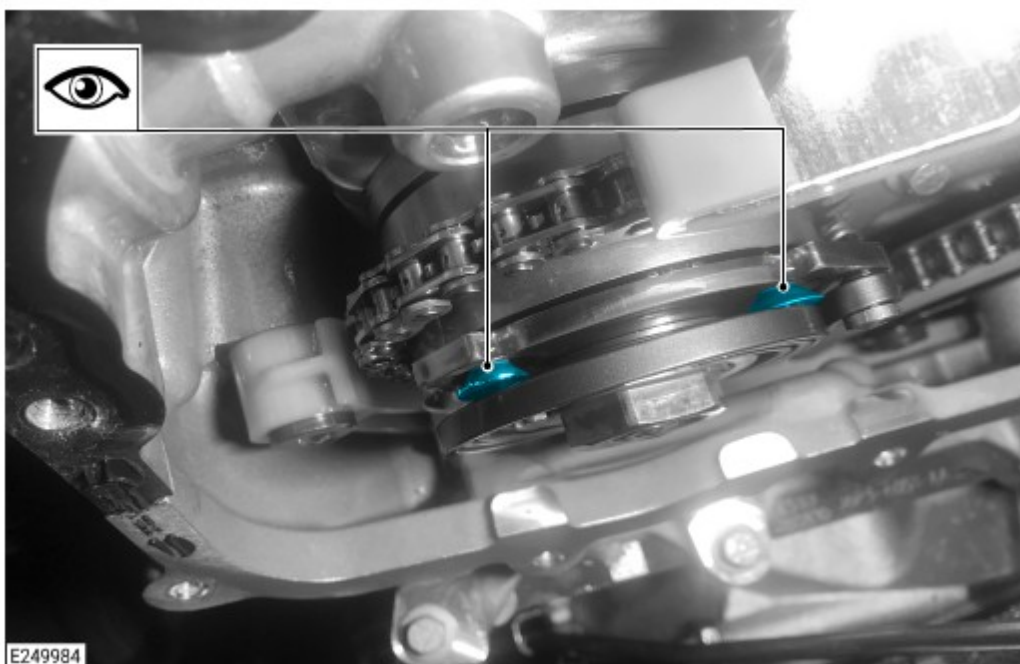
2.

The retaining bolt(s) for the inlet Variable Camshaft Timing (VCT) actuator have become loose.

To assist with diagnosis, the image shows the loose VCT actuator bolt(s) on the inlet camshaft.

Also renew the exhaust VCT actuator due to potential consequential damage caused by the chain rattling.

1. Renew the inlet and exhaust VCT actuators, (see TOPIx Workshop Manual section 303-01F: Engine - INGENIUM I6 3.0L Petrol - Repairs - Variable Camshaft Timing Actuator - Engine Set).
