# Technical Journal

**Park Assistance “Sensor Blocked” warning message, XC90 R-design**REF NO:  
**TJ 34922.1.0**ISSUING DEPARTMENT:  
**Technical Service**CAR MARKET:  
**United States and Canada**PARTNER:  
**3 US 7510 Volvo Car USA**ISSUE DATE:  
**2019-08-22**STATUS DATE:  
**2019-08-30**FUNC GROUP:  
**3871**FUNC DESC:  
**Parking assistance**

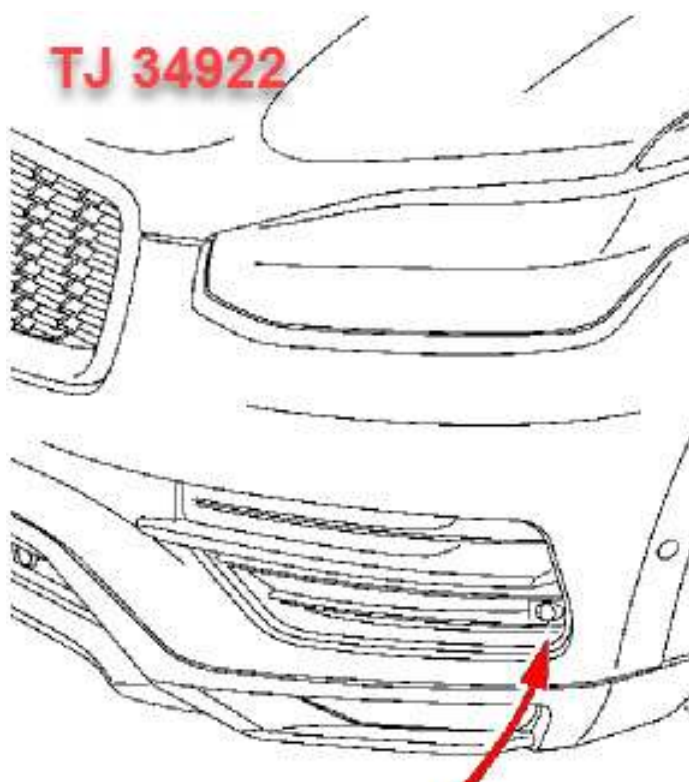
If there is message in the DIM about "Sensor Blocked" and the car has DTC CEM B1B3629 and/or B1B4029, follow instructions under "Service".

Replace the left and right front outer parking assistance sensors with the latest part number according to VIDA instructions. See attachment TJ 34922\_1.jpg to correctly identify affected sensors.
