# Technical Service Bulletin

## 94 Vehicle lights malfunction message in instrument cluster, DTC 03280, 01800 or B126AF0 stored in the vehicle module

94 19 13 2017806/12 September 17, 2019. Supersedes Technical Service Bulletin Group 94 number 15-64 dated March 4, 2015 for reasons listed below.

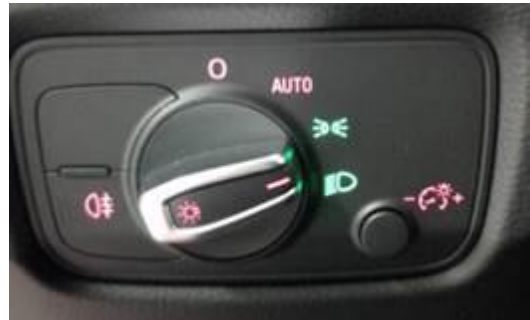
If the headlight switch is moved to an intermediate position and remains there (Figure 1), the light bulb warning light and the error message appear after approximately ten seconds (Figure 2).

**Figure 1.** A headlight switch in an intermediate position.

Determine if the above situation applies to the vehicle, and explain the *Technical Background* to the customer. Replacing parts does not change the behavior.

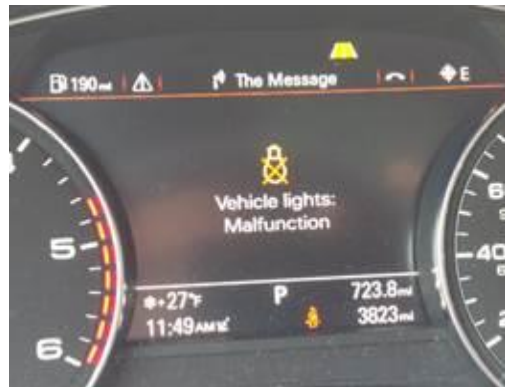
**Figure 2.** The warning light and error message in the instrument cluster display.

Once displayed, the message turns off after approximately five seconds. The light bulb warning light turns off only after the headlight switch is turned to a defined position, and the status of **DTC 03280**, **DTC 01800** or **DTC B126AF0** are changed to sporadic.
