MODEL  
2018-2019MY  
Niro (DE PHEV)

NUMBER  
161 (Rev 1, 09/16/2019)

## TECHNICAL SERVICE BULLETIN

SUBJECT: COMBINATION TSB / SERVICE ACTION: COOLANT  
LEAK – OBC INLET HOSE DETACHING (SA365)

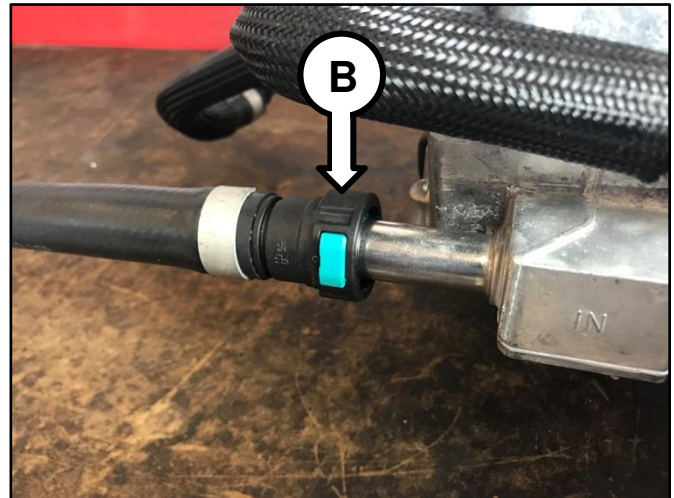
OBC assembly and inlet hose removed from vehicle for demonstration purposes only.

2. Ensure the OBC inlet hose (B) is fully installed.
