# Preliminary Information

## PIT5707 ABS MIL and/or Service Stability Message with C050A and/or C0504 set

| Brand: | Model: | Model Years: | VIN: | | Engine: | Transmissions: |
|---|---|---|---|---|---|---|
| Chevrolet | Silverado 2500HD/3500HD | 2020 | All | All | All | All |
| GMC | Sierra 2500HD/3500HD | 2020 | All | All | All | All |

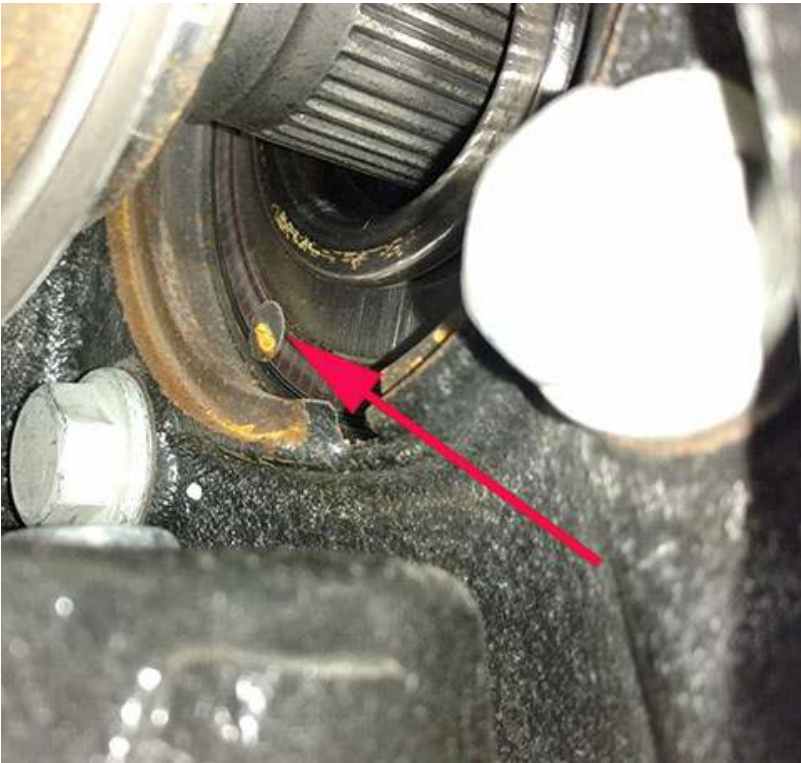
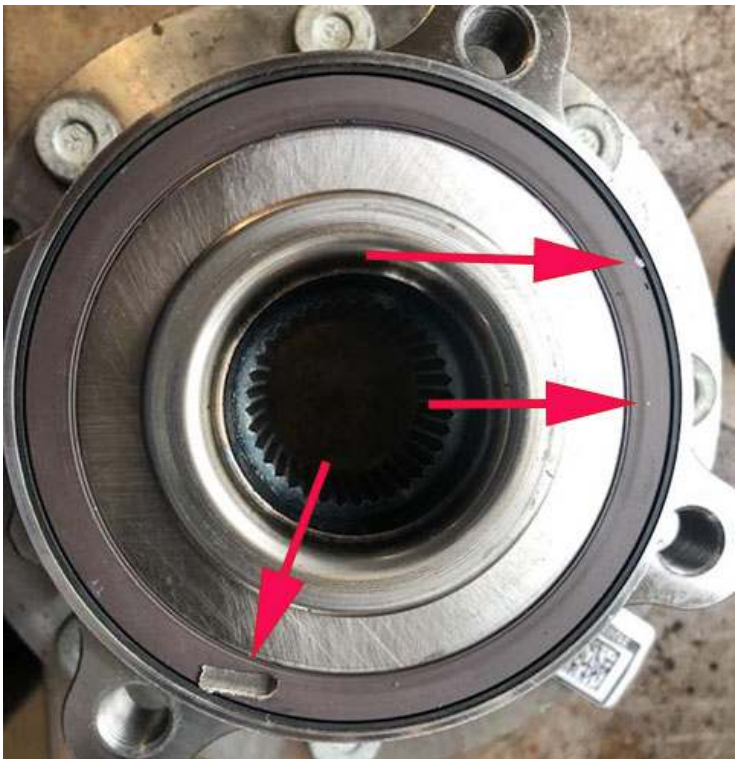
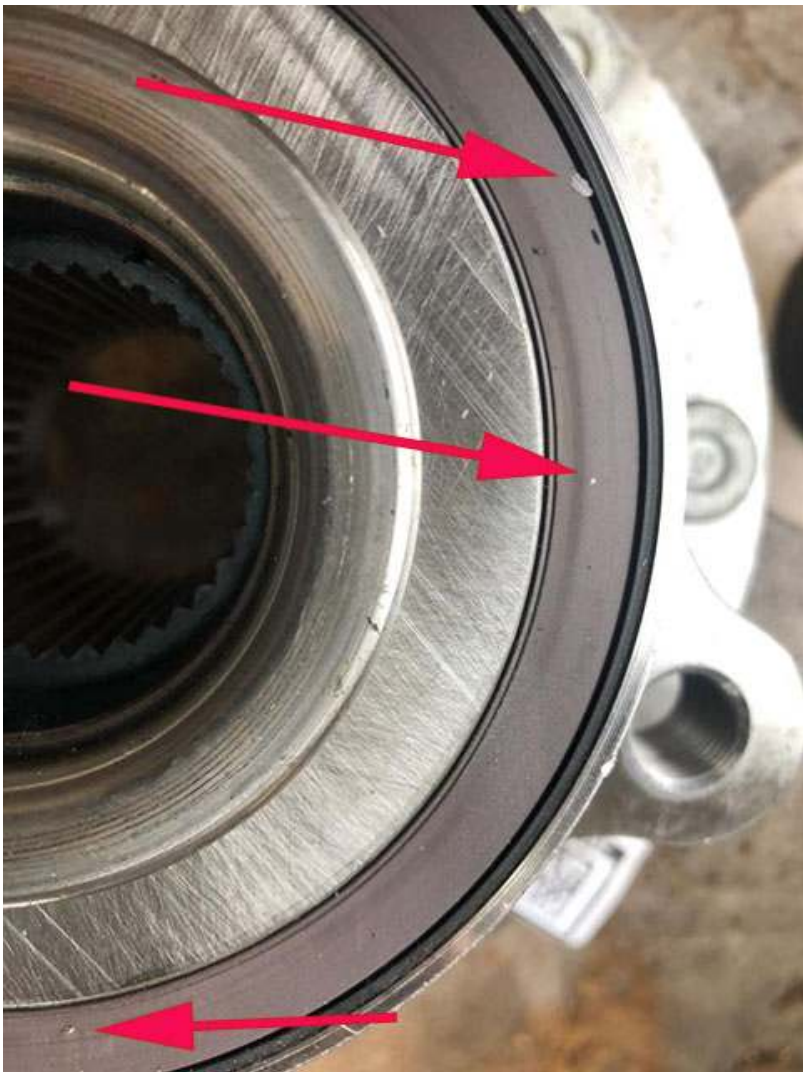
| Condition | Some customers may comment the ABS MIL is on and/or Service Stability Message is displayed on the DIC. Technicians may find DTC's C050A or C0504 set in the EBCM. |
| Cause | There may be debris from manufacturing on the wheel speed sensor reluctor ring (as shown below.) |

Clean debris from reluctor wheel, clear DTC's, and test drive to verify DTC's do not reset.

**Note:** DO NOT use a magnet to remove the debris from the reluctor ring.

It may be necessary to remove the front wheel bearing assembly to find and remove debris.
